HMS *Velox*

Site Report

**FORGOTTEN WRECKS
OF THE FIRST WORLD WAR**

**HMS *VELOX*
SITE REPORT**

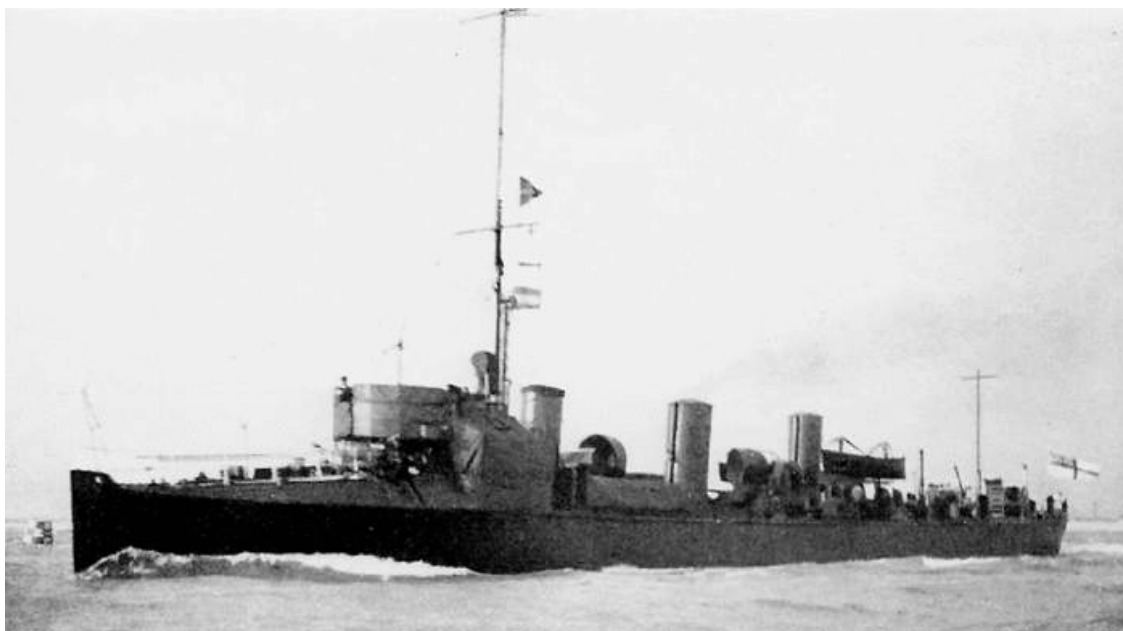
Figure 1: HMS *Velox* (Source: Wrecksite EU, no copyright stated)

HMS *Velox* (Figure 1) was chosen as one of the Forgotten Wrecks case study sites because it was part of the Snake class of Naval vessels, along with HMS *Viper* and HMS *Cobra*, that were notable for signaling the beginning of Royal Naval vessels using steam turbine propulsion. Prior to these vessels the reciprocating piston steam engine was used. This changed with the experimental craft *Turbinia*, the motor of which was invented by C. A. Parsons. The *Turbinia* used a compound steam turbine and impressed the Admiralty to the extent that in 1898 they commissioned Charles Parsons to build a destroyer using turbine machinery. This was the first turbine powered Naval vessel, HMS *Viper* (Laird Clowes, 1997). Both *Viper* and *Cobra* were lost in 1901 (see Section 3.4).

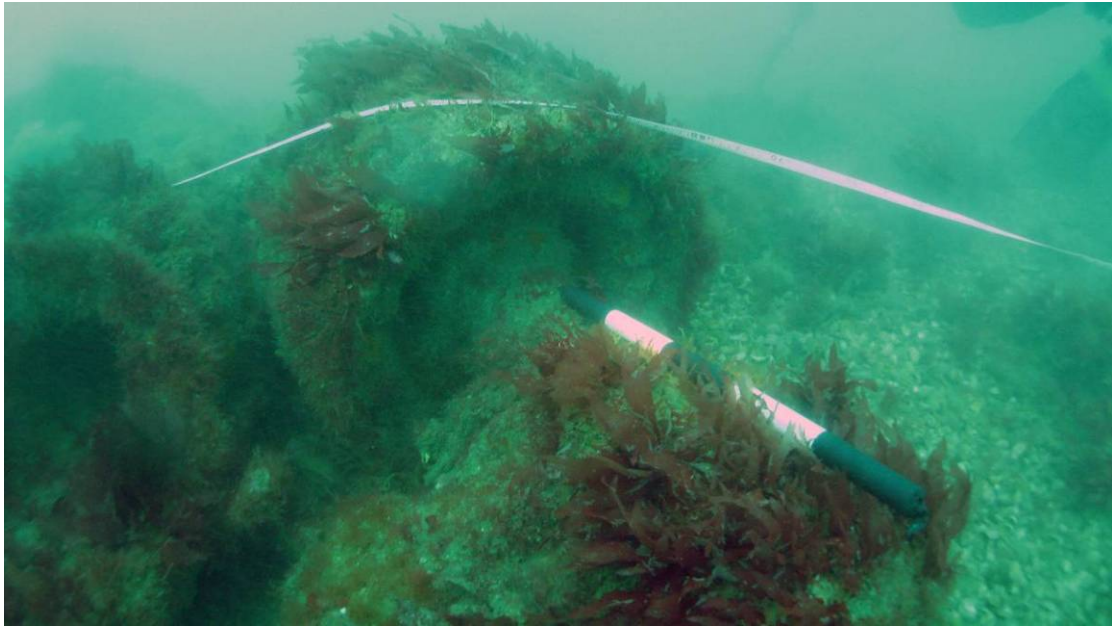
Figure 9: Engine part visible on seabed

The site consists of a number of individual features separated by areas of seabed. In the central area of the site lies the remains of part of the engine (Figure 9) and a funnel (Figure 10).

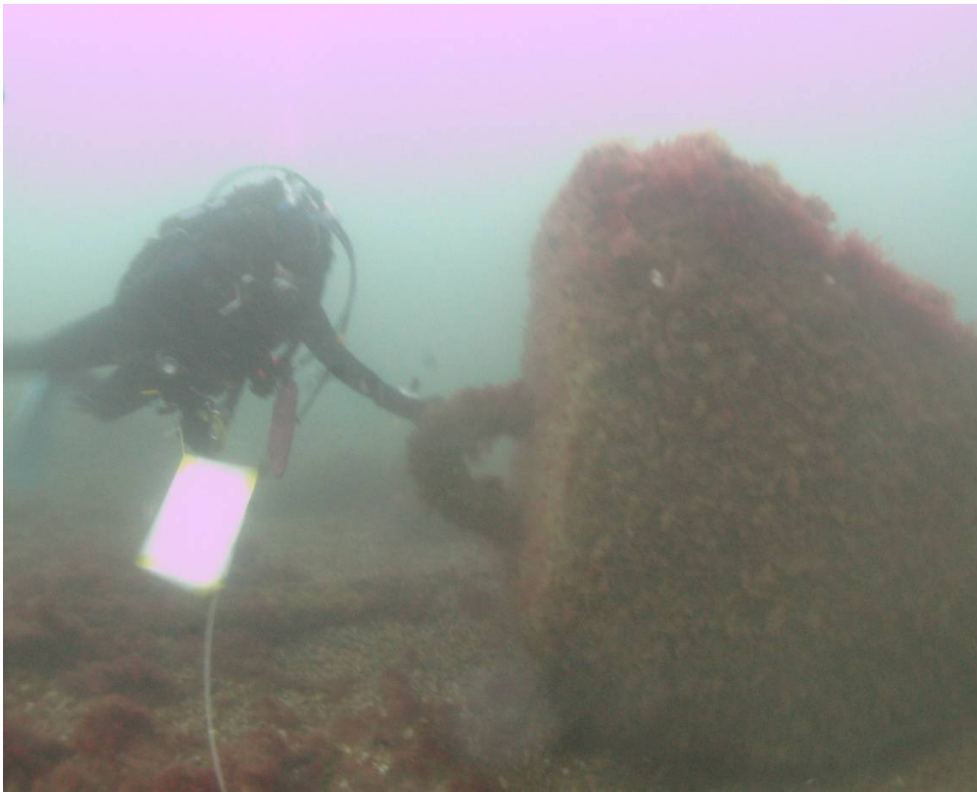
Figure 13: Concrete mooring block

The site also shows evidence of previous salvage/diver activity, with a series of concrete mooring blocks scattered across the area (Figure 13).

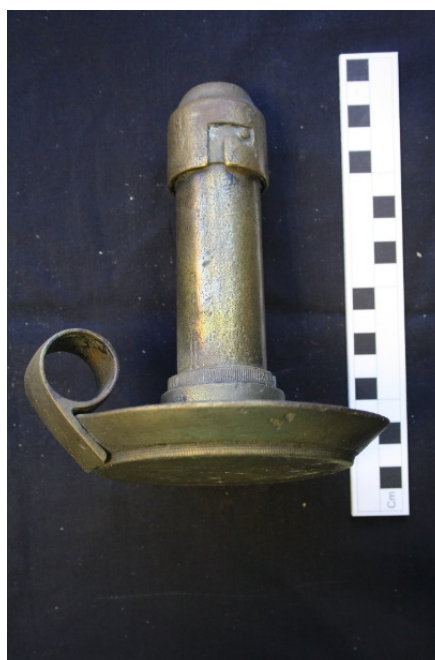
Figure 14: Brass candle holder (FW0250)

An example of ships equipment is a brass candle holder (Figure 14).

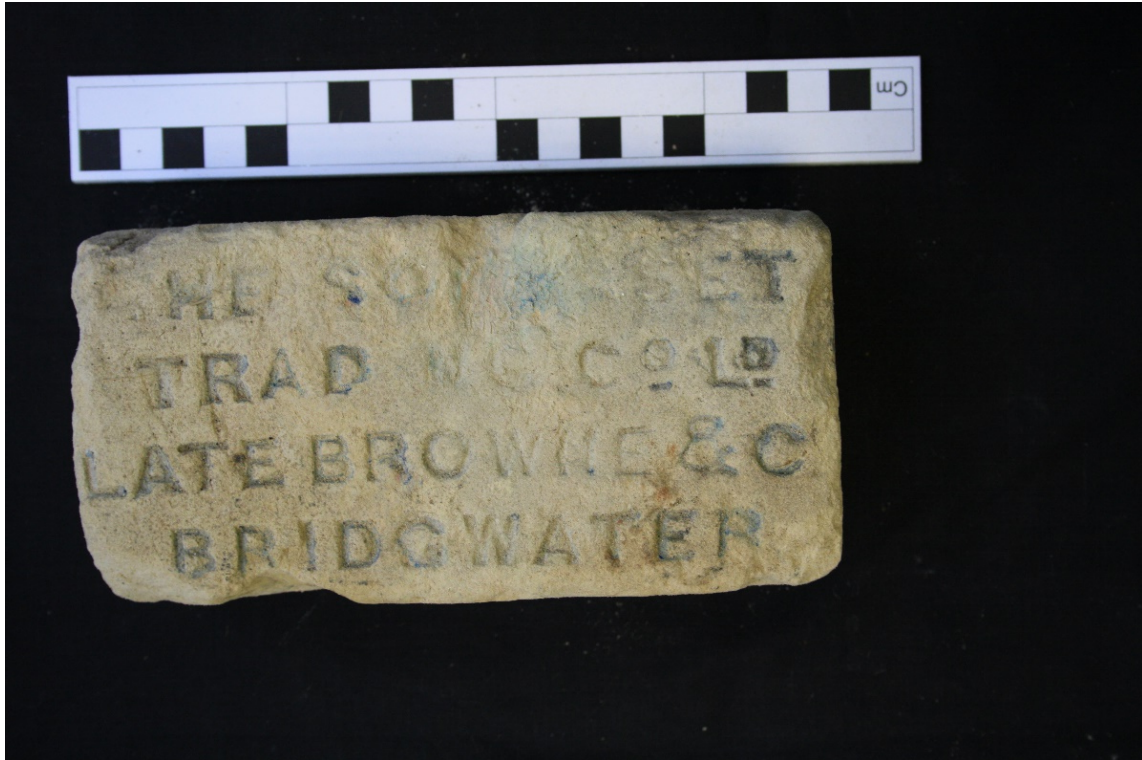
Figure 15: Fire brick (ID FW0254) has also been produced as a 3D computer model

A fire brick that was recorded using photogrammetry and a 3D computer model produced is available to view at <https://sketchfab.com/models/767a93473cc946b2bbfa435348e63534>. The brick (Figure 15) made up part of the coal burning furnace that heated water for the Parsons Marine steam turbines, a fairly new, but important form of technological advancement when *Velox* was launched in 1902.

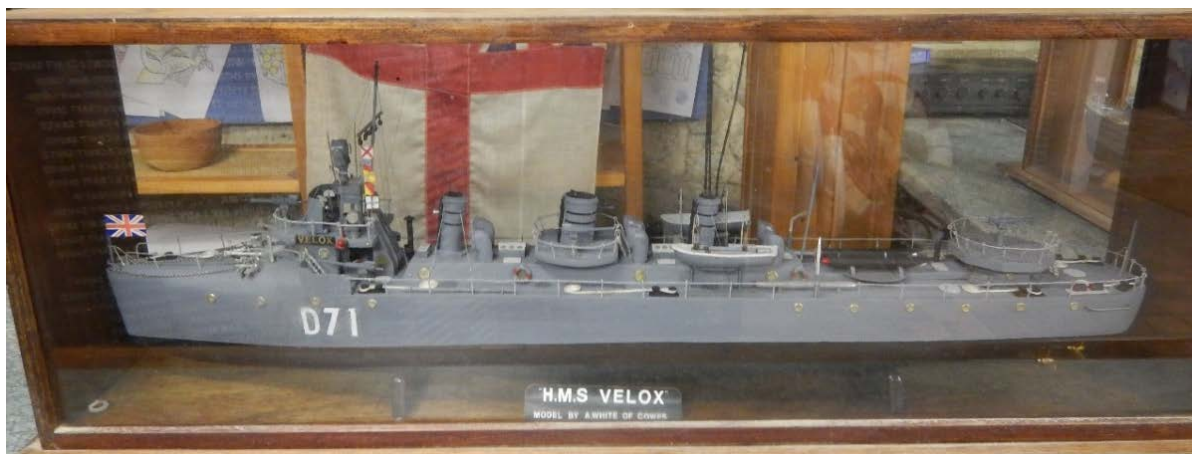
Figure 16: Model of HMS *Velox* at the Shipwreck Centre on the Isle of Wight

The Shipwreck Centre and Maritime Museum also have a model of the *Velox* built by A White of Cowes (Figure 16), and a model built by Steve Pickering can be seen sailing in Richmond Park at <https://vimeo.com/73461624>
