**Forgotten Wrecks
of the
First World War**

SS Eleanor

Site Report

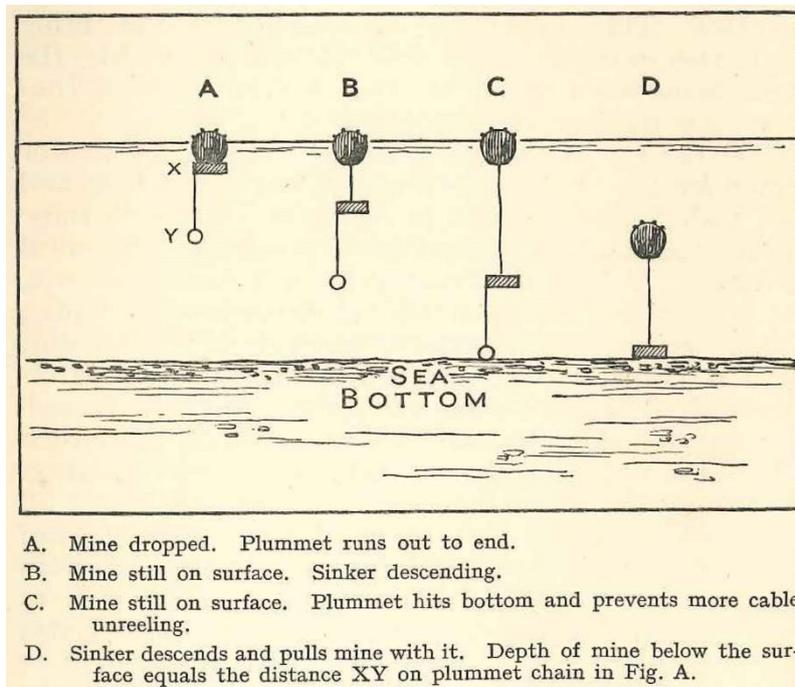
Figure 2: Diagram showing mine components referred to in *Eleanor's* cargo manifest (Taffrail 1935)

They are found in large concentrations at the stern of the ship, being some of the 600 Mark VI mine sinkers, recorded in *Eleanor's* cargo manifest (see Section 3.3, Figure 2, 39 & 40).

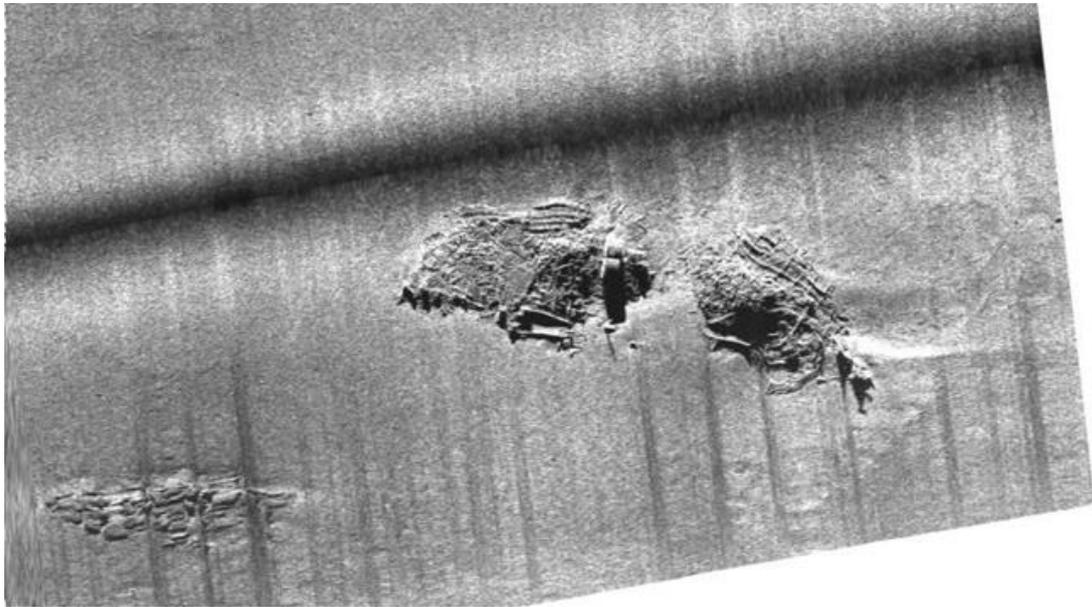
Figure 11: Sidescan sonar images of NB1046 (Navitus Bay Wind Park 2013)

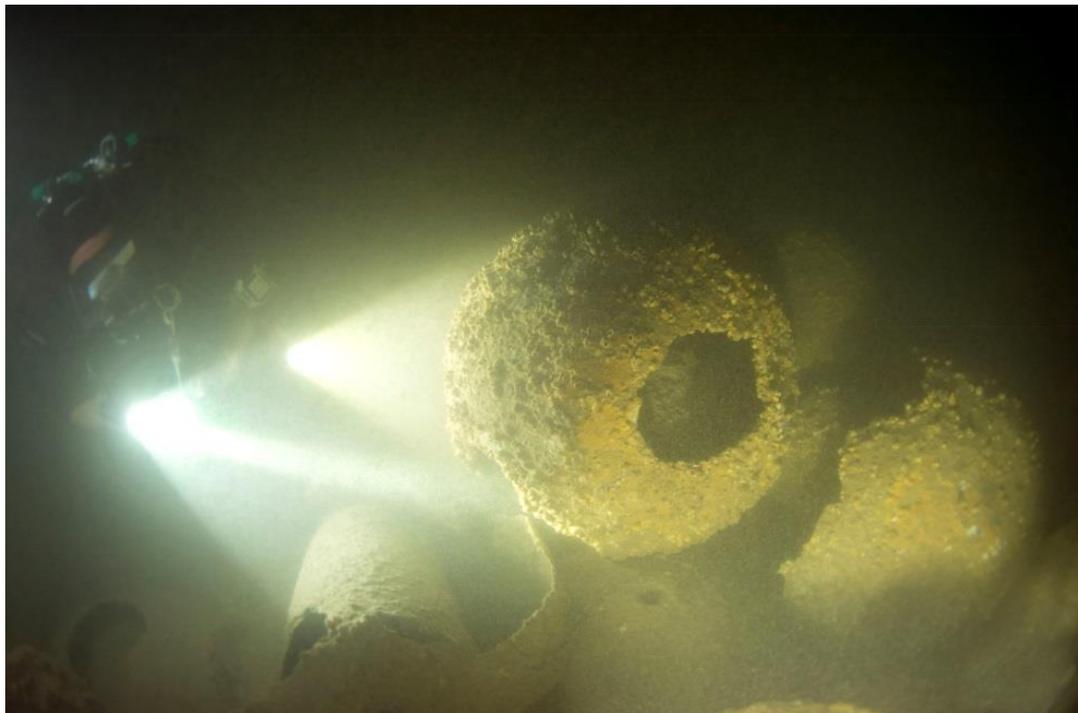
Figure 12: Mines photographed with powerful lights, corrosion of the munitions is evident ©Michael Pitts

Conditions were such that it was not possible to take measurements which might have enabled identification of the type of mine (B.E. or Naval Spherical Mk III – see Section 3.3).

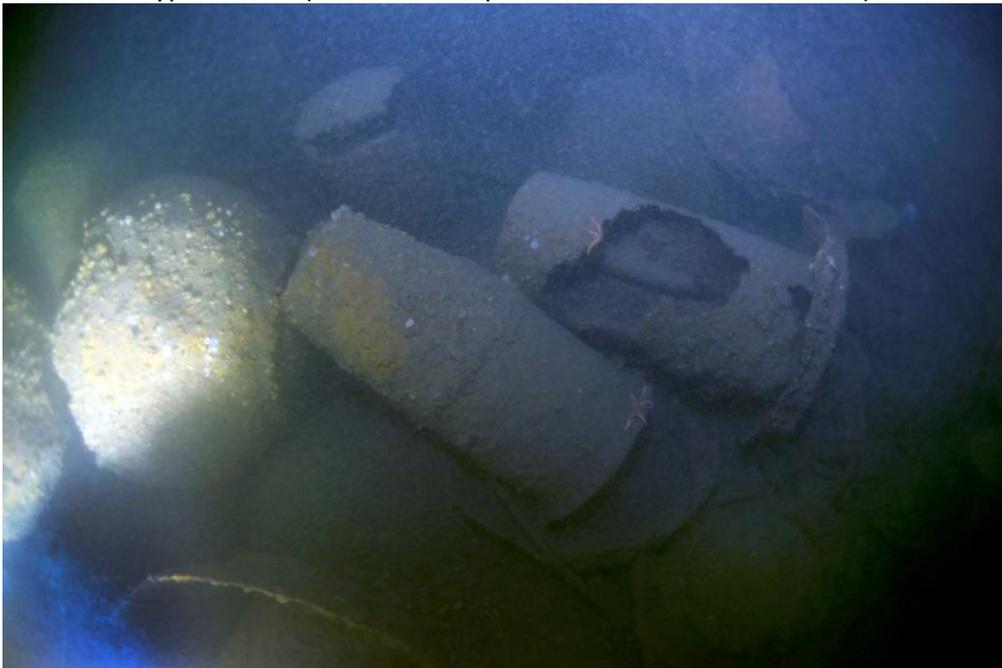
Figure 13: Depth charges and mines lie in piles forward of the boilers ©Michael Pitts

In Figure 13, two depth charges can be seen lying next to each other and some spherical mines. Only the end (right side) of the outer cylindrical canister of the depth charges survives, revealing an inner tapered cylinder which held the charge.

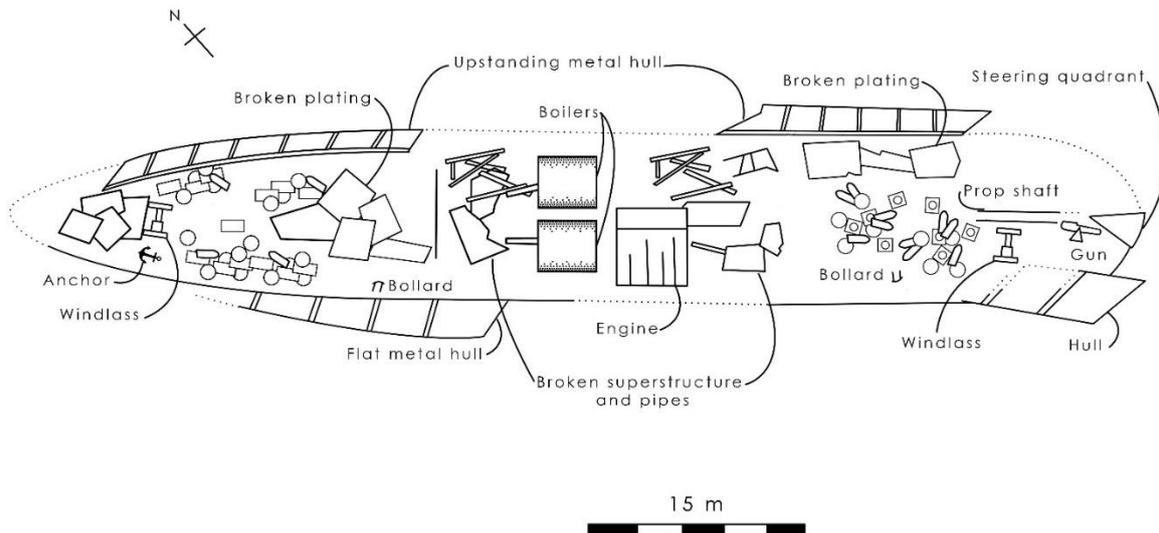
The measured site plan (Figure 14) produced following the dives in extremely low visibility in 2014 shows a simplified representation of site layout.

Figure 14: Measured site plan of the wreck of Eleanor (2015)

In the forward section of the wreck there are piles of collapsed hull plating with rivet holes. A bulkhead survives, approximately 19m forward of the boilers and the hull plating on the starboard side of the vessel is still vertical in places (Figure 14).

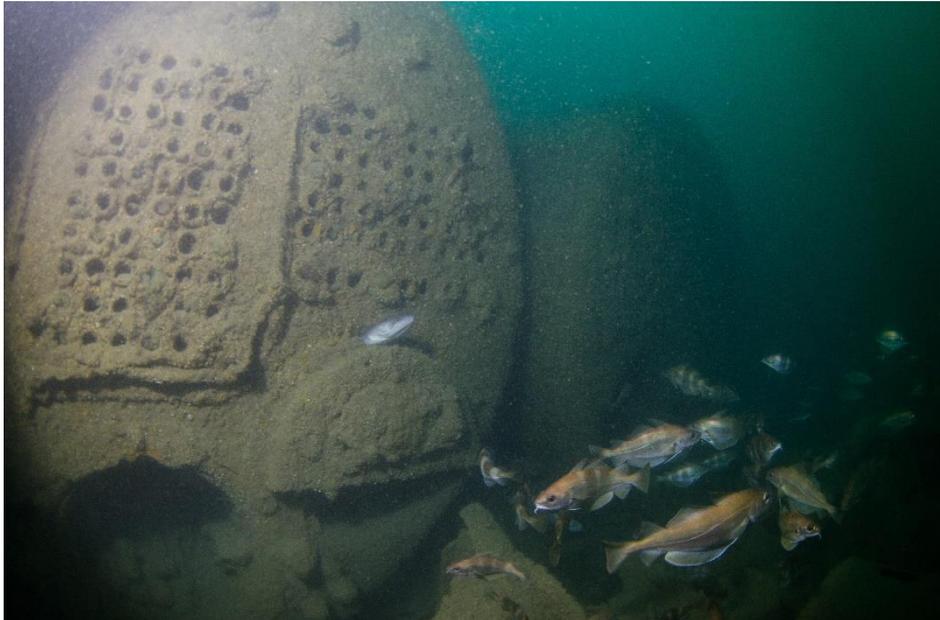
The two single-end, three-furnace Scotch boilers are intact and well-preserved, lying side by side at the eastern end of the forward section of the wreck (Figure 15).

Figure 15: Forward end of boilers

In the forward end of each boiler, the end of the stays, tubes and three furnace fronts can be seen. A jumble of ship structure and machinery is piled up immediately forward of the port boiler. The central and left furnace fronts and fire/furnace-doors are no longer attached (Figure 16).

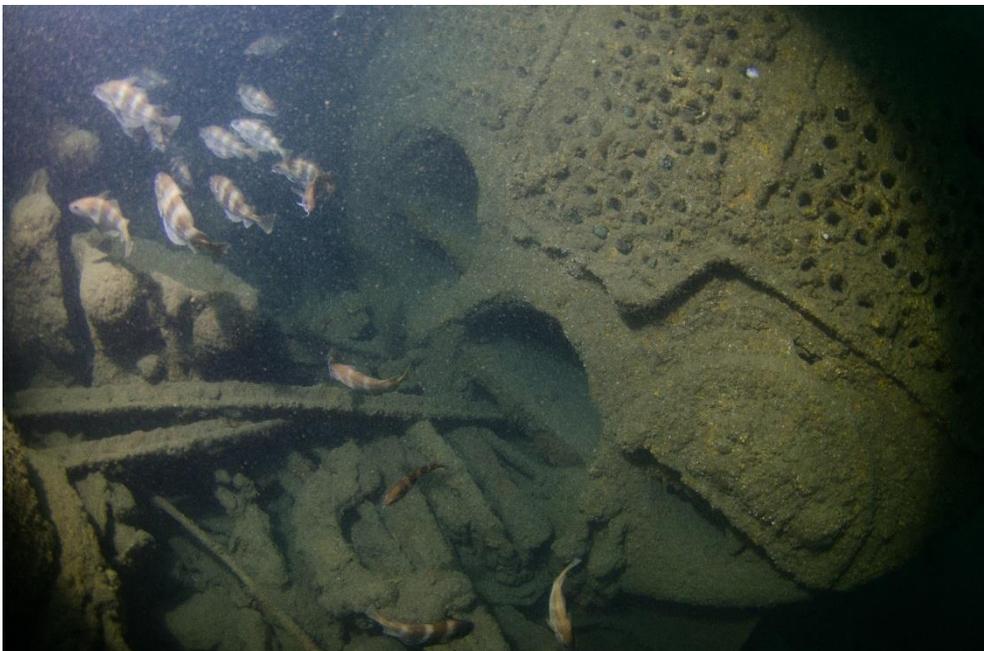
Figure 16: Forward end of port boiler

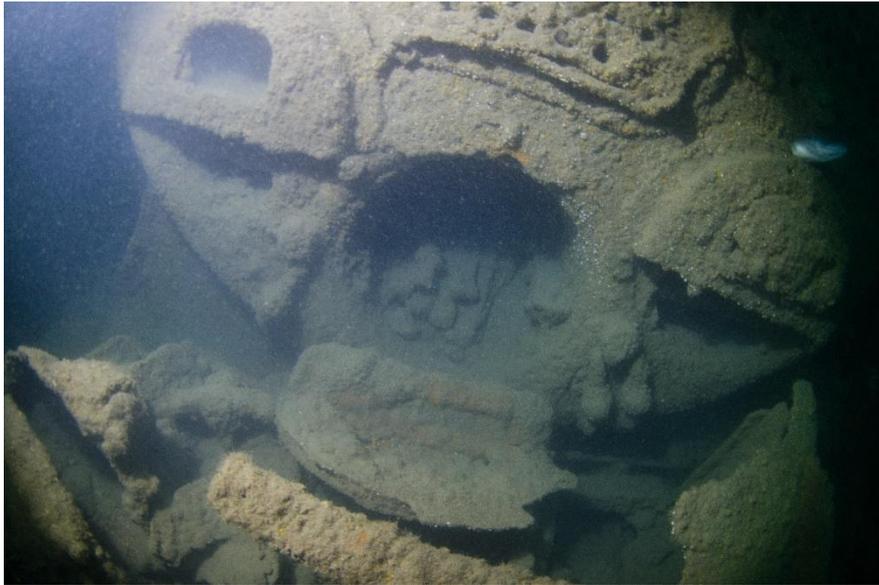
On the starboard boiler (Figure 17), the central furnace front with fire/furnace-door has broken off but lies immediately in front of the central ash-pit, with coal from *Eleanor's* final voyage visible inside. The furnace front (left of Figure 17) is missing its fire/furnace-door.

Figure 17: Starboard boiler (2017)

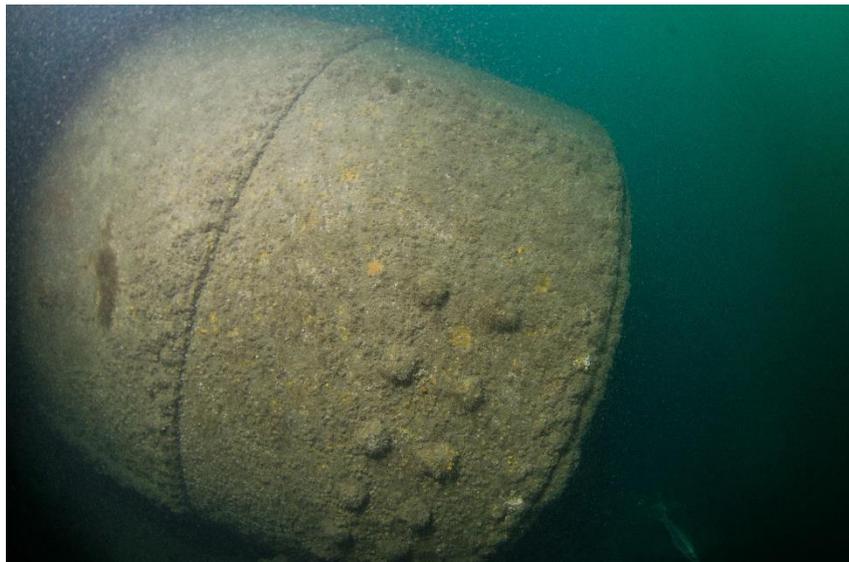
The riveted construction of the boilers can clearly be seen (Figure 18).

Figure 18: Port side of port boiler

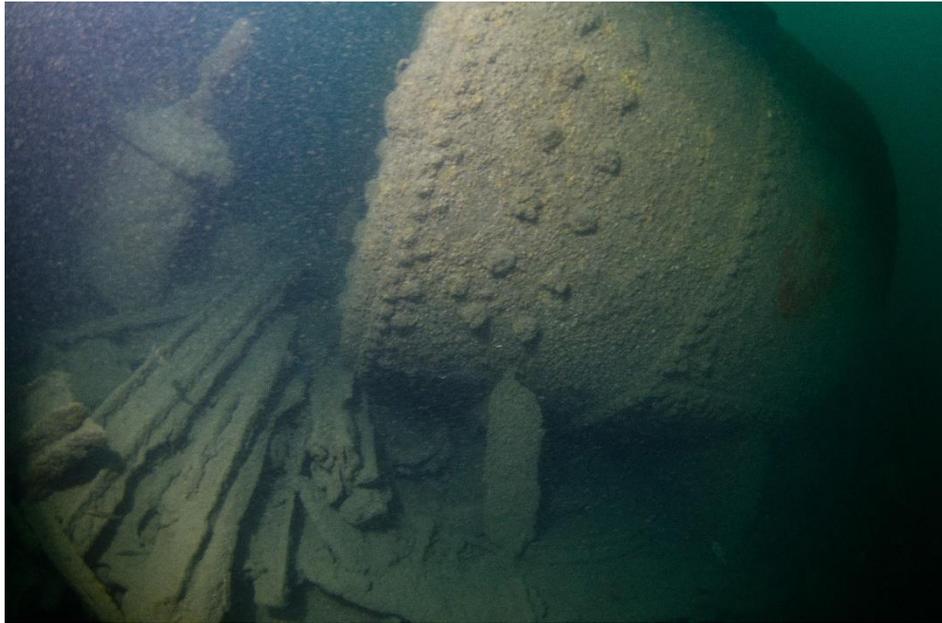
And both boilers are still seated on their cradles (Figure 19).

Figure 19: Starboard side of starboard boiler, front of engine top left

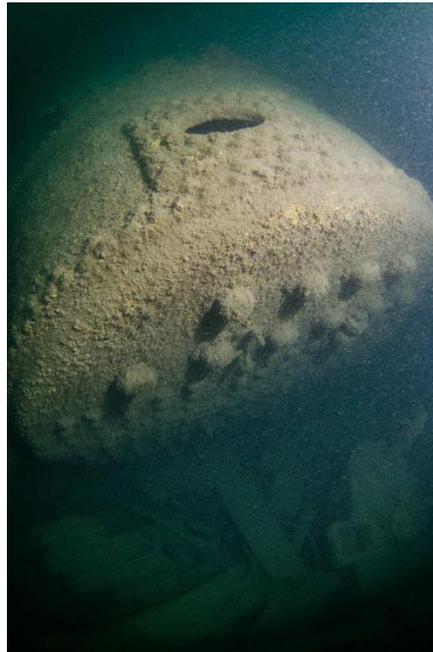
In the top of the starboard boiler, towards the aft end, the boiler manhole can be seen: a circular hole, with surrounding riveted reinforcement plate (Figure 20).

Figure 20: Top of starboard boiler, aft end

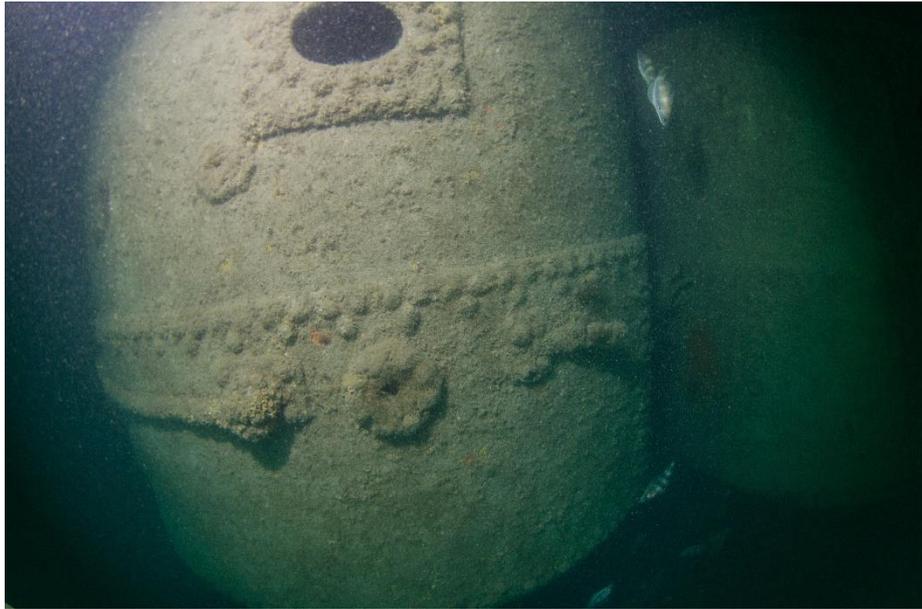
Forward of the riveted mid-join of the same boiler, is the fitting for the boiler's safety valve (Figure 21).

Figure 21: Starboard boiler, from above

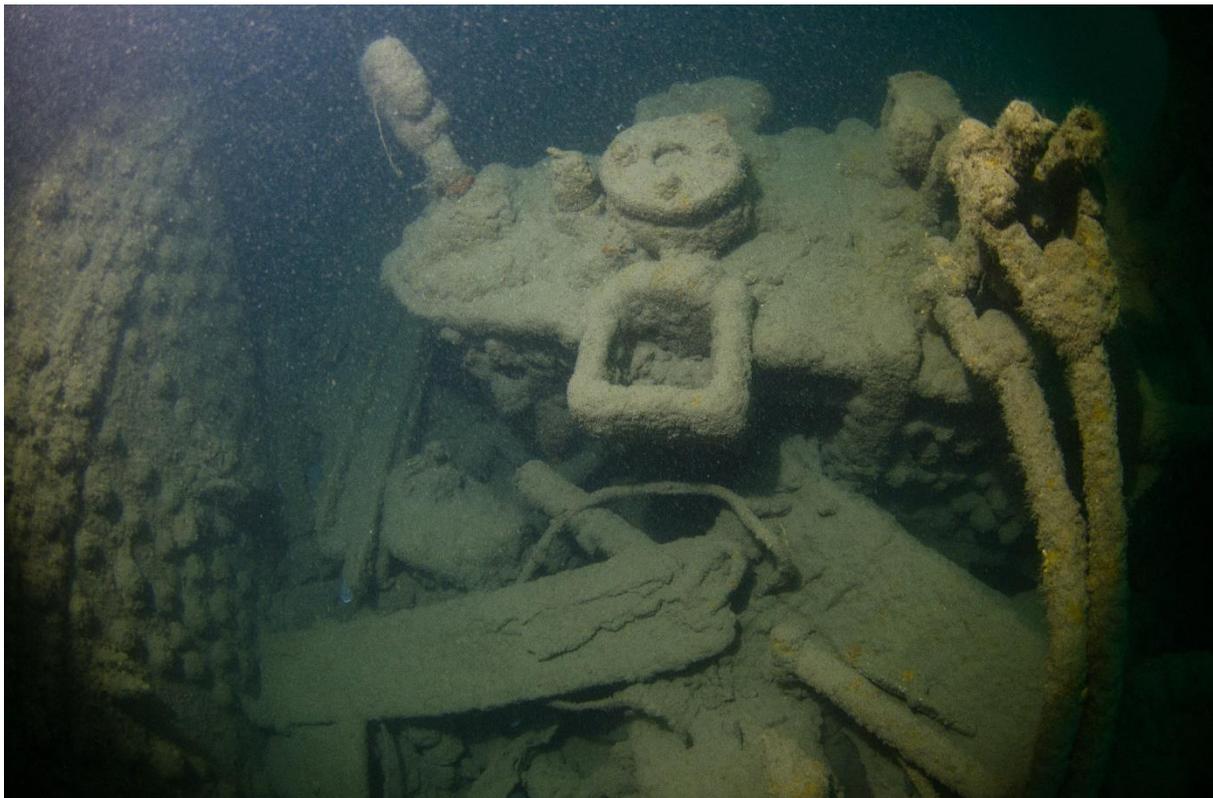
Eleanor's engine, leaning to port, lies immediately aft of the boilers (Figure 22).

Figure 22: Aft end of starboard boiler with engine immediately behind

The engine is a three-cylinder triple expansion built by J. P. Reynolds and Sone of South Shields. The cylinder heads have collapsed over and lie upside down on the starboard side of the crankshaft. The underside of the engine's cylinders are now uppermost. High-pressure cylinder nearest to the boiler is shown in Figure 23. The connecting rods on the high-pressure and intermediate cylinders are no

longer attached but in the case of the low-pressure cylinder (aft) the connecting rod is still attached to both crankshaft and cylinder, the rod being bent over (Figure 22 to 24).

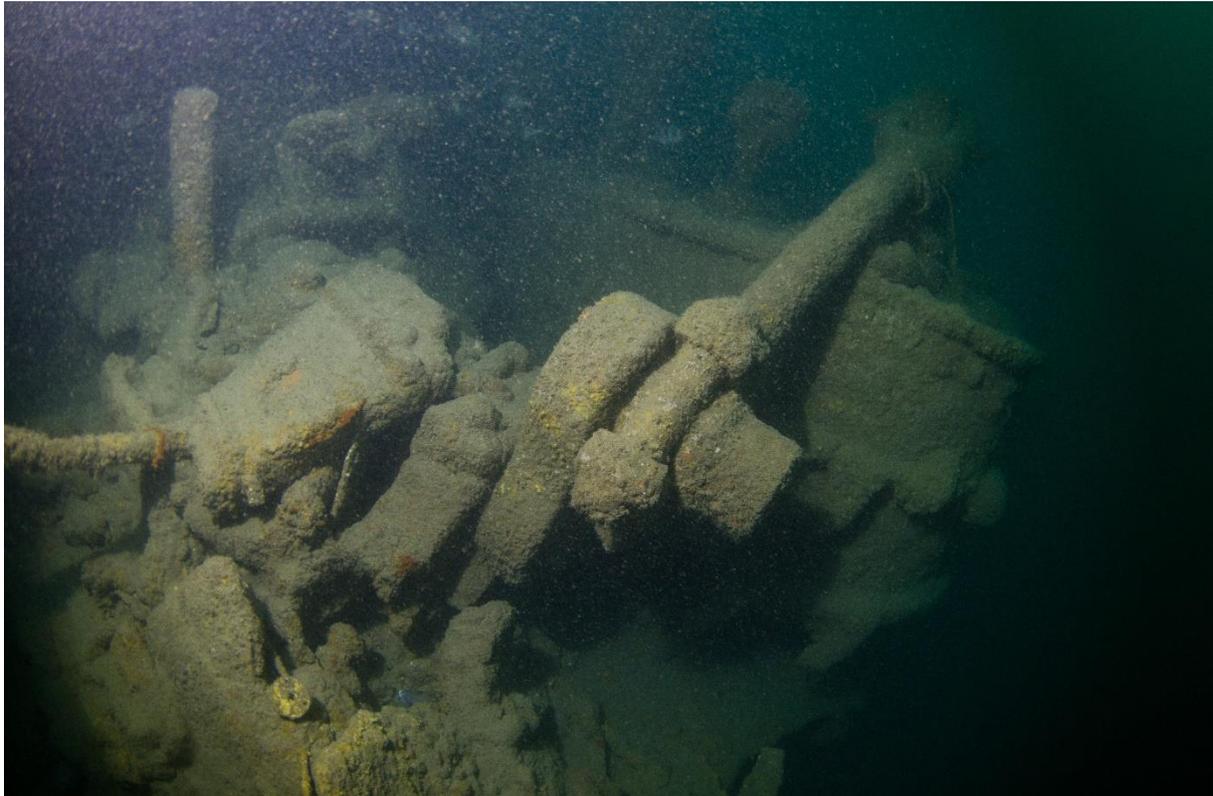
Figure 23: Engine from port side. Centre foreground: crankshaft bearing for the low pressure cylinder. The connecting rod is still attached to the cylinder. The cylinders lie upside down in background.

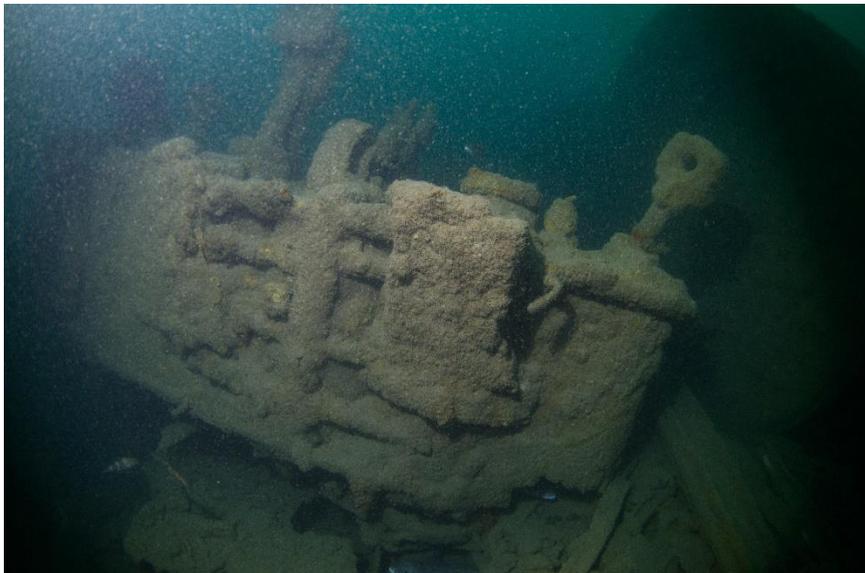
Figure 24: Engine from starboard side, cylinders bent over so the top of the cylinders are now on the seabed. HP cylinder to right/forward. Boiler in background to the right.

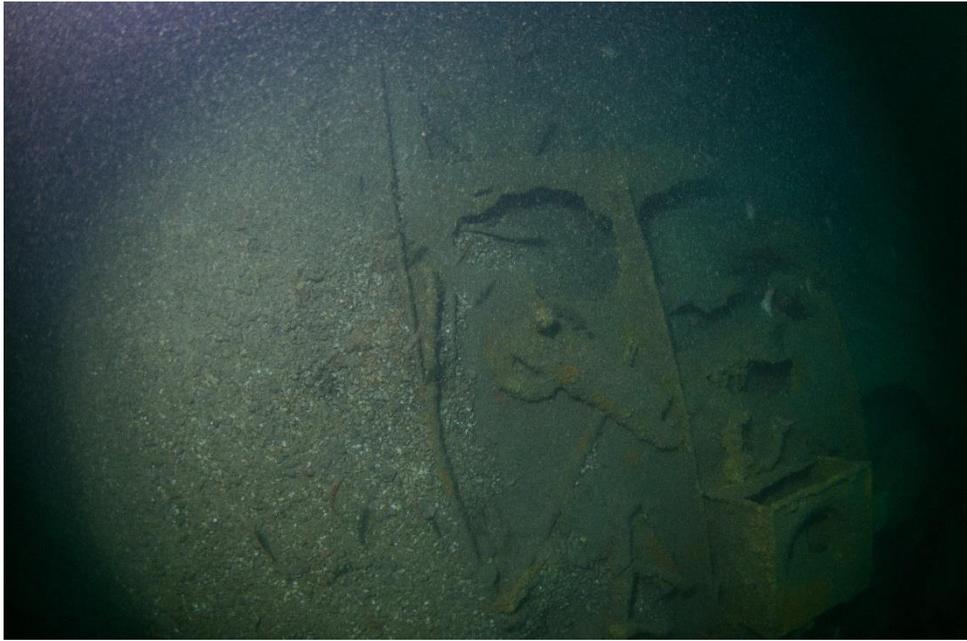
Between the bow and stern sections of the wreck, is a relatively flat area comprising mostly sandy seabed, with scattered cargo and parts of ship structure (Figure 25). This is presumably around the position of number three hatchway, where the torpedo hit the ship in 1918 (see Section 3.3).

Figure 25: Between the bow and stern sections of the wreck, just aft of the engine

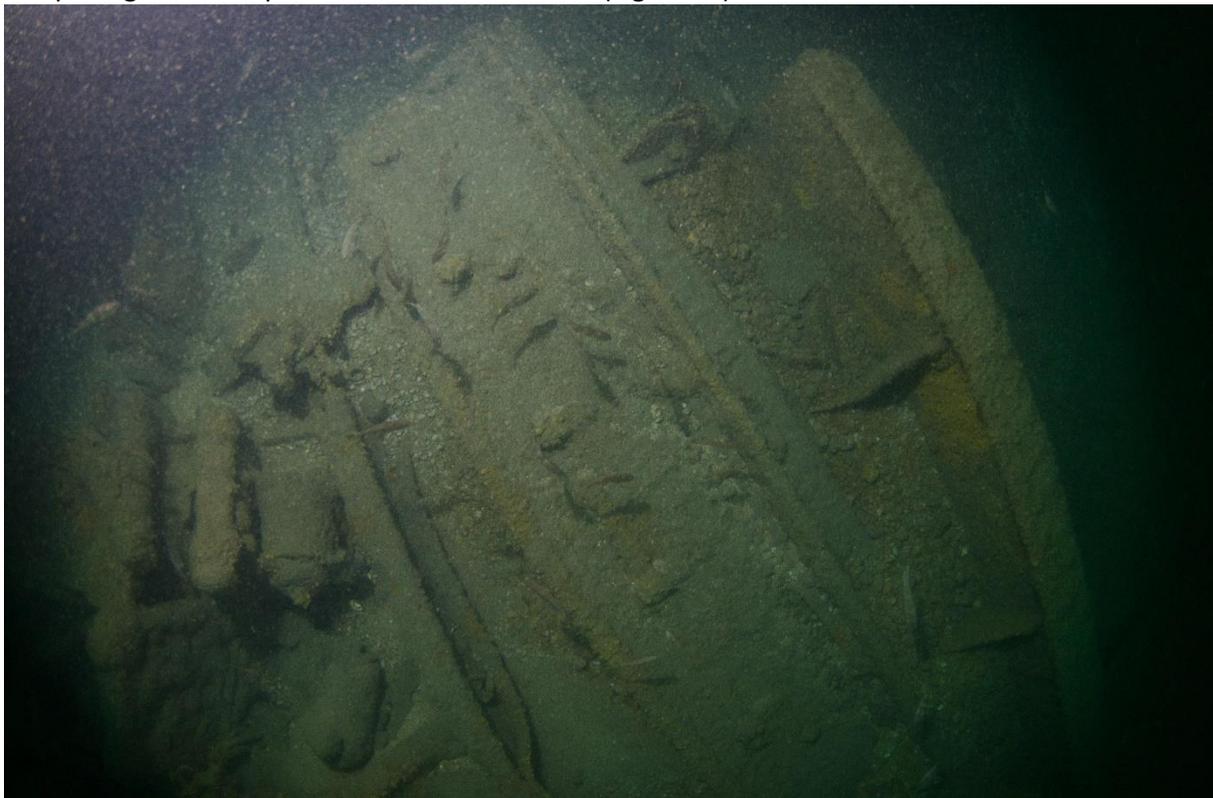
In the stern section of the wreck, parts of the hull and deck are relatively intact, in places sections of hull plating have collapsed inwards onto the deck (Figure 26).

Figure 26: Section of aft starboard hull, deck frames with collapsed hull plating

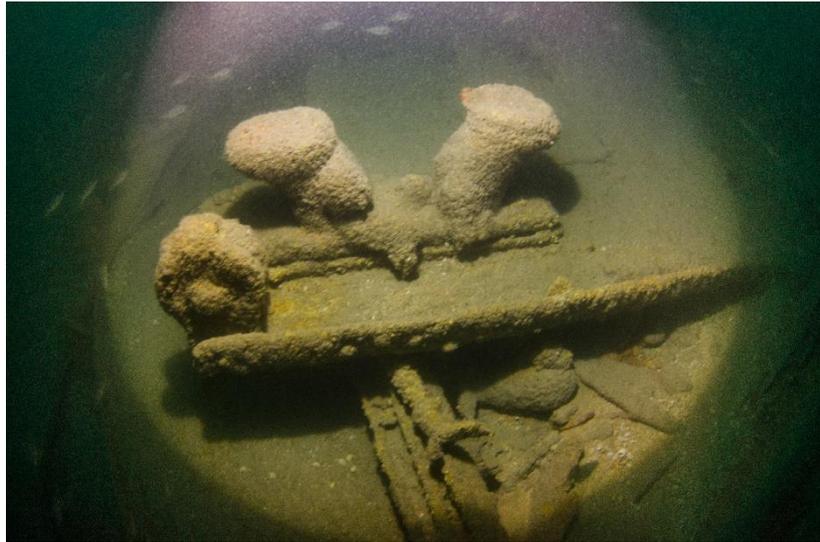
On the port side, aft of the boilers, a pair of double bitt inclined bollards survive (Figure 27).

Figure 27: inclined bollards, port side, aft of boilers (2017)

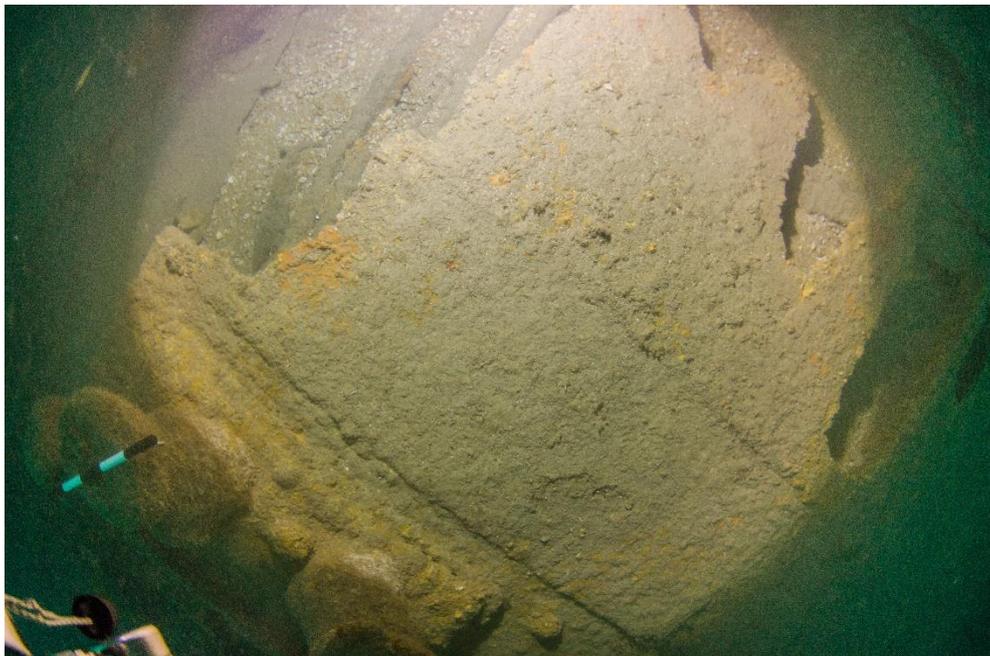
Parts of *Eleanor's* decking are well preserved in this area (Figure 28).

Figure 28: Inclined bollards (bottom left) with extant decking

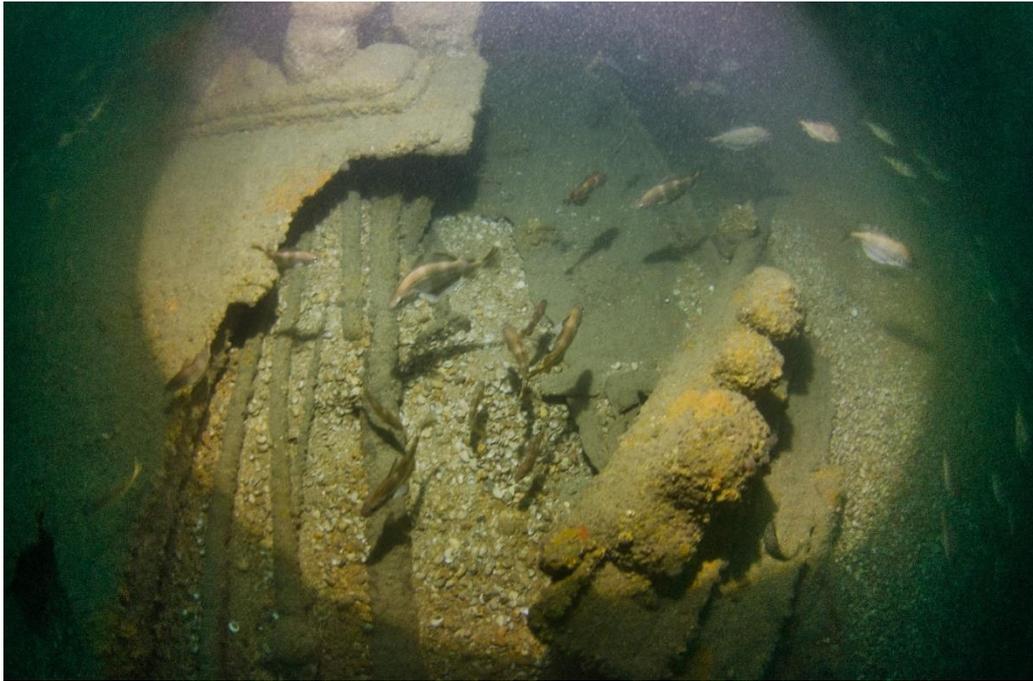
Under the deck, beneath the bollards, metal bars with a circular cross-section are stacked (Figure 29), these possibly relate to *Eleanor's* cargo of firing levers or mine pistols (see Section 3.3).

Figure 29: Metal bars stored below deck in forward section of wreck, possibly firing levers or mine pistols

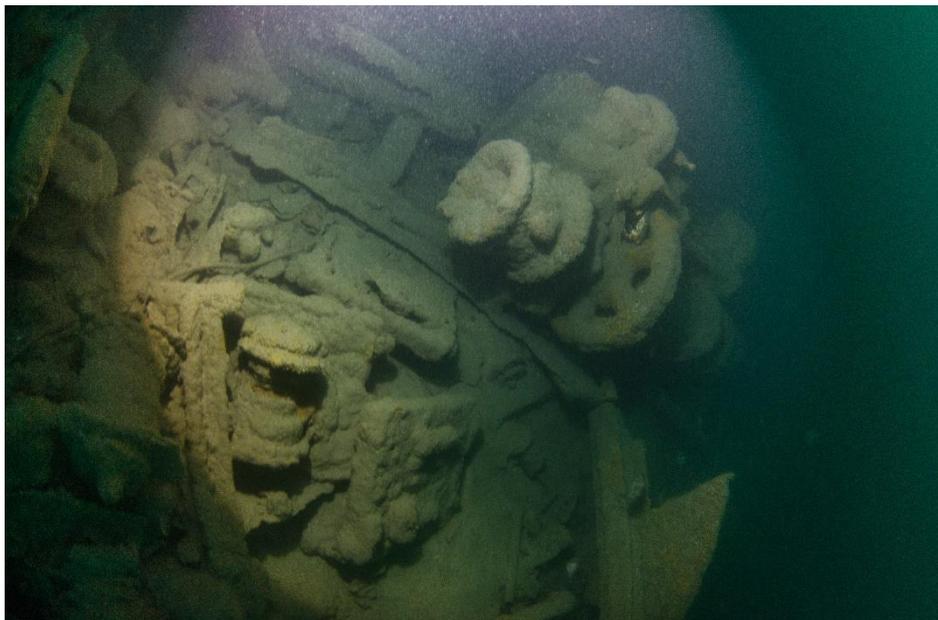
A deck winch survives approximately amidships in the aft section of the wreck (Figure 30).

Figure 30: Winch, amidships in the aft section of the wreck

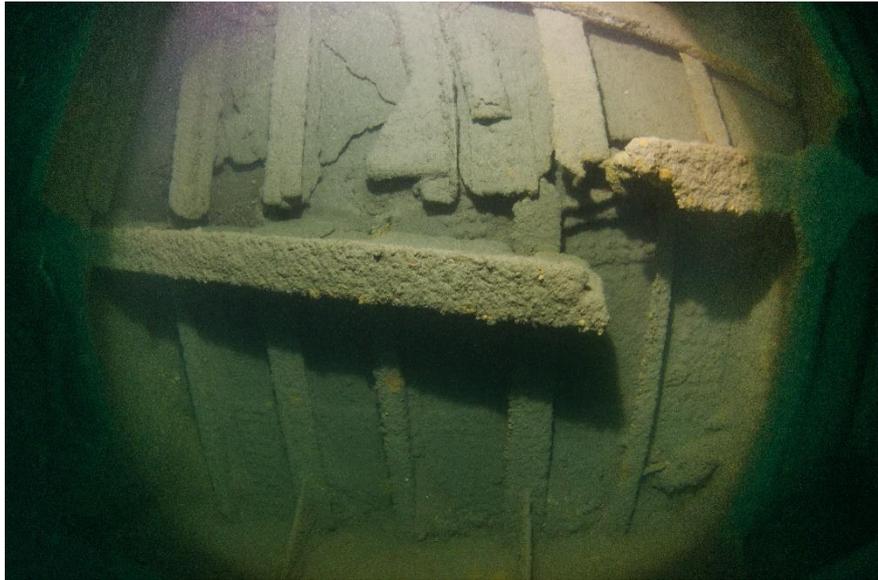
In the area close to the winch, considerable sections of deck survive (Figure 31).

Figure 31: Extant deck near the windlass

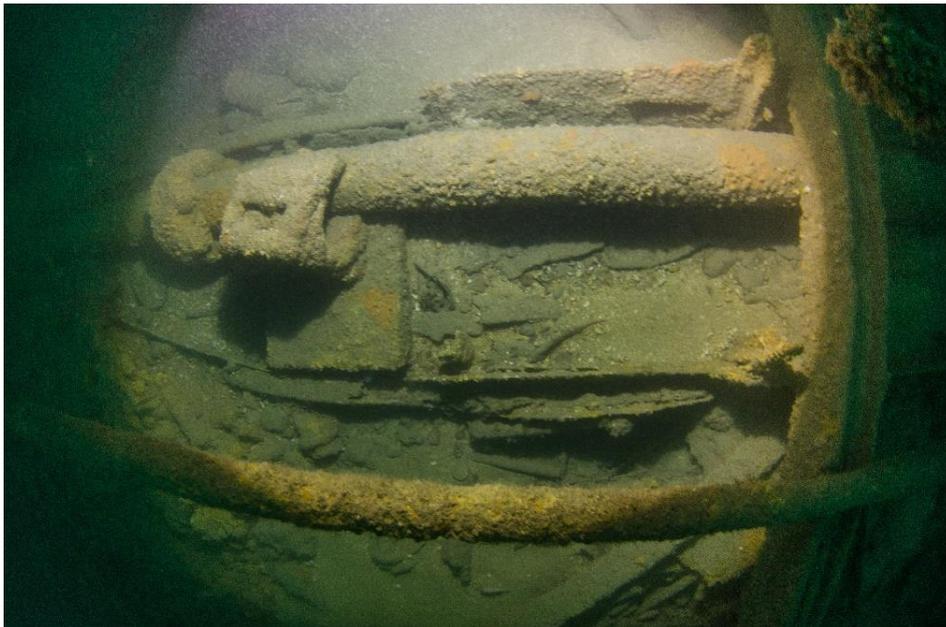
And where the deck is missing, the prop shaft can be seen running down the centreline of the ship (Figure 32).

Figure 32: Prop shaft

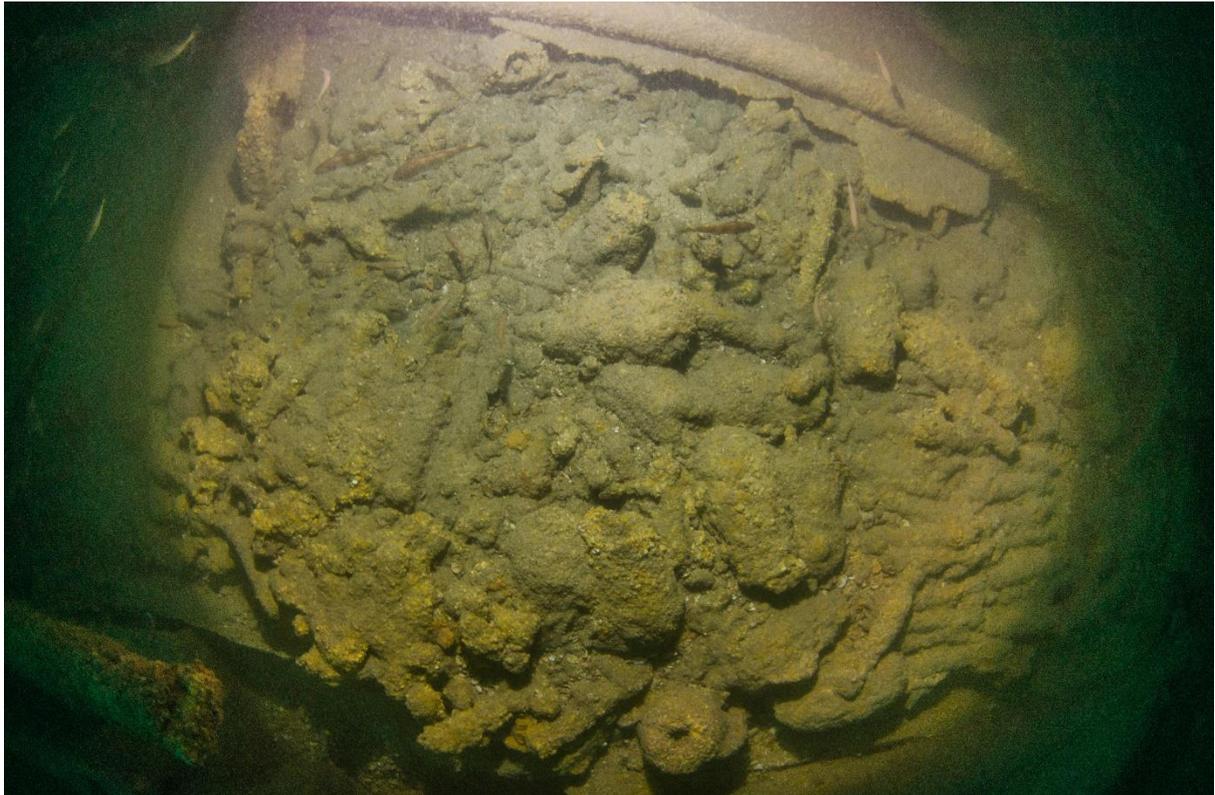
Another area in the aft section of the wreck is packed with smaller items of cargo (Figure 33).

Figure 33: Aft section of wreck: smaller items of cargo packed tightly

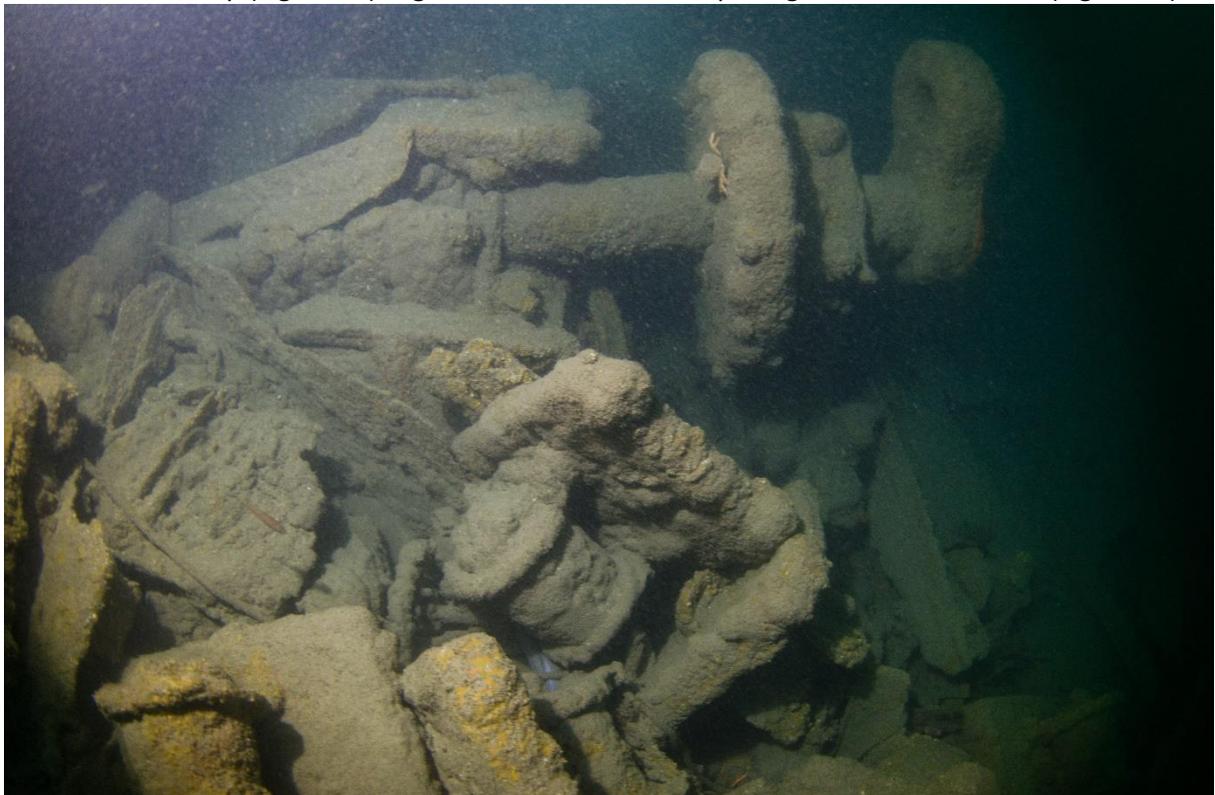
At the stern of the wreck, a prominent unidentified feature protrudes from a pile of cargo stacked in this area of the ship (Figure 34). Significant amounts of hull plating survives in this area (Figure 35).

Figure 34: Collapsed hull and cargo at the stern. Top right, unidentified feature.

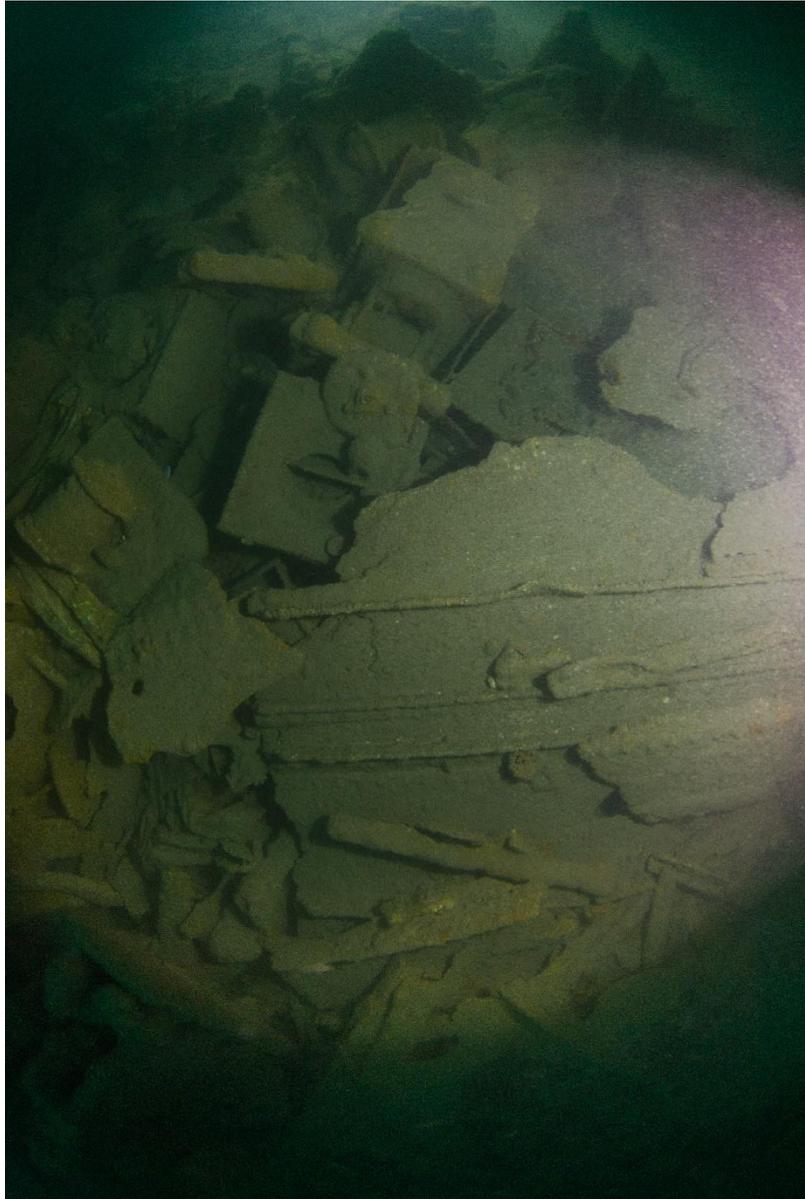
Figure 35: *Eleanor's* stern, extant hull plating with the cargo stacked inside the ship

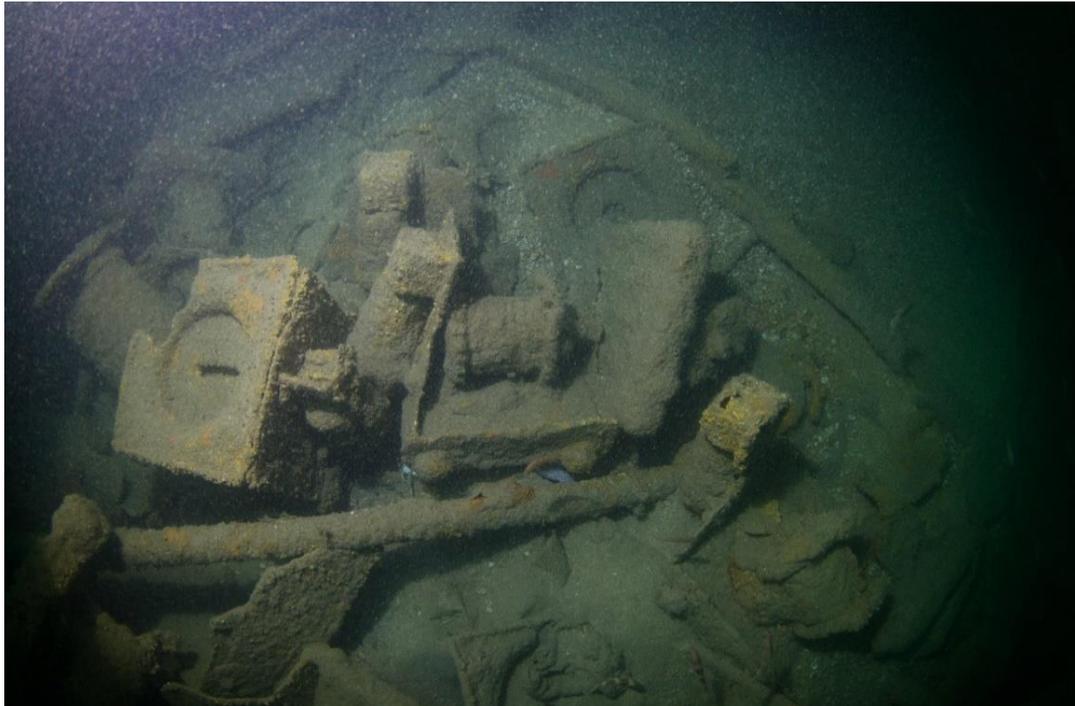
In the stern of the wreck, piles, comprising considerable numbers of square boxes with holes in, are visible. In some cases the box casing has corroded away and an internal reel wound with line/cable (possibly rope or chain) can be seen (Figure 36).

Figure 36: On the left a relatively intact box, centre: a reel wound with cable inside a damaged box

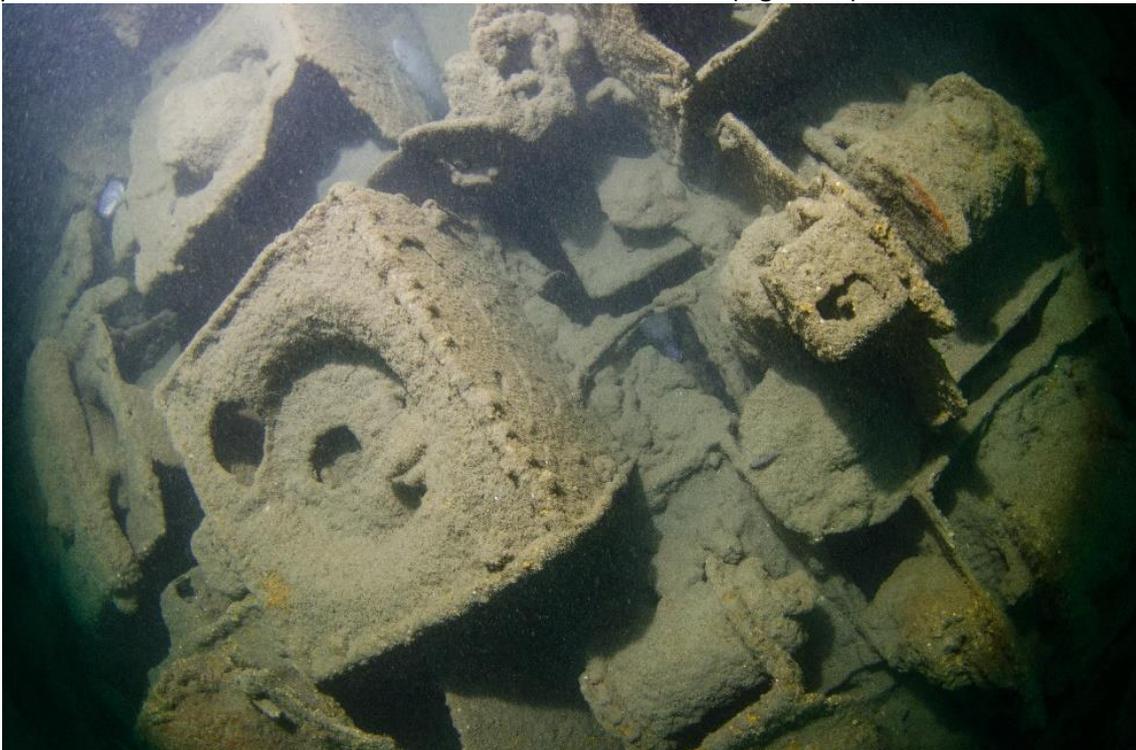
The boxes are of metal construction, with bolts or rivets apparent around the edges (Figure 37). Approximate dimensions of the boxes are 65cm x 65cm x 50cm (Figure 38).

Figure 37: Metal box, construction

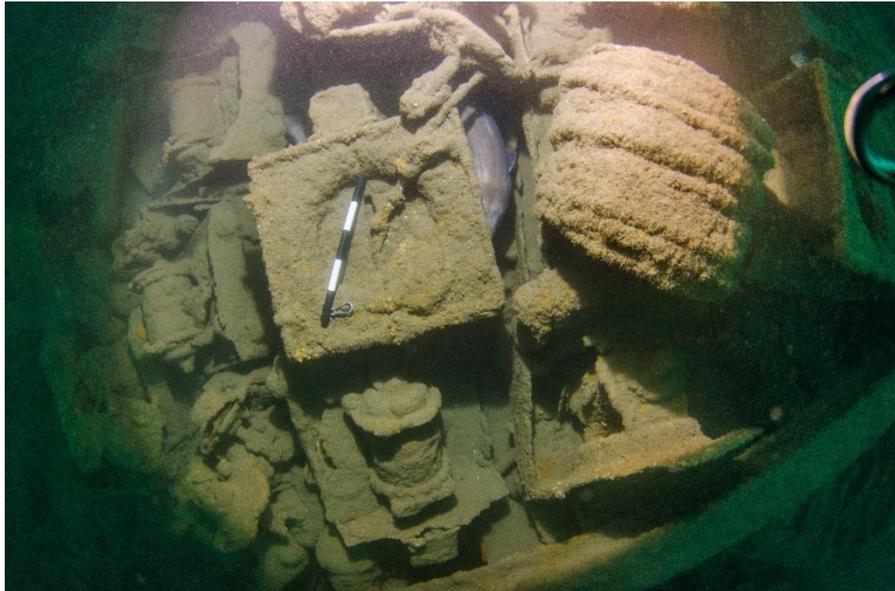
Figure 38: Metal box with scale

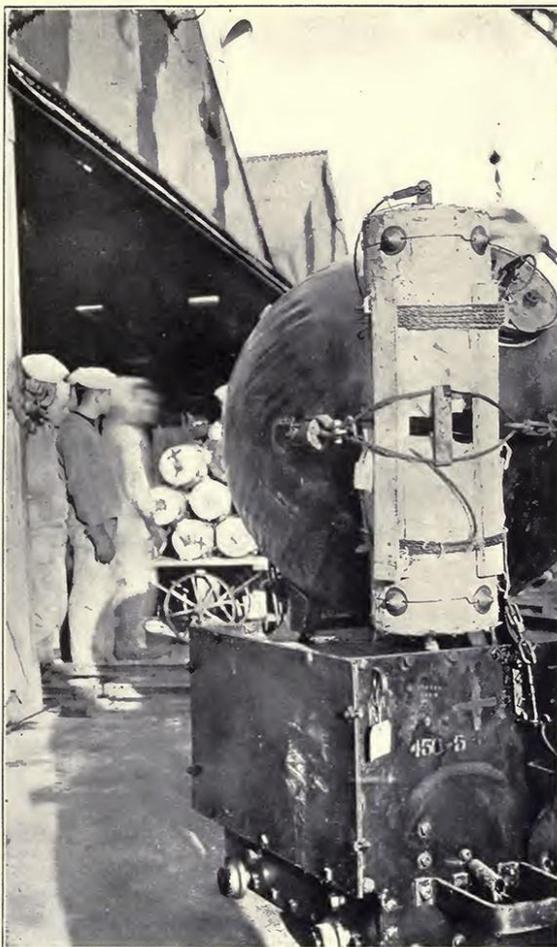
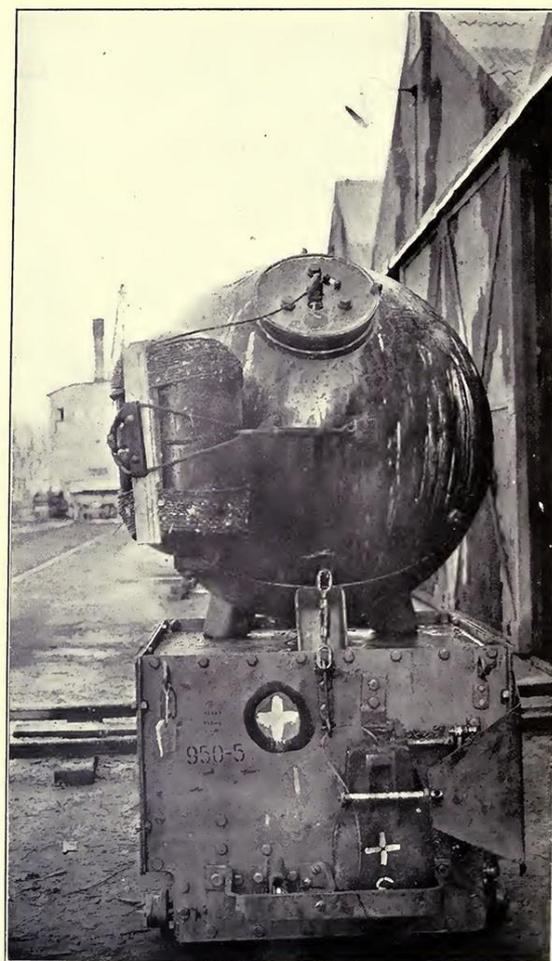
MARK VI MINE WITH SINKER, FITTED WITH Balsa FLOATS FOR PLANTING IN SHALLOW DEPTHS. (Page 42)
16-3,

MARK VI MINE FITTED WITH D-4 FLOAT FOR PLANTING AT LOWER LEVELS. (Page 42.)
16-4

Figure 39: American Mark VI mine and sinker designed for the Northern Barrage. This sinker was an adapted version of the British Mark VIII sinker (Daniels 1920)
