**Forgotten Wrecks
of the
First World War**

SS Eleanor

Site Report

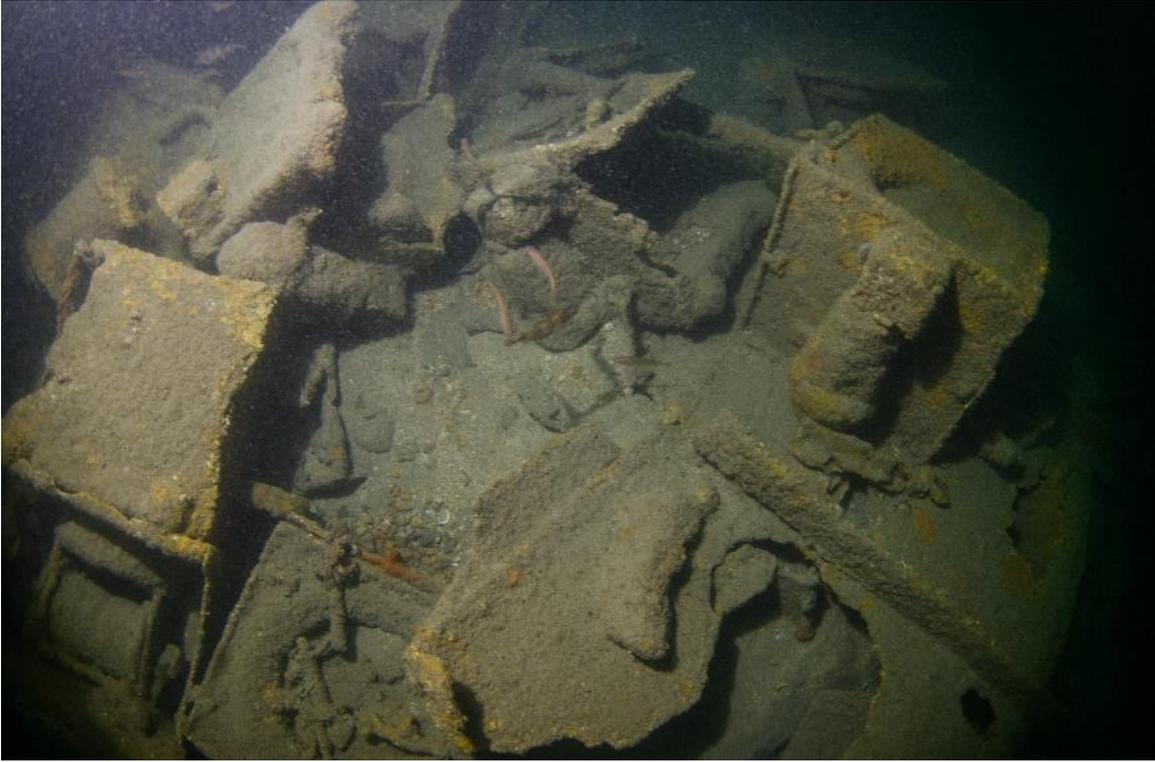
Figure 40: Intact and broken mine sinkers

They are found in large concentrations at the stern of the ship, being some of the 600 Mark VI mine sinkers, recorded in *Eleanor's* cargo manifest (see Section 3.3, Figure 2, 39 & 40).

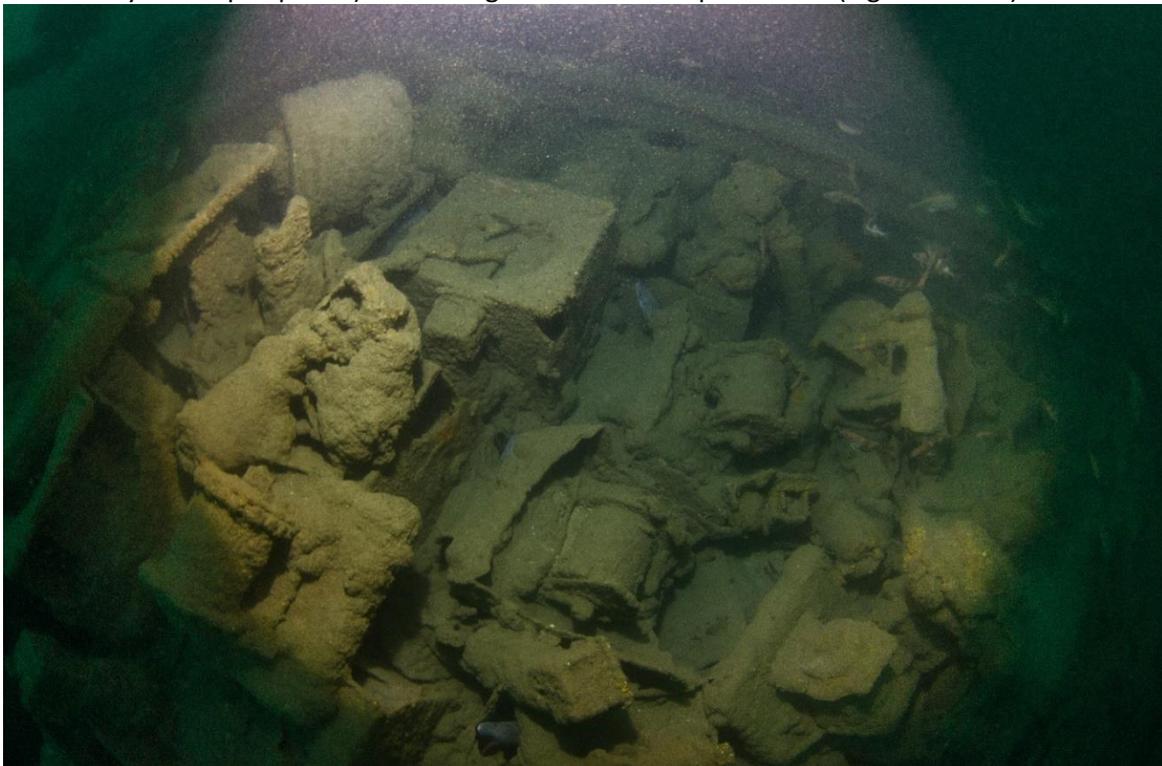
While sometimes appearing to be in disorganised piles, in places the cargo can be seen to be stacked (at least 3 layers deep in places) and arranged within the ship structure (Figure 41 - 43).

Figure 41: Mine sinkers stacked in the ship's hold

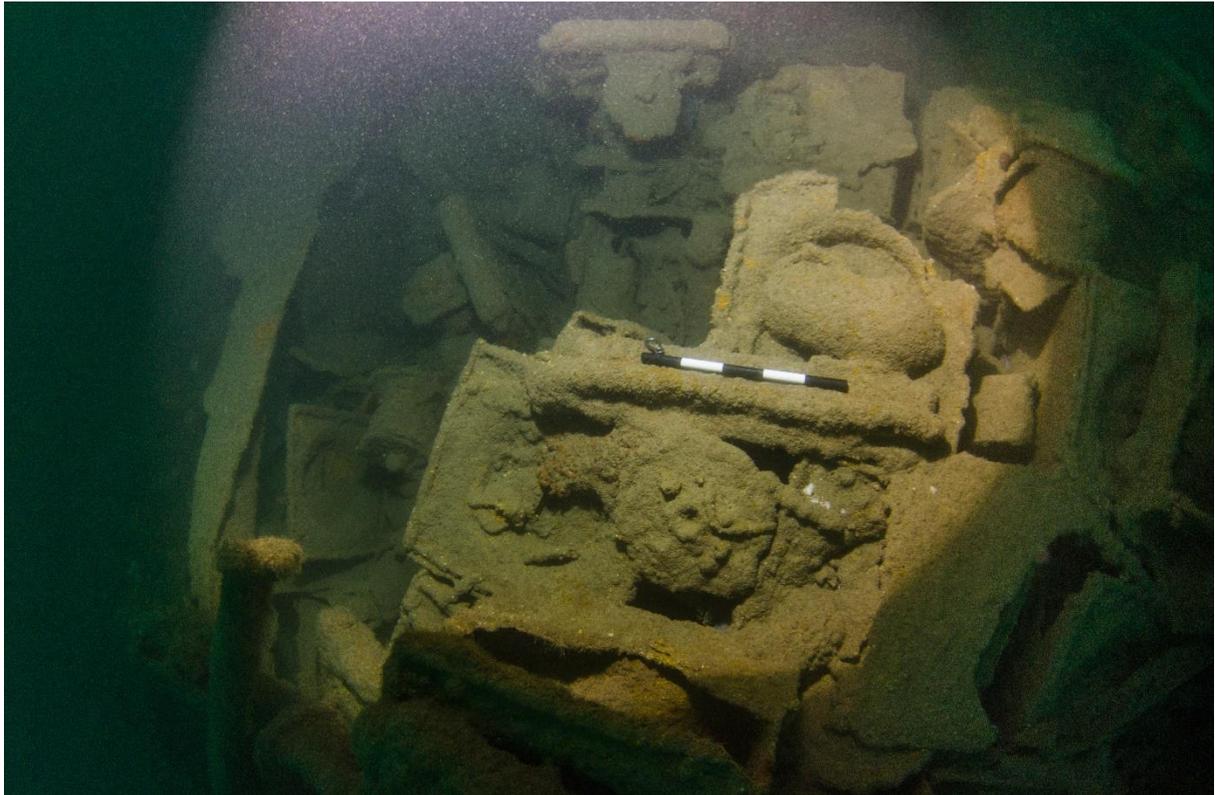
Figure 42: Cargo stacked below decks in *Eleanor's* aft holds

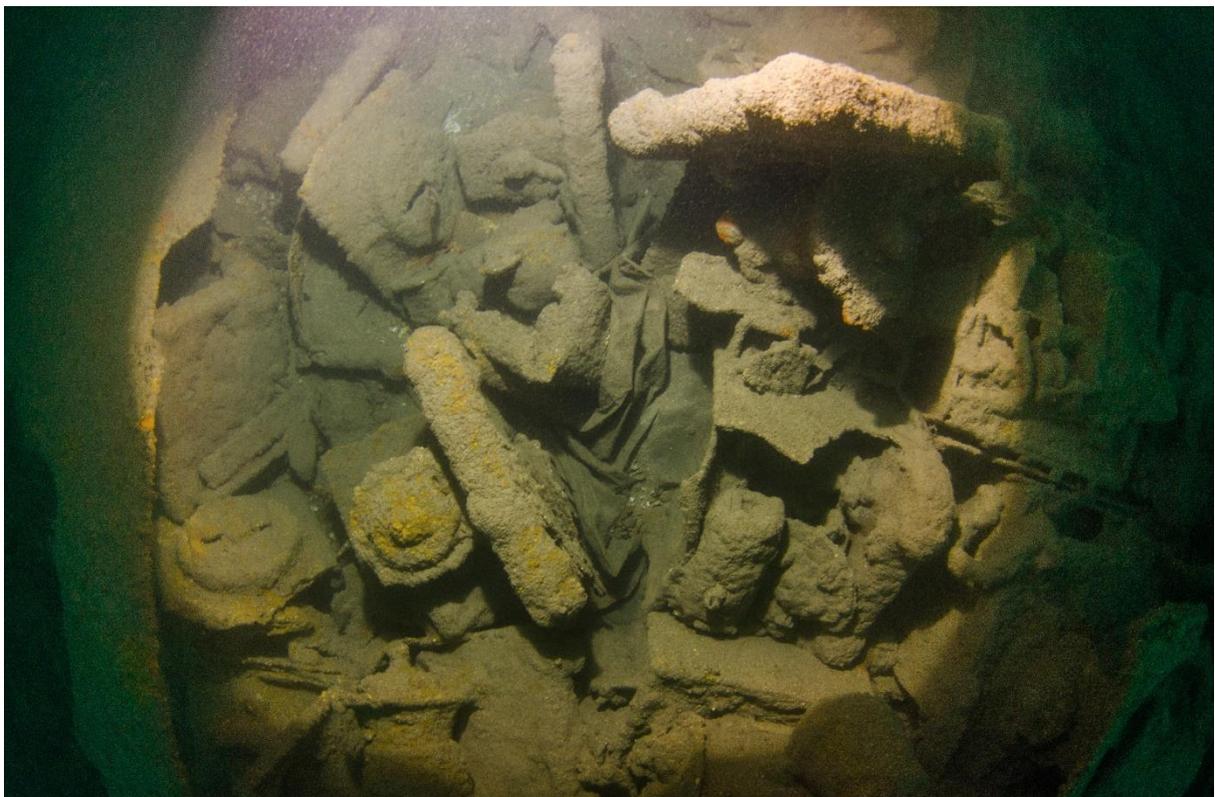
Figure 43: cargo packed into hold at stern, unidentified black sheeting (centre) can be seen amongst the cargo

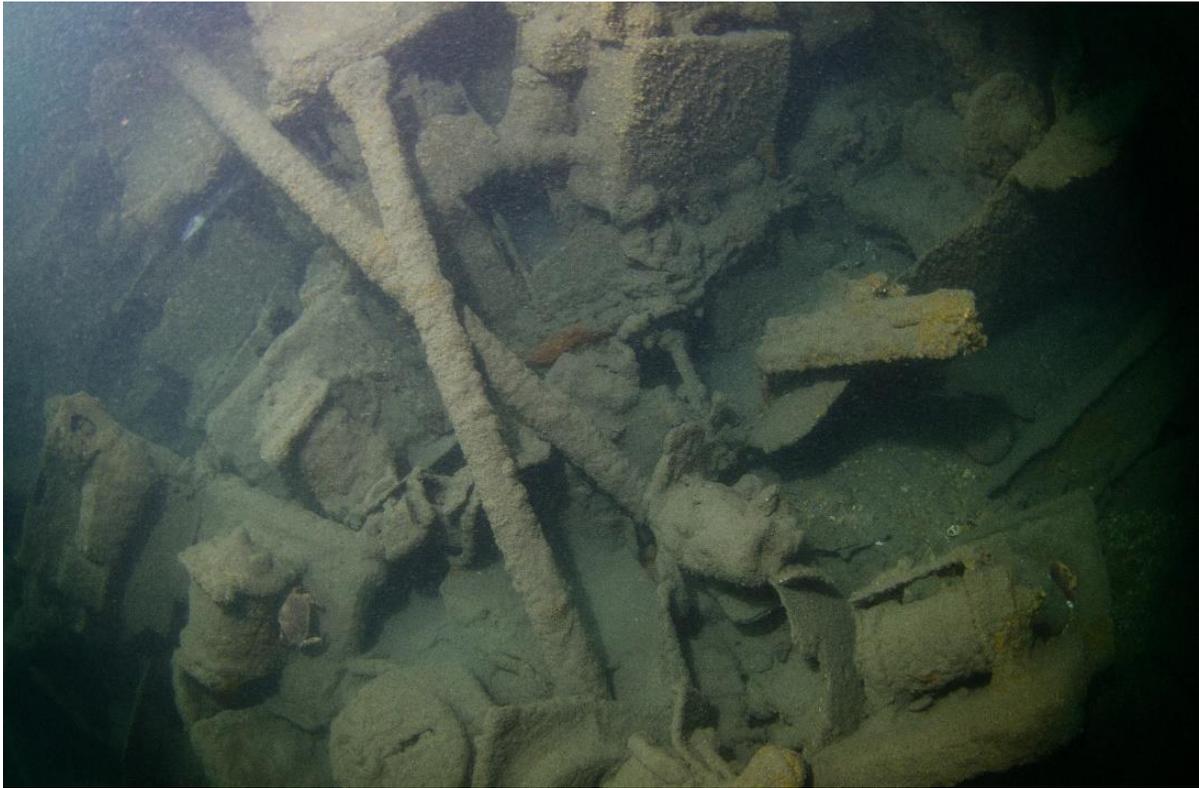
Amongst the cargo are sections of metal bar, circular cross-section, possibly related to the firing levers or pistons for mines listed in *Eleanor's* cargo manifest (Figure 44).

Figure 44: Possible firing arms from Naval Spherical Mine

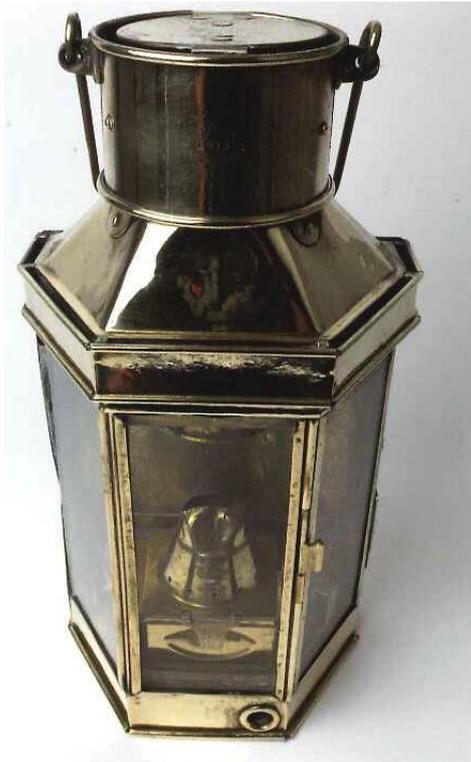
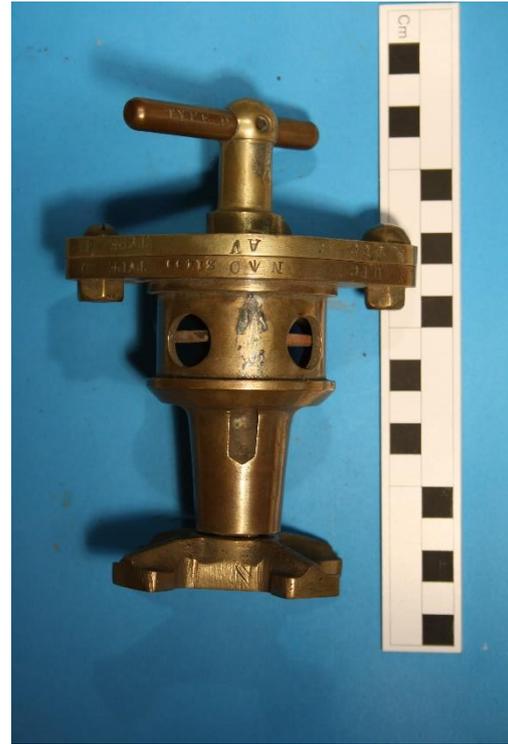
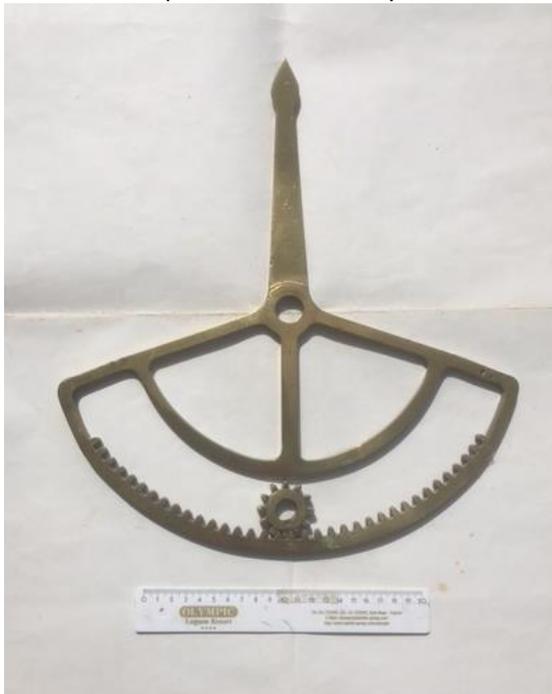
Figure 45: Artefacts recovered from the wreck of *Eleanor*

*Oil lamp from Eleanor
(Wendes collection)*

*Depth charge primer from Eleanor
(Wendes collection)*

*Steering indicator from Eleanor
(Wendes collection)*
