Forgotten Wrecks
of the
First World War

SS Molina
Site Report

***SS MOLINA* SITE REPORT**

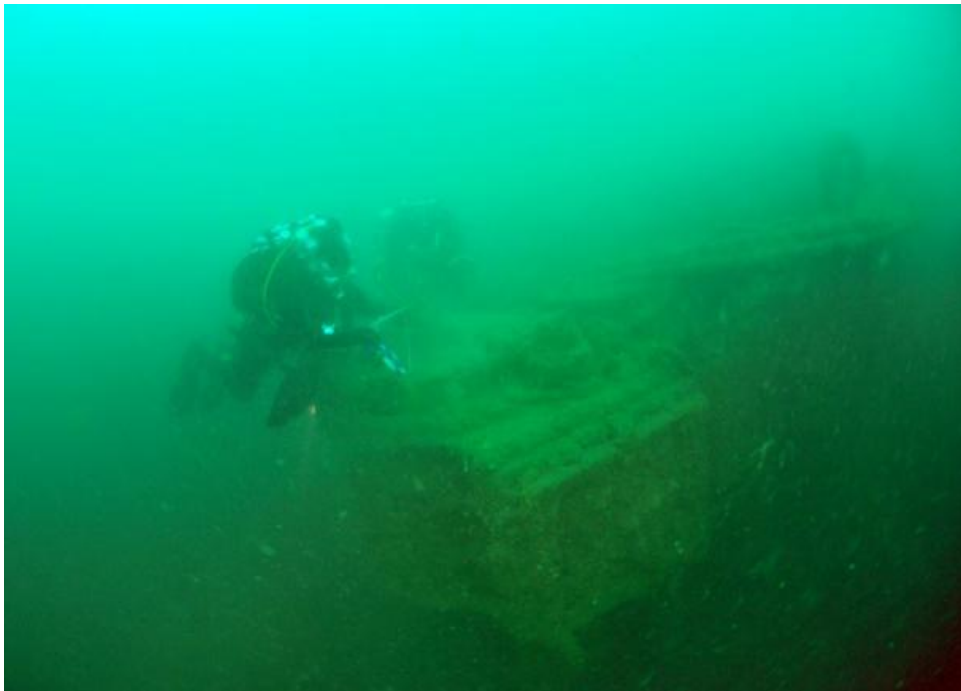
The *Molina* sits upright on a seabed of sand and shingle in around 35m of water. It is orientated NE/SW with the bows to the NE. A multibeam survey in January 2012 reported the length of the wreck at 65m and the width 13m, with scour 2.5m deep to the north and south of the wreck (PastScape). The forward end is fairly intact from amidships forward, whilst the aft end of the ship is flattened. The

highest part of the wreck stands around 6m high which is the boiler and the triple expansion engine which can be seen in Figure 3. The approximate measurements of the three pots of the engine (in diameter) are 50cm first pot, 80cm middle pot and 122cm top pot (Figure 4).

Figure 3: Divers at the triple expansion engine (image Roland Brookes)

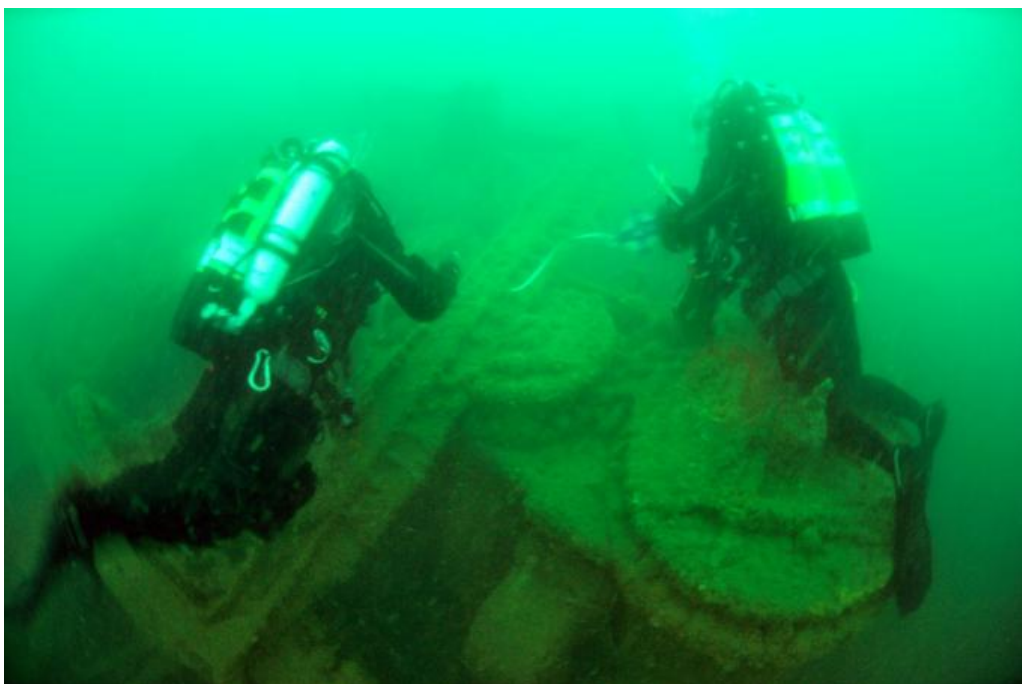
Figure 4: Divers measuring the engine pots (image Roland Brookes)

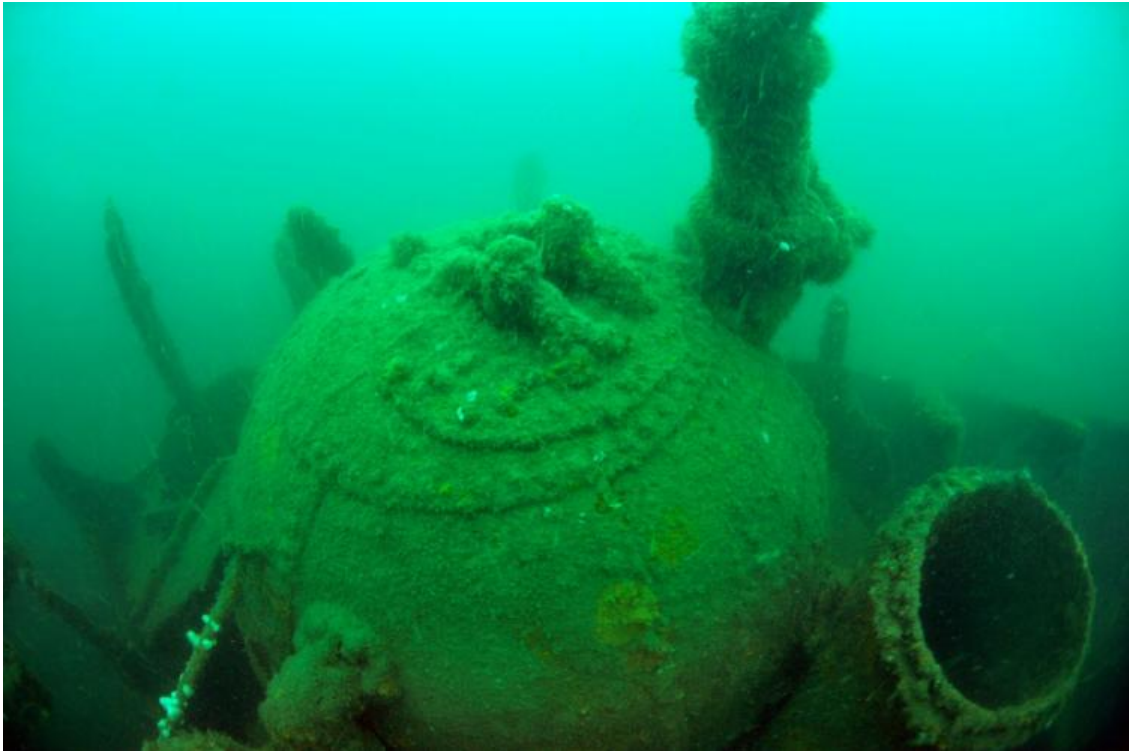
Forward of the engine lie the two boilers and there is also a donkey boiler present (a small boiler which is used to run the ships auxiliary engines when the main boilers are cold) (Figure 5).

Figure 5: Donkey boiler (image Roland Brookes)

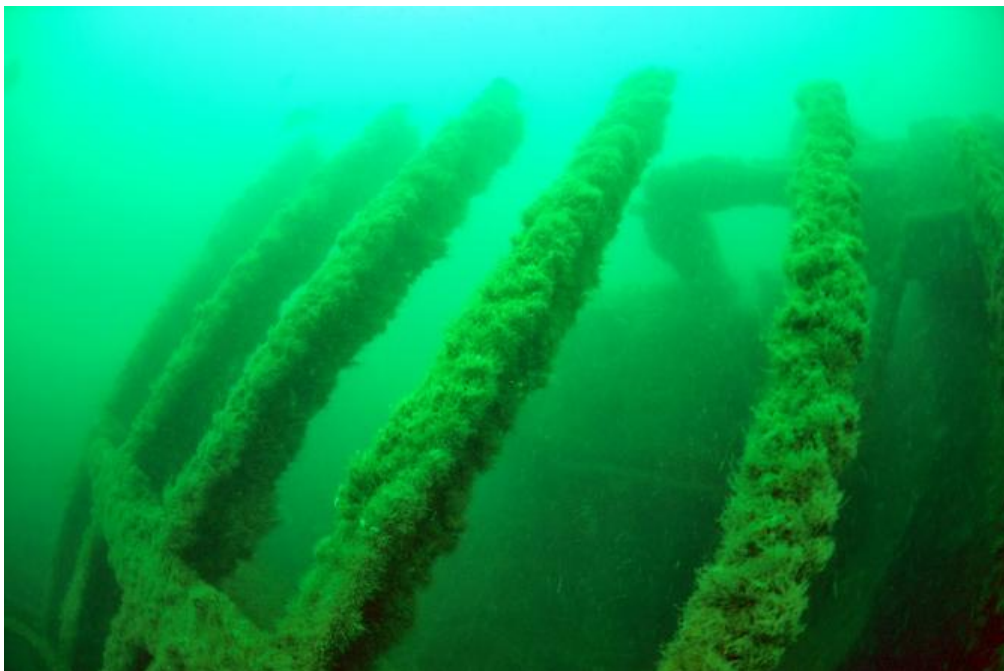
On travelling towards the stern of the vessel the remains begin to flatten as more ribs become apparent and the sides of the vessel are collapsing (Figure 6). Lots of structure is still recognisable including hatches and combings but further dives would be required to generate a full plan of the vessel. Go pro video footage was taken by divers around the wreck and a short annotated video tour produced and posted on You Tube (Maritime Archaeology Trust, 2017). The deck is evident in many places and its possible to look down amongst the fallen structure into the holds.

Figure 6: Ribs on Port side (image Roland Brookes)

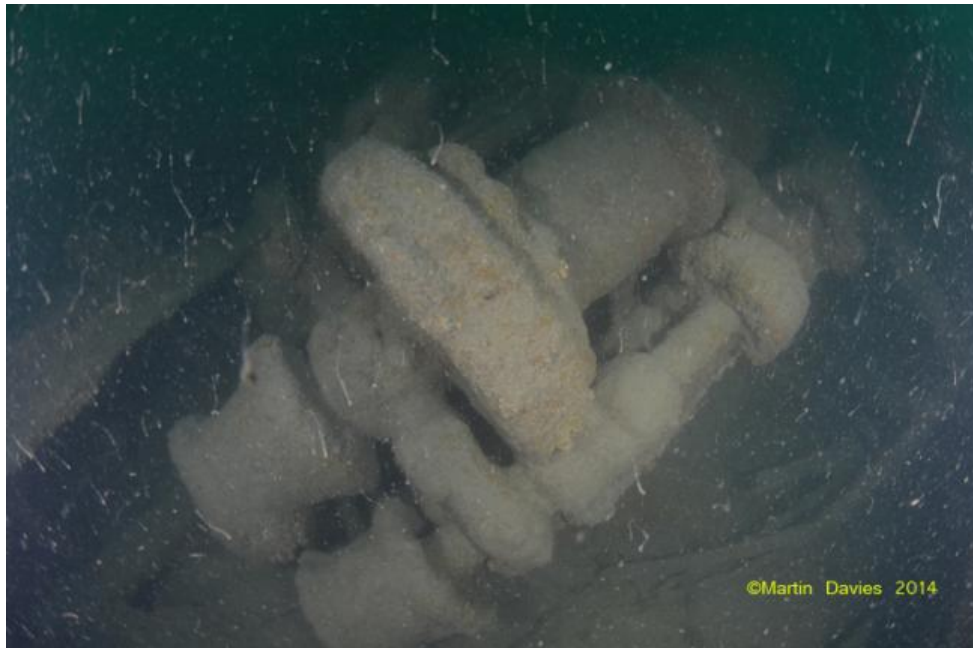
Towards the stern a deck winch lies with two bollards nearby (Figure 7). At the stern, the bronze propeller is reported to have been raised by salvage divers and it had two blades missing (Wendes, 2006). No armament is present as SS *Molina* was sailing under the neutral flag of Norway, and therefore, was unarmed.

Figure 7: Winch near the stern (image Martin Davies)

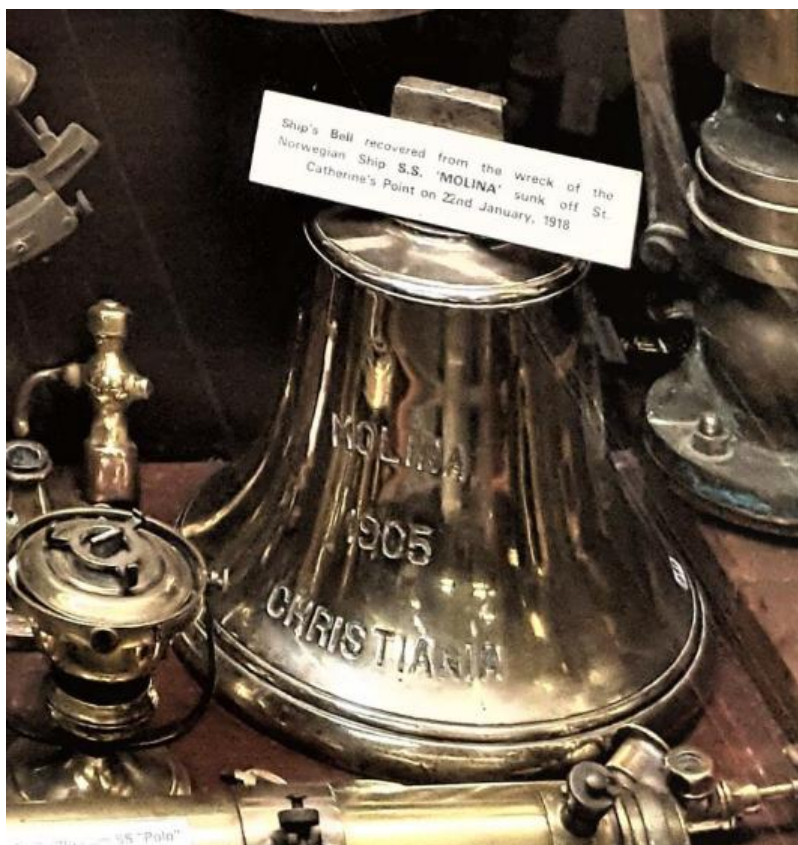
- Fixtures and fittings: Brass ships bell bearing the ships name and 'Christiania' (330mm high) and builders nameplate.

Figure 8: Ship's bell on display at the Shipwreck Centre and Maritime Museum, Isle of Wight
