Forgotten Wrecks of the First World War

Hulks of the River Dart, Devon

**Hulks of Vessels used during the First
World War, River Dart, Devon:**

***Winifred, Six Brothers, Effort,
Esther (Irene), Fiery Cross, Glory and
Kingswear Castle***

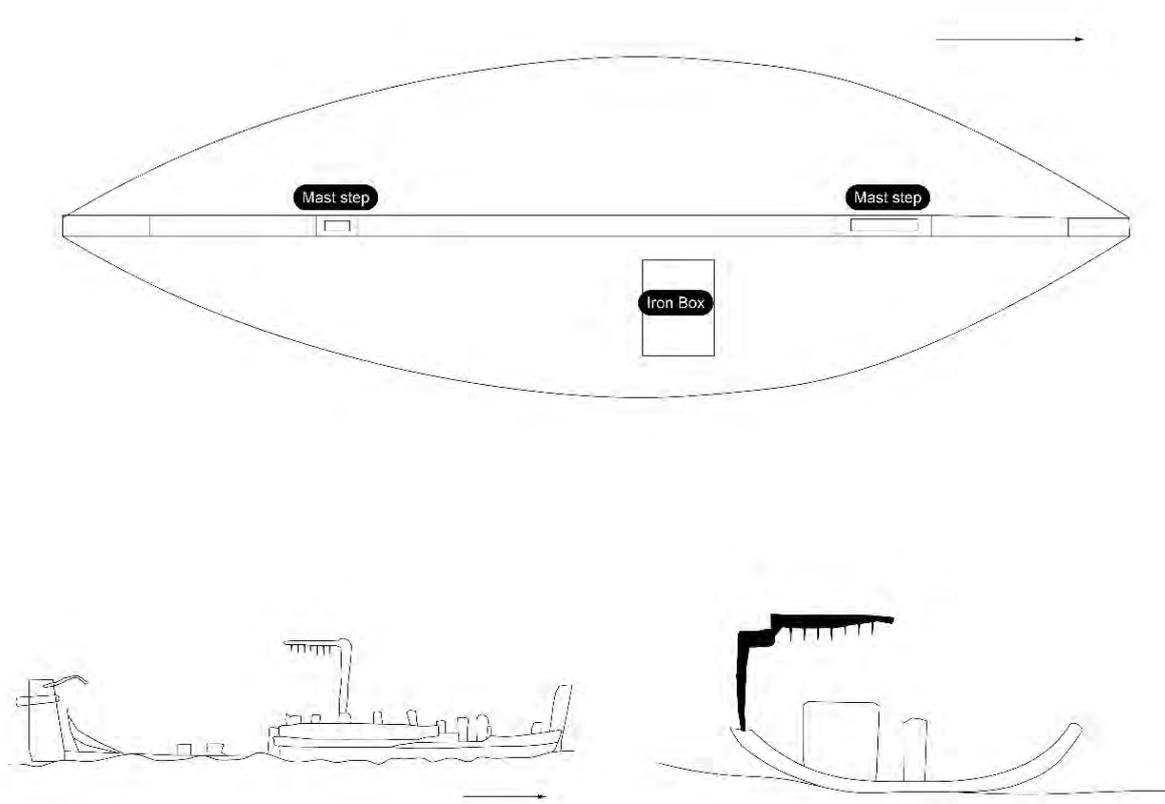
Figure 3: Site plan of the hulk Winifred (arrow indicates North)

The physical remains measure 19.20m (63ft) long, 5.5m (18ft) wide and up to 2m high. The site lies on a north – south alignment with the bow to the north (Figures 4 and 5). The hull is sitting on an even keel and is formed of wooden frames and planks with iron reinforcement and fastenings.

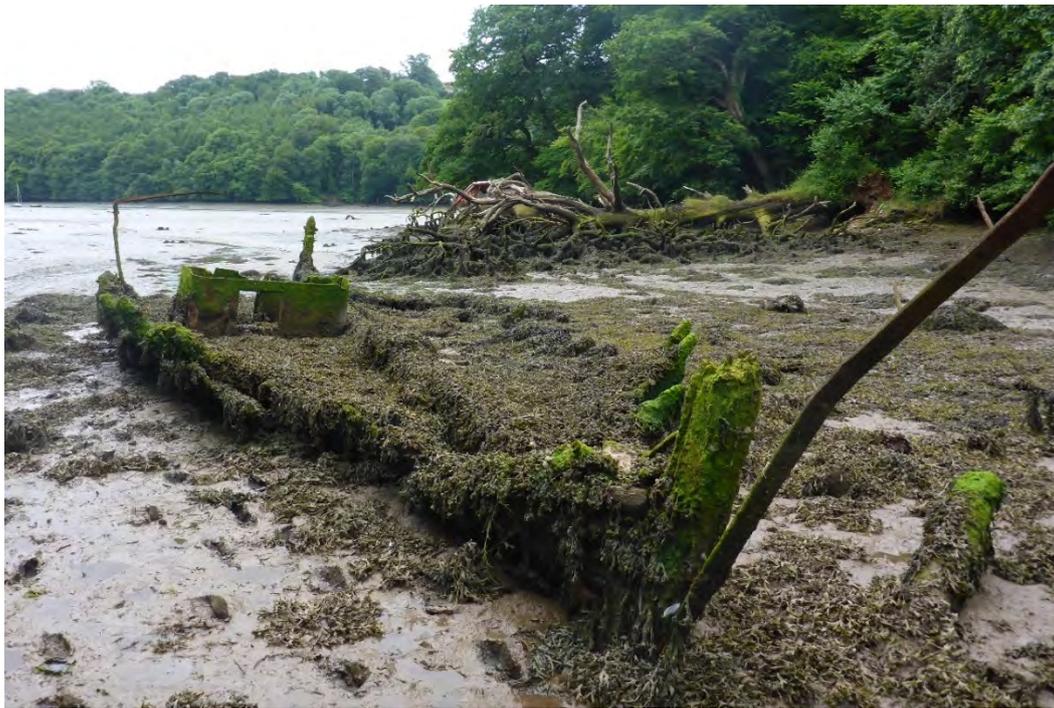
Remains of an iron tank present on the starboard side in the mid ships area, likely to have been the ships water tank.

Figure 5: Forward half of the hulk Winifred, showing bow timbers and iron tank feature

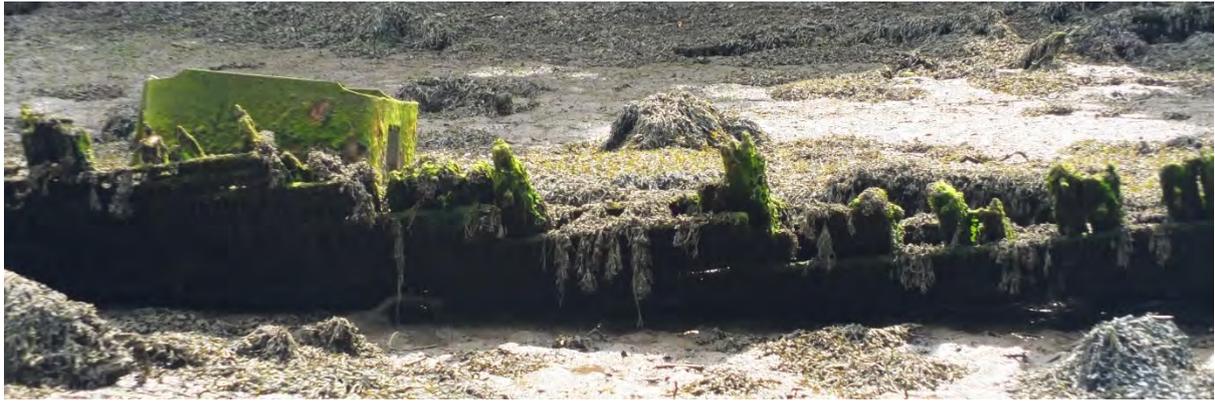
Planking and framing preserved on both sides to just past the turn of the bilge, the framing is paired (Figure 6). The sides have fallen away on the stern quarters. The keelson is in-situ along with two mast steps (Figure 7 and 8). The bulk of the stem and stern assembly are in-situ and preserved. Gudgeons are present on the stern post 4ft (1.22m) apart (Figure 9).

Figure 6: The paired frames and outer planking of the hull

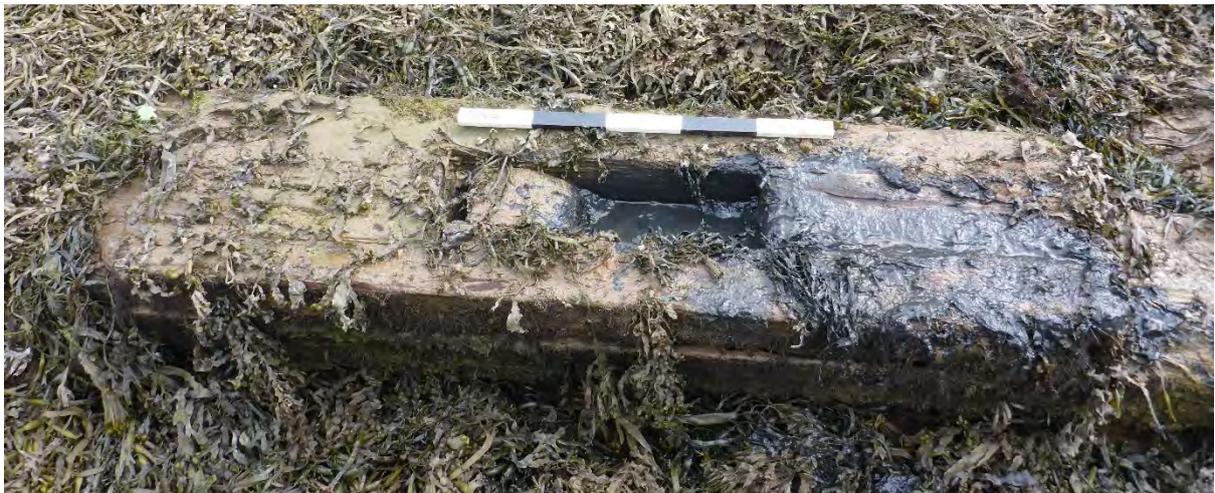
Figure 7: Forward mast step on the hulk Winifred

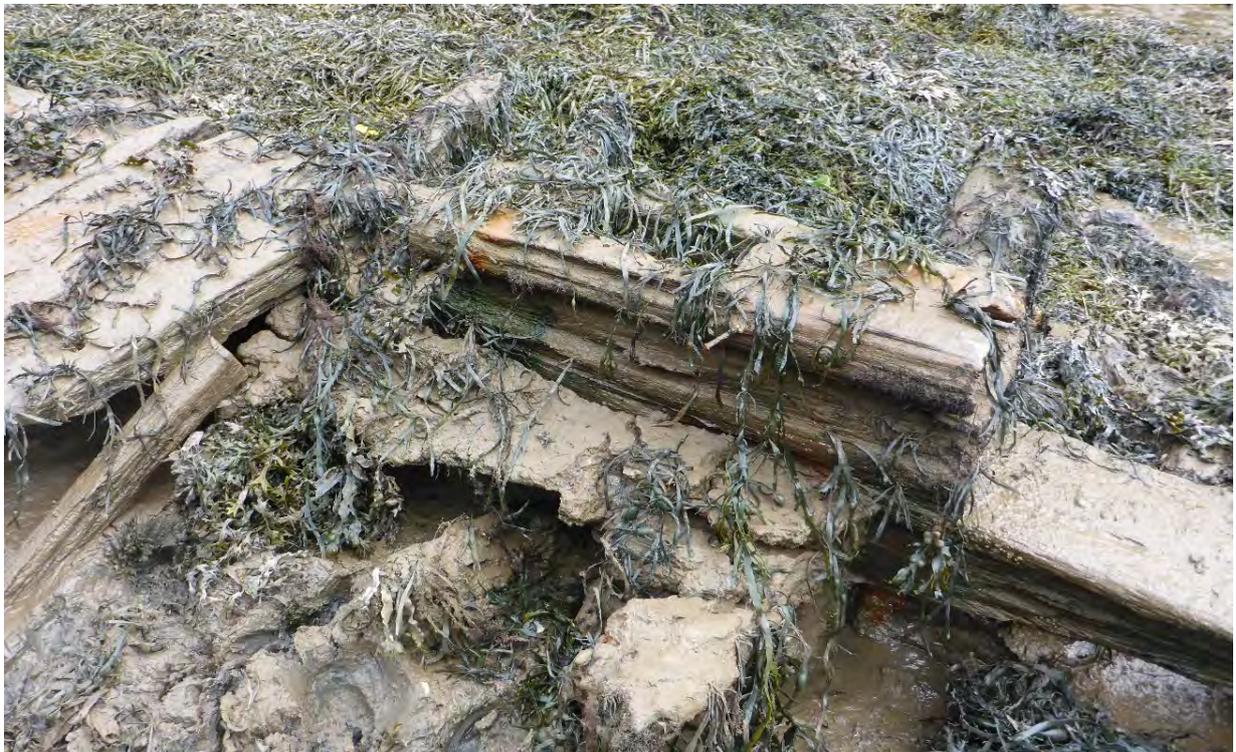
Figure 8: Aft mast step on the hulk Winifred

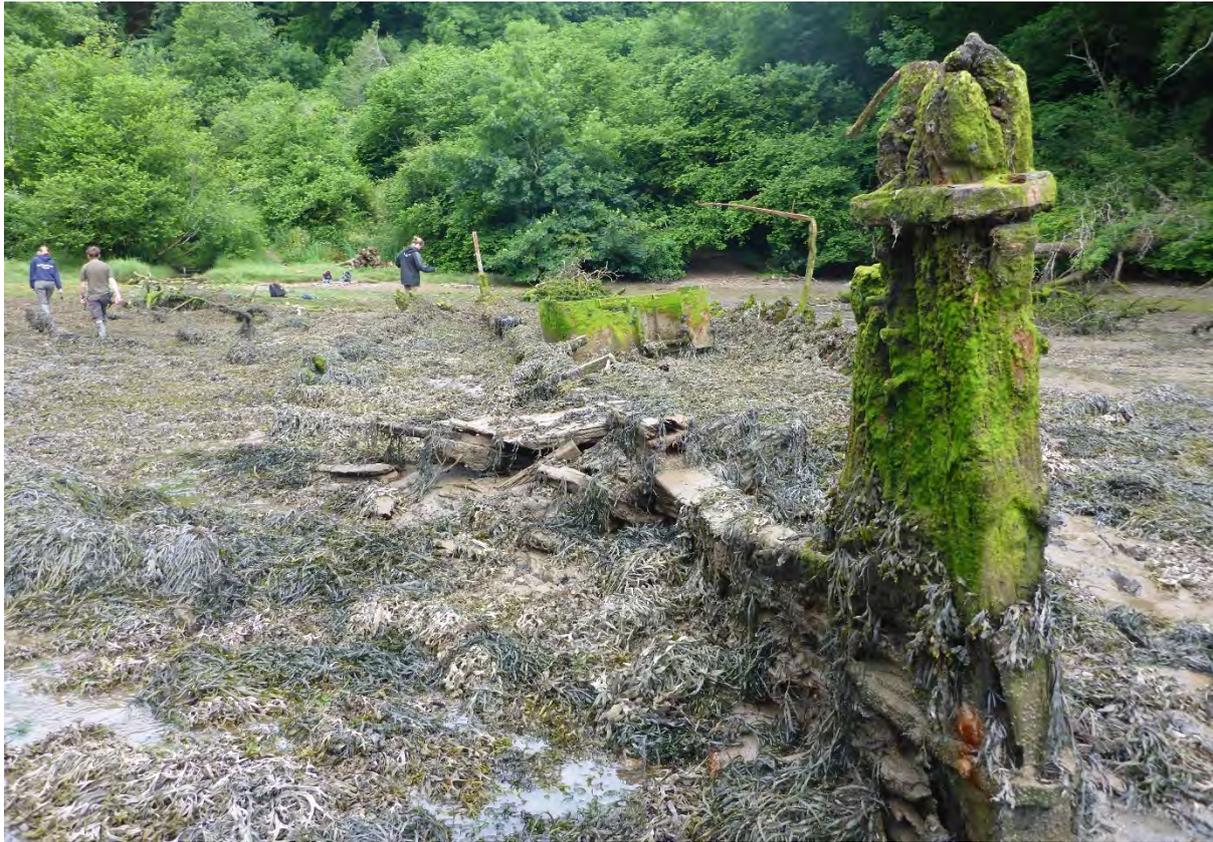
Figure 9: Stern of the hulk Winifred, gudgeons still in place on the stern post

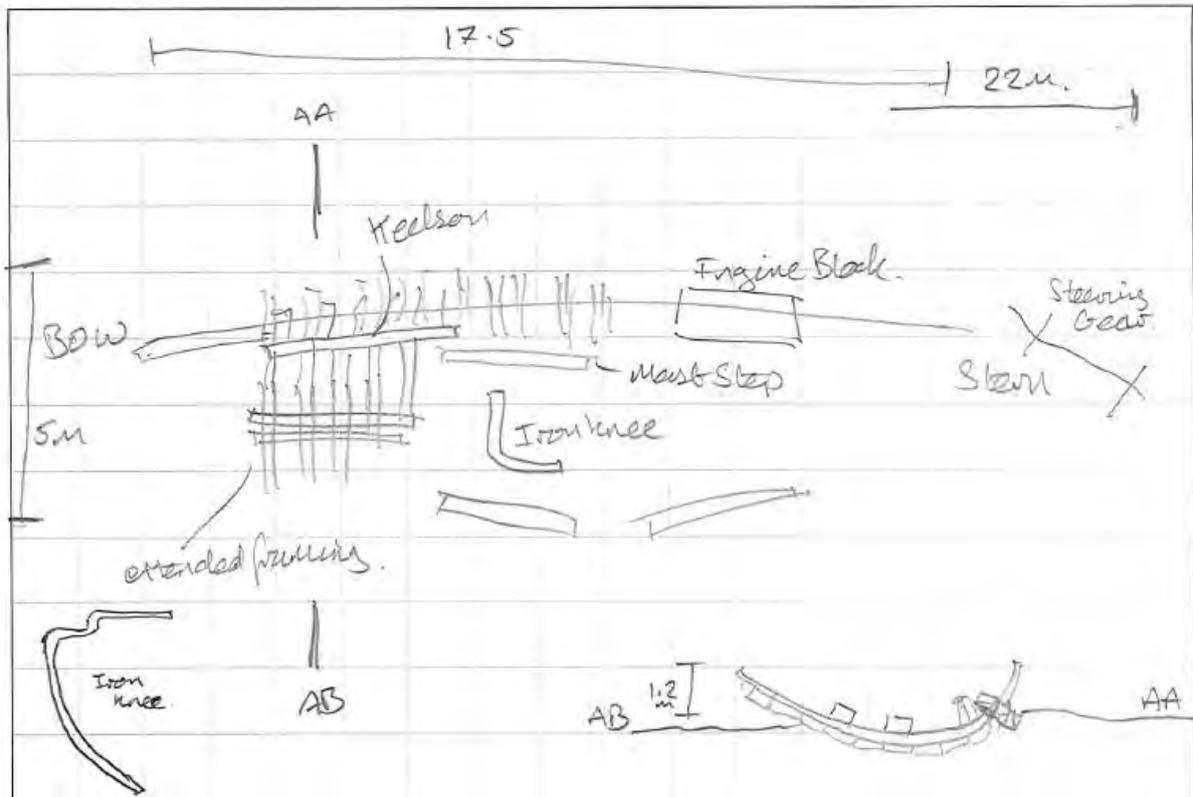
Figure 11: Site sketch plan of the Six Brothers

The hull remains measure 17.5m in length, with the full extent of remains (including steering gear etc) being 23m long. The remains are 5m wide (which include the debris field) and the maximum height of the exposed hull is 1.2m. A sketch plan (Figure 11) and photographic survey of the site were produced. The hull lies on an east – west alignment perpendicular to the river bank and leans over to the port side. The port side is badly degraded except in the fore quarter where it is preserved to an extended height for several frames (Figure 12).

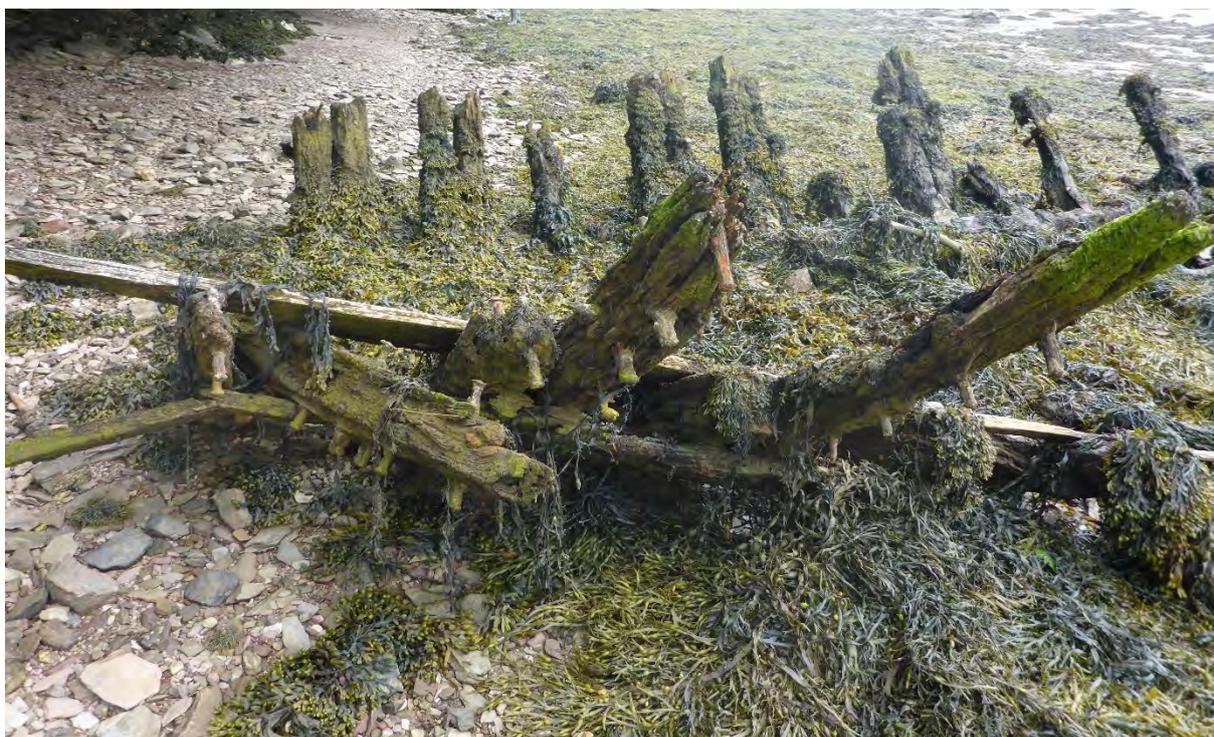
Figure 12: Hull towards the bow showing paired frames and fastenings that once held outer planking

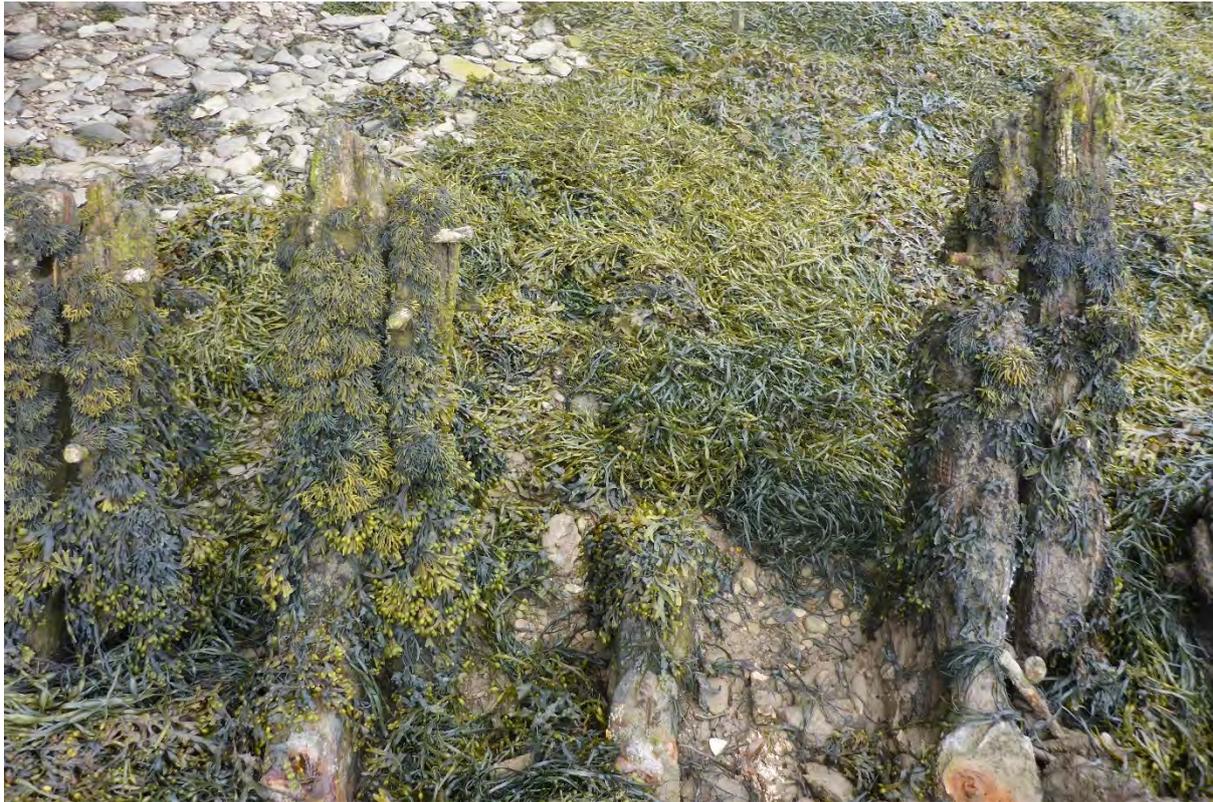
Figure 13: Pairs of frames showing the lateral bolts between floors and first futtocks

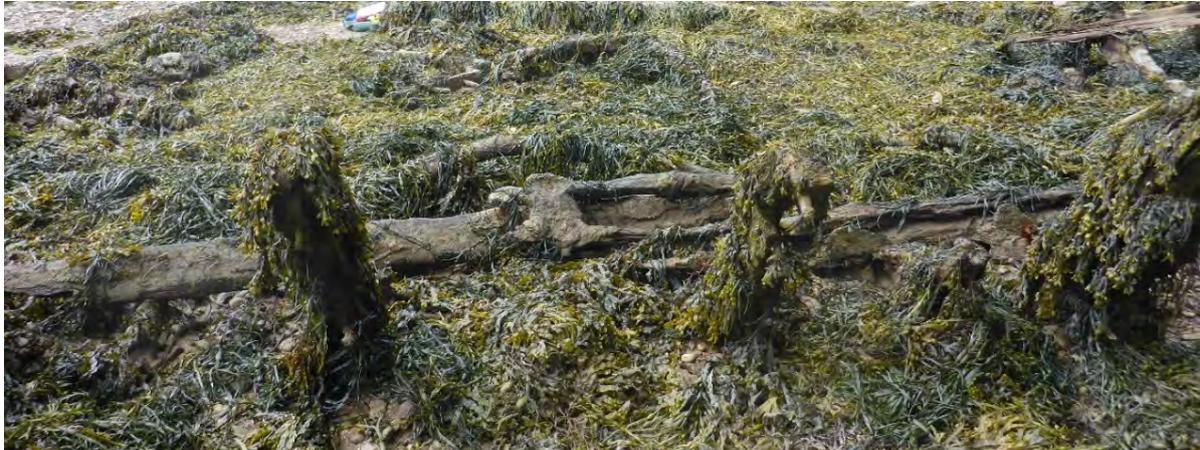
Figure 14: Possible mast step within the Six Brothers

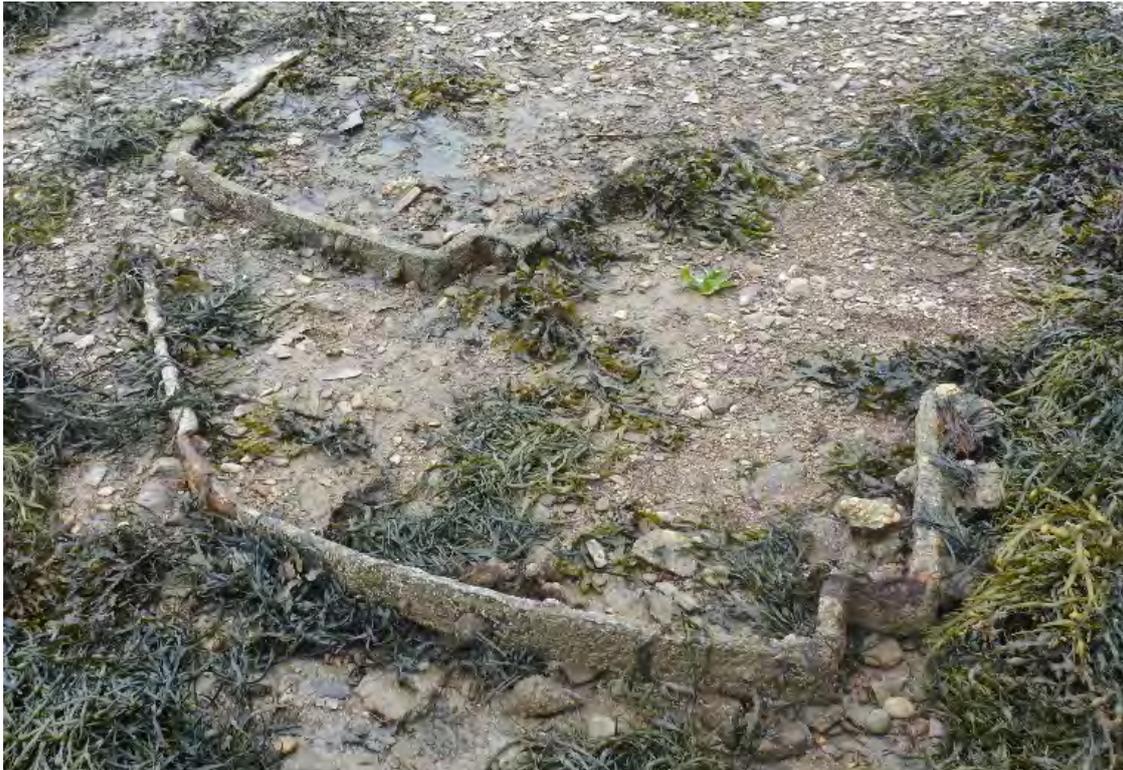
Located close to the port side of the vessel are iron knees (Figure 15), and these show the original curve of the hull and the height that the deck would have been.

Figure 15: Iron knees that have become detached from the vessel, they show the curve of the hull up to deck level

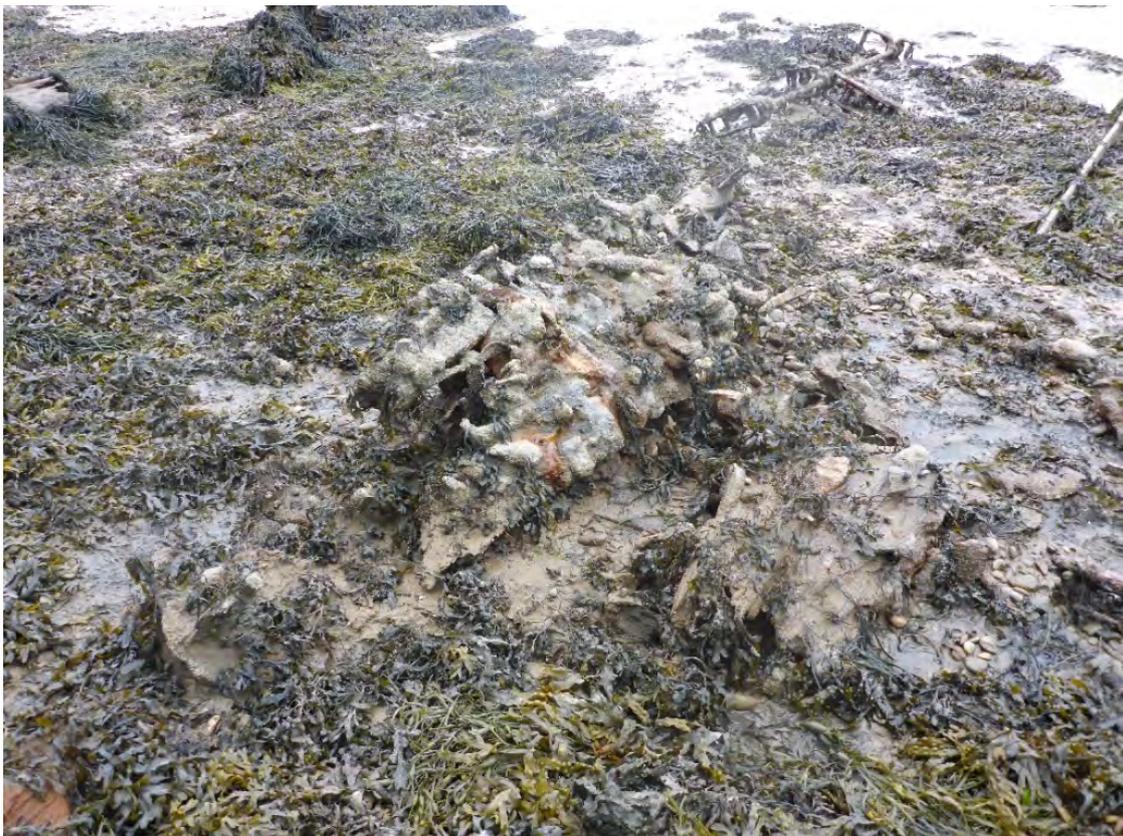
Evidence of propulsion comes from what is thought to be the concreted remains of the engine block (Figure 16) and the steering gear which is at the stern of the vessel, although no longer directly attached (Figure 17).

Figure 16: Area thought to have housed the engine block

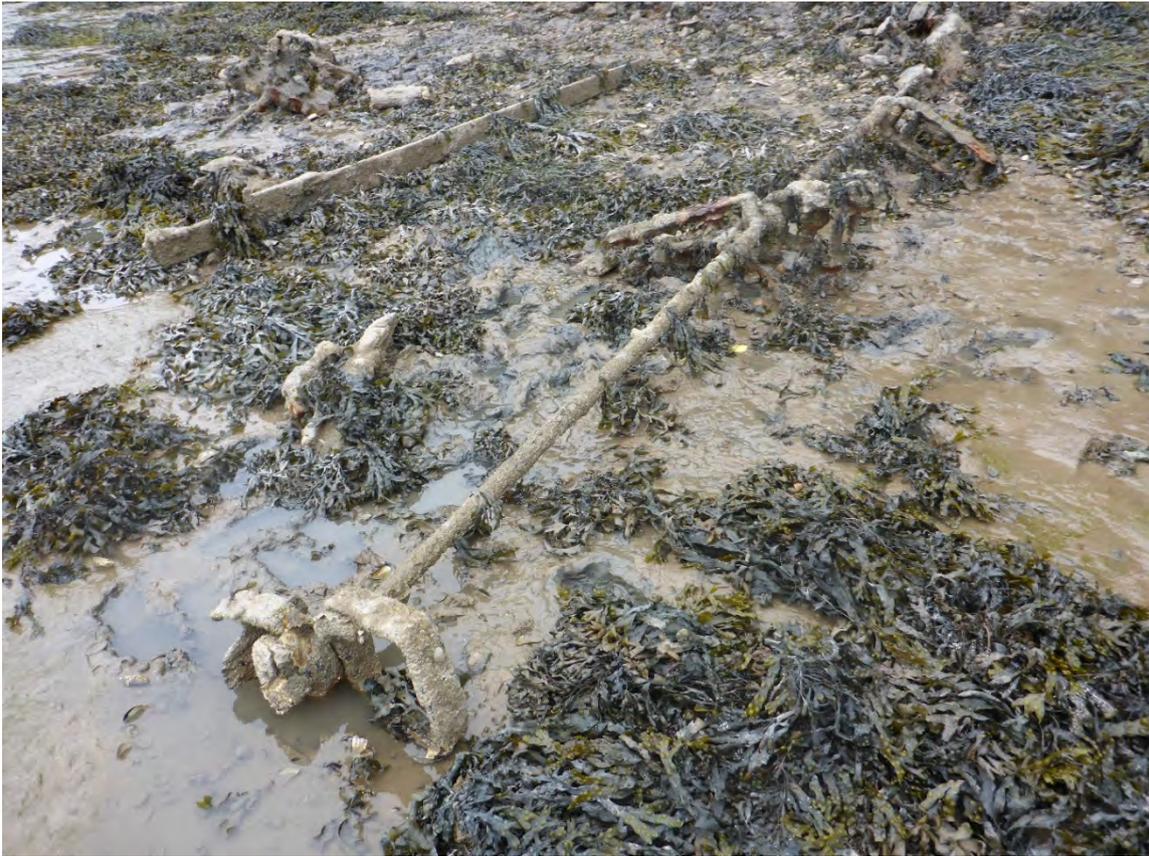
Figure 17: The remains of the steering gear delineate the stern of the vessel

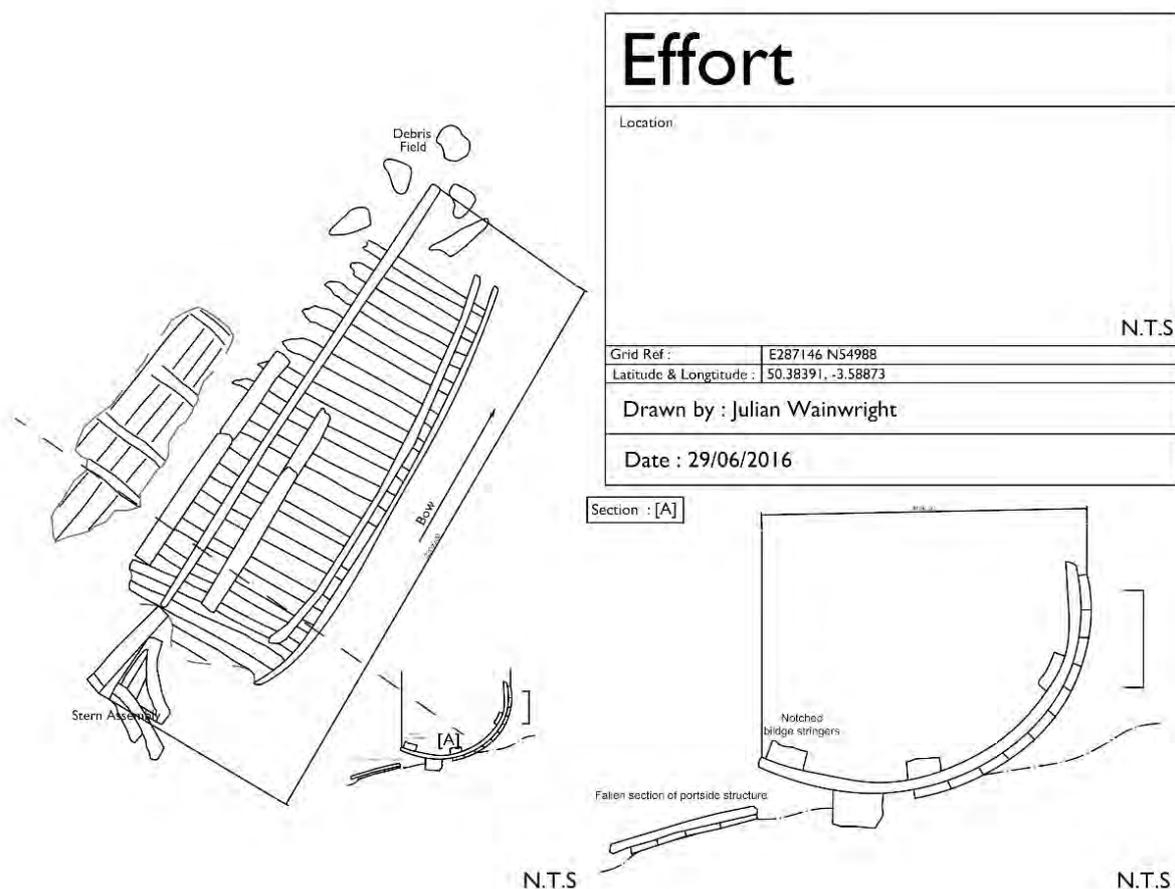
Figure 20: Site plan of the remains of the *Effort*

Using an RPAS (drone) a series of aerial photographs were obtained which were processed through photogrammetric software to produce a scaled orthographic image of the site. An offset survey collected detailed measurements of the ground plan which, together with the photographs, enabled scaling of the images to create a site plan (Figure 20).

The physical remains on the site measured 22.2m of hull structure, with 25m length including the debris field, the hull is 4m wide with debris taking site width to 6m, the wooden remains are a maximum of 1.2 m high (Figure 21). The hulk is of wooden hull construction and has iron fastenings and reinforcement. The bow points to the north east and stern to the south west.

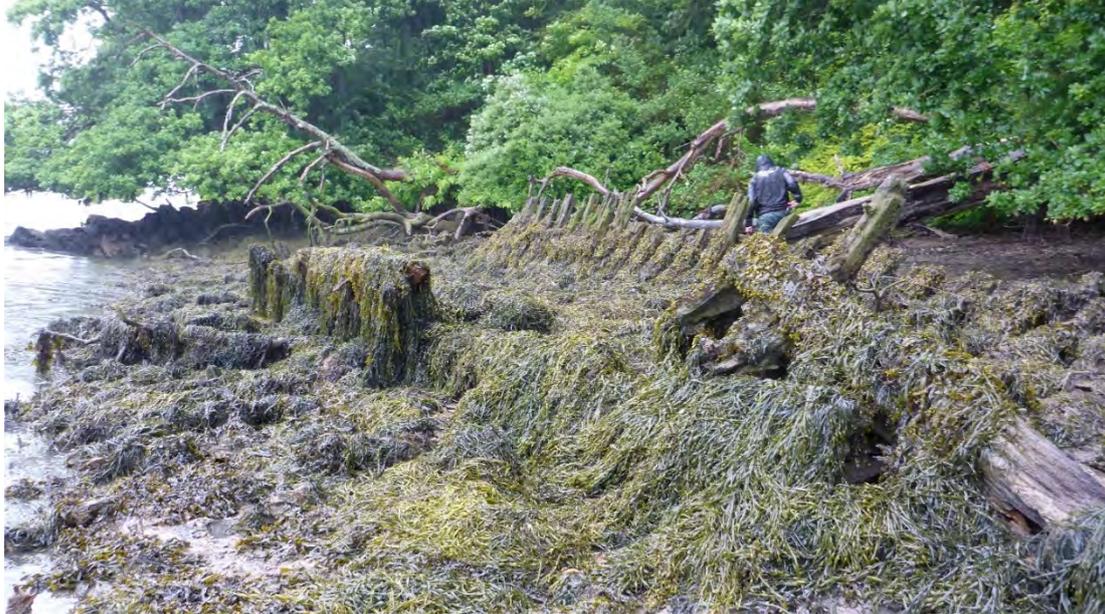
The vessel has listed to starboard with much of the starboard planking and framing still in-situ and fairly coherent at least past the turn of the bilge (figure 21). Some of the port side framing and planking has fallen outboard.

Figure 21: The remains of the Effort

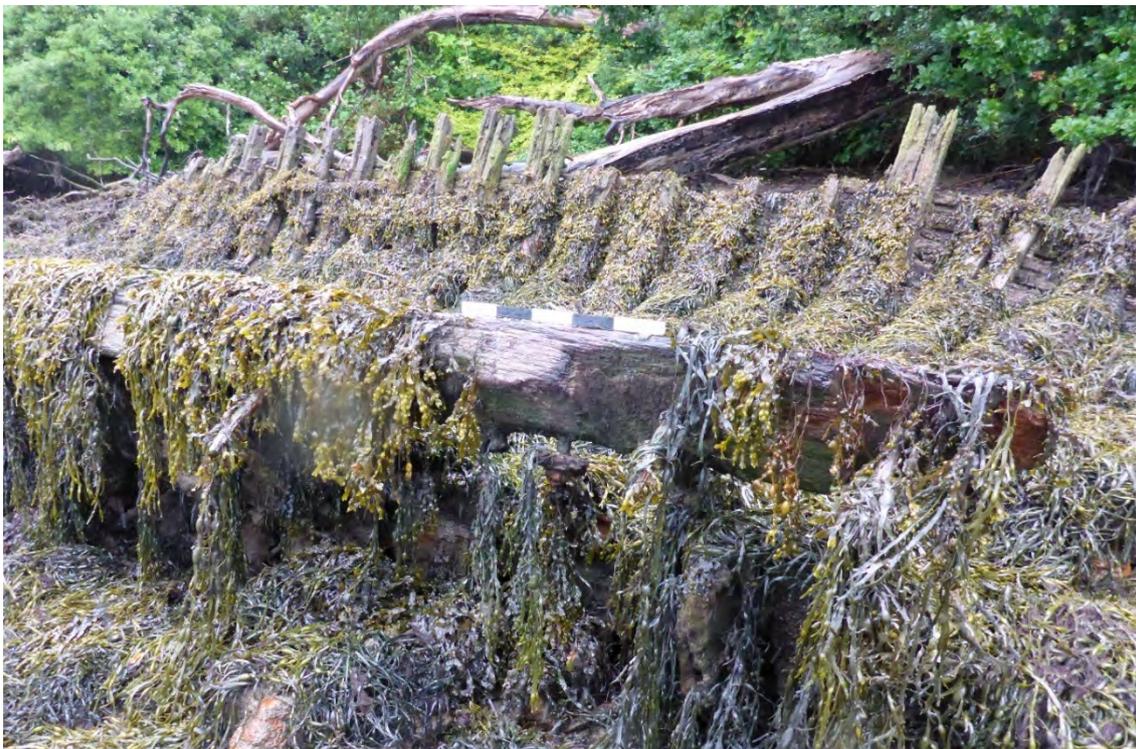
The keel/ keelson and stern post/ deadwood assembly are present although disjointed. The bow area is more disarticulated and dispersed. Engine block keelsons are also preserved in situ (Figure 22). The framing consists of floors and futtocks (Figure 23), with some apparent iron reinforcement. All visible fastenings are iron. Frames are also laterally bolted with iron bolts. The outer planking is also fastened with iron bolts with two bolts per plank per frame offset from each other (Figure 24).

Figure 22: Hull remains, paired frames on the far side of the hull, notched engine keelson in foreground

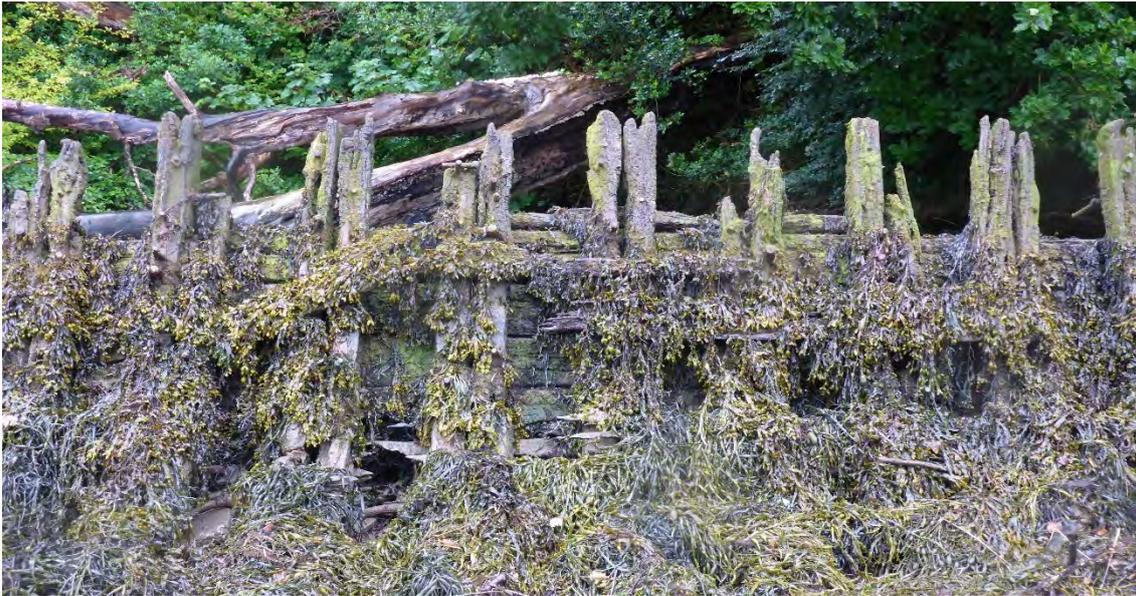
Figure 23: Hull side with paired frames, fastenings can be seen where ceiling planking has gone, lateral fixings between frames also visible

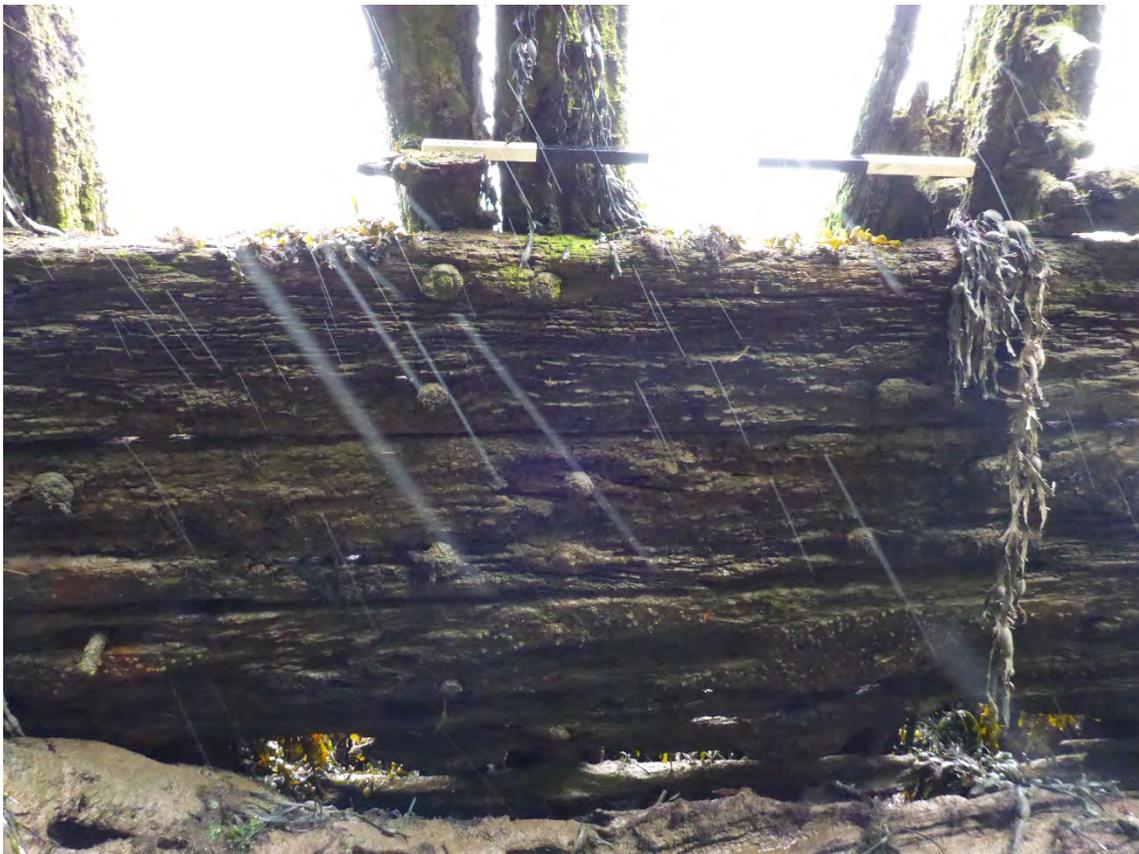
Figure 24: Outer hull planking showing the pattern of fastenings through to the frames

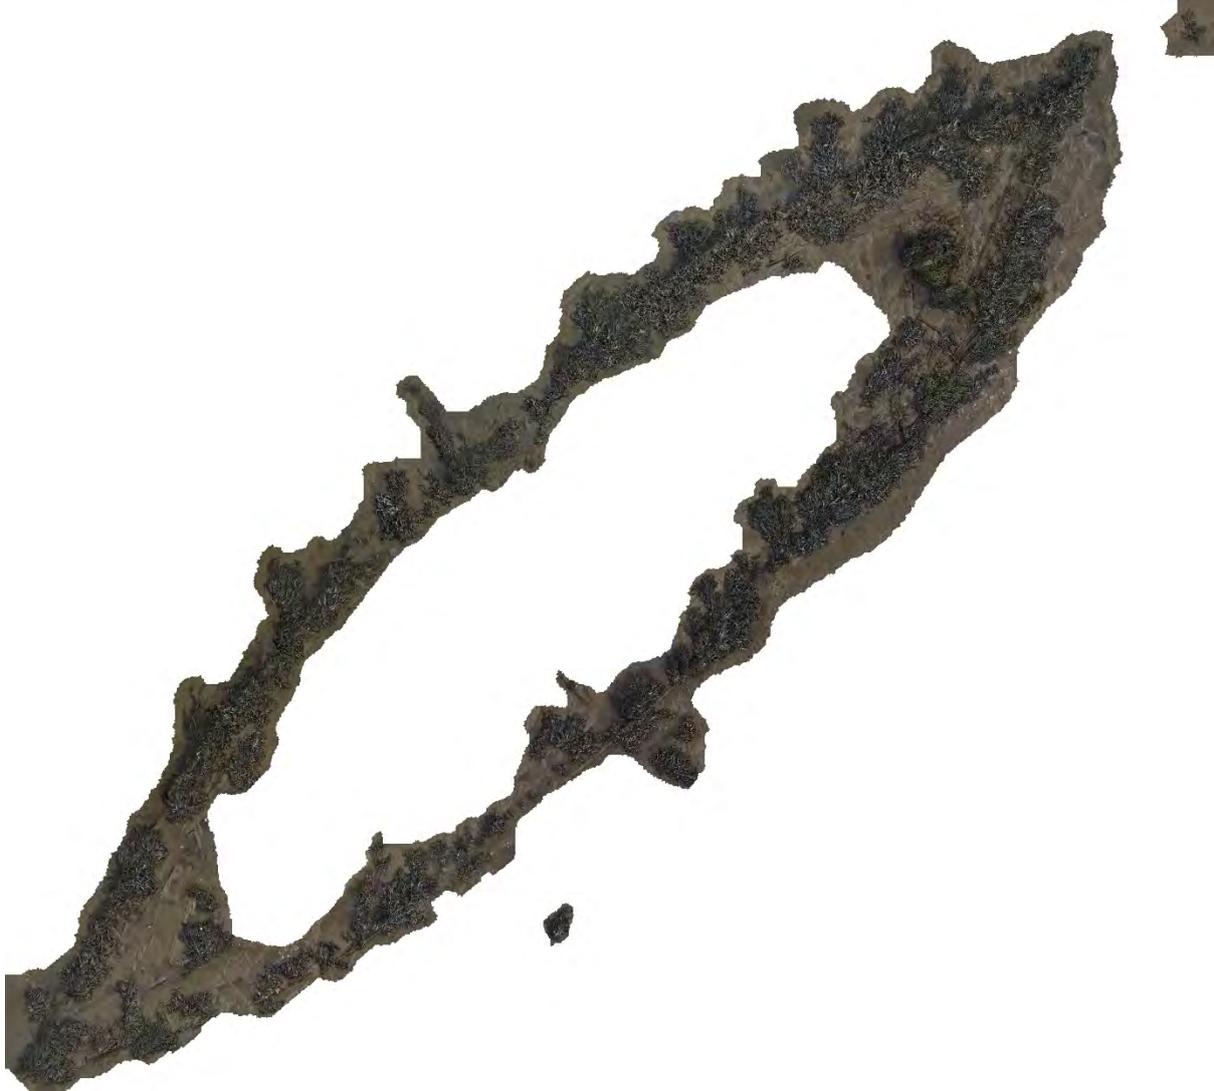
Figure 26: Orthographic image of the hulk Esther (Irene)

Due to the location of the hulk being inaccessible on foot an RPAS (drone) was used to obtain a series of aerial photographs which were processed through photogrammetric software to produce a scaled orthographic image of the site (Figure 26). It has also enabled the production of the 3D model of the site, which is available here: <https://sketchfab.com/models/3a7afc8ea263407ca1b7ecb38a01ba9f>

The physical remains of the site measure approximately 20m long by 5m wide with 1-2ft (0.3 – 0.6m) upstanding. Although the amount of upstanding remains is limited, the vessel is clearly delineated and appears to be intact at both the bow and stern. The covering of weed on the timbers makes it difficult to interpret the structural remains, although due to its position in such deep mud the timbers below the surface are likely to be very well preserved and they could represent a relatively large amount of the original hull.

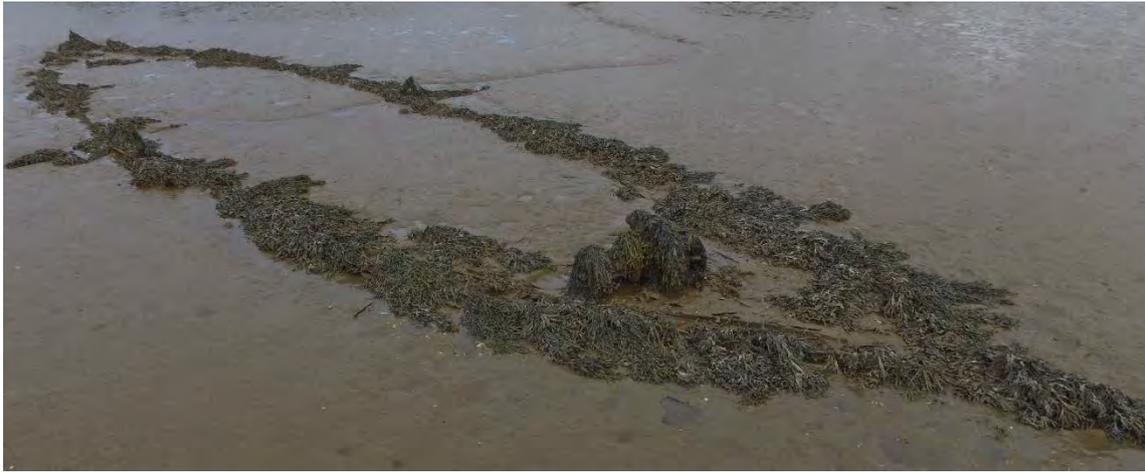
There is a feature lying within the vessel, close to one end, that appears to be a winch or capstan, this would have been present at deck level and provides further suggestion that a substantial amount of the vessel is preserved (Figure 27).

Figure 27: Feature, thought to be the capstan, within the hulk of Esther

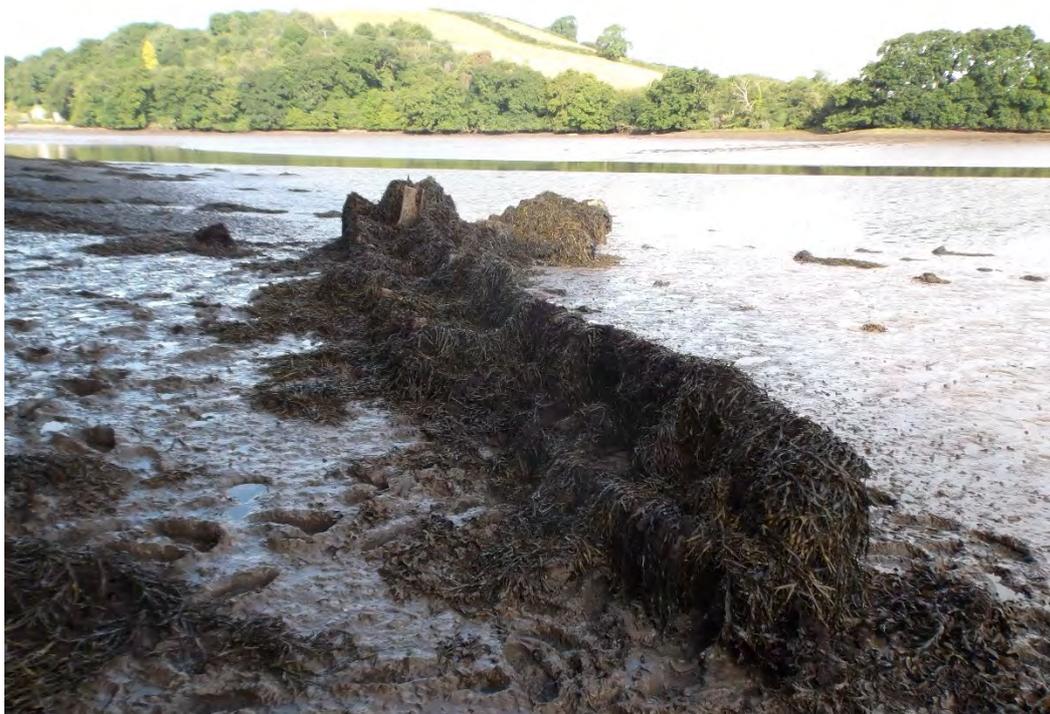
There is also some large structural material on the foreshore comprised of iron right angle knees and timber, but it is unclear if it is related to the main site (Figure 28). This is thought to be unlikely due to the amount of the hull thought to be preserved at the main site.

Figure 28: Disarticulated structure on the foreshore that could be related to Esther

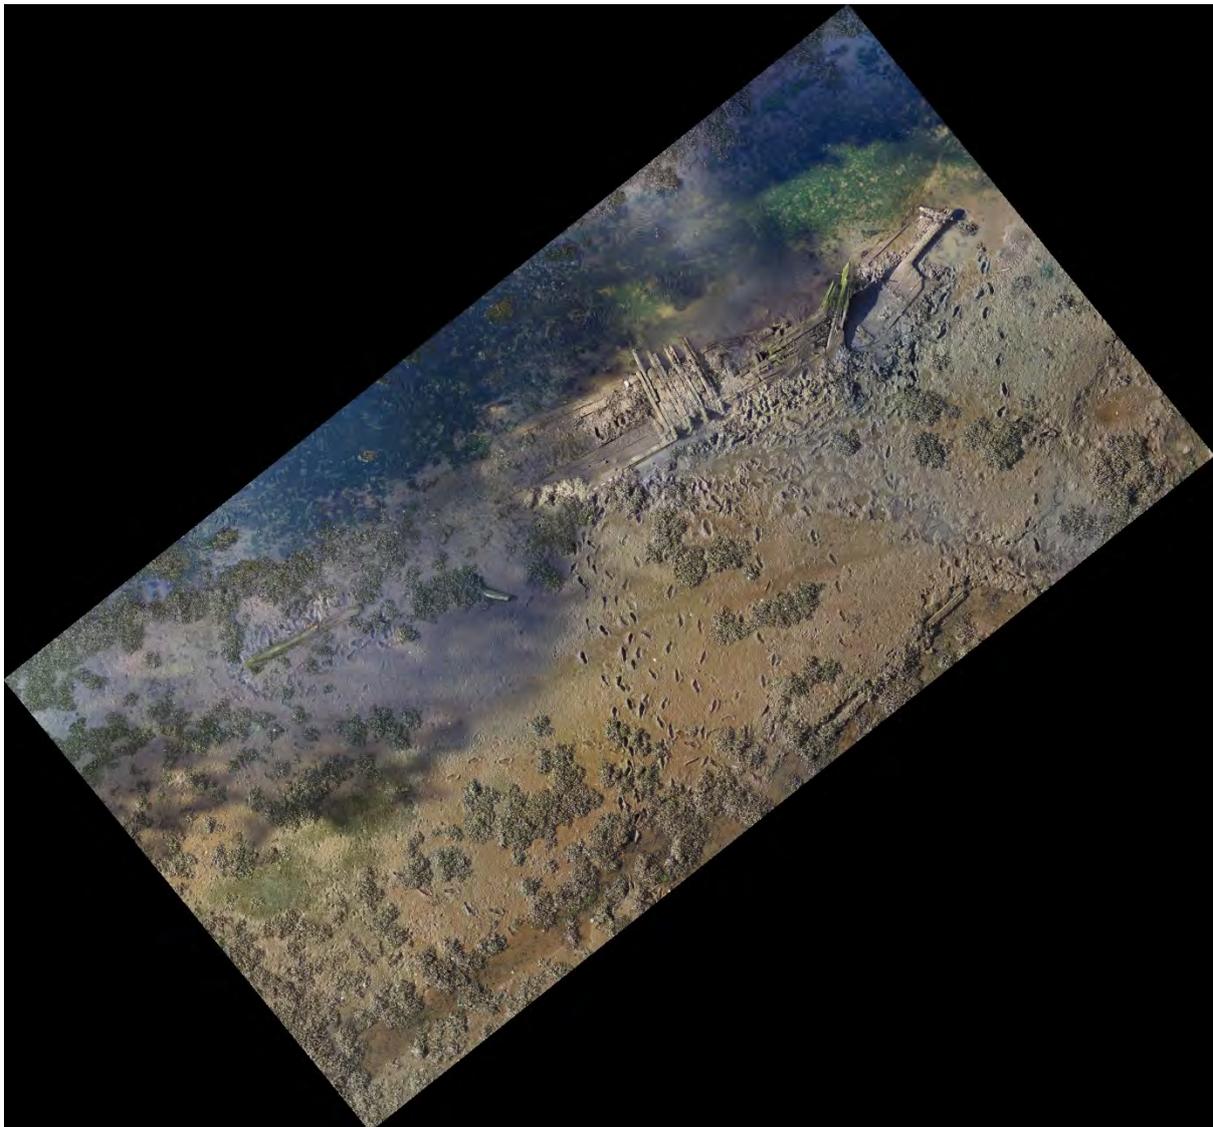
Figure 29: Orthorectified image from photographs of the Fiery Cross showing full site extent

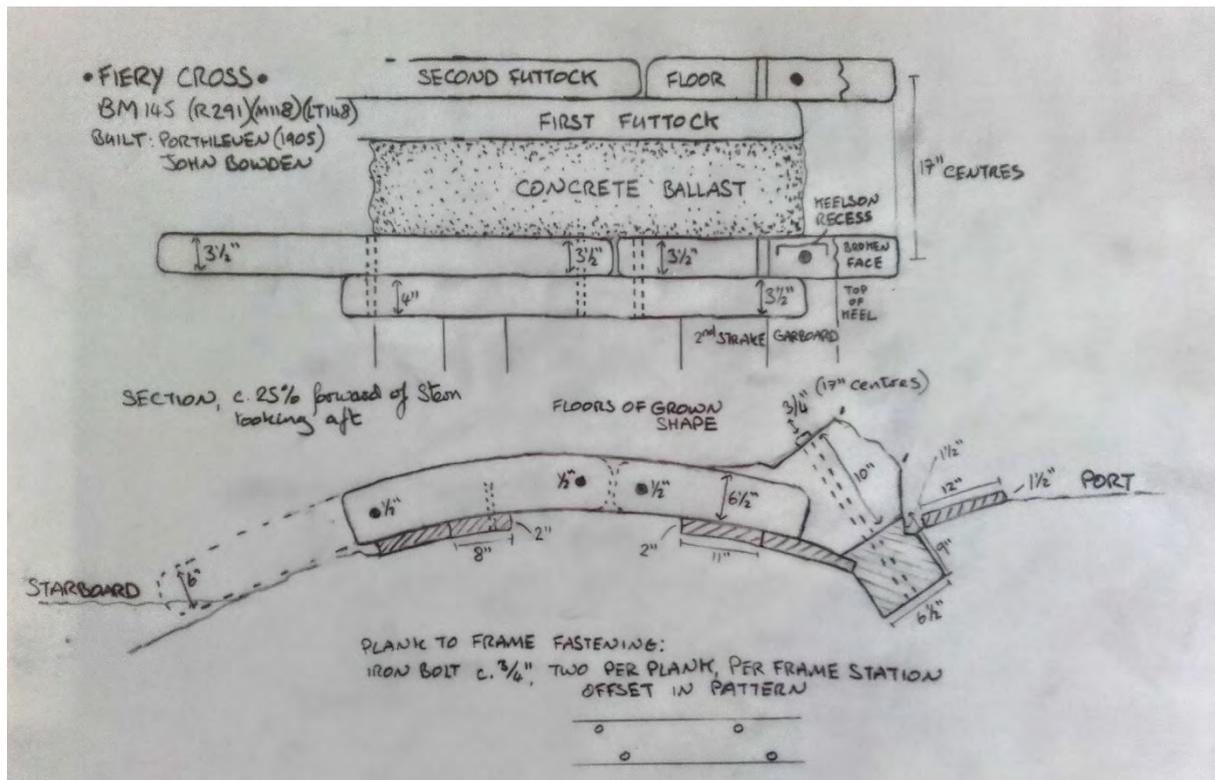
Figure 30: Detailed sketch plan of the framing of the Fiery Cross

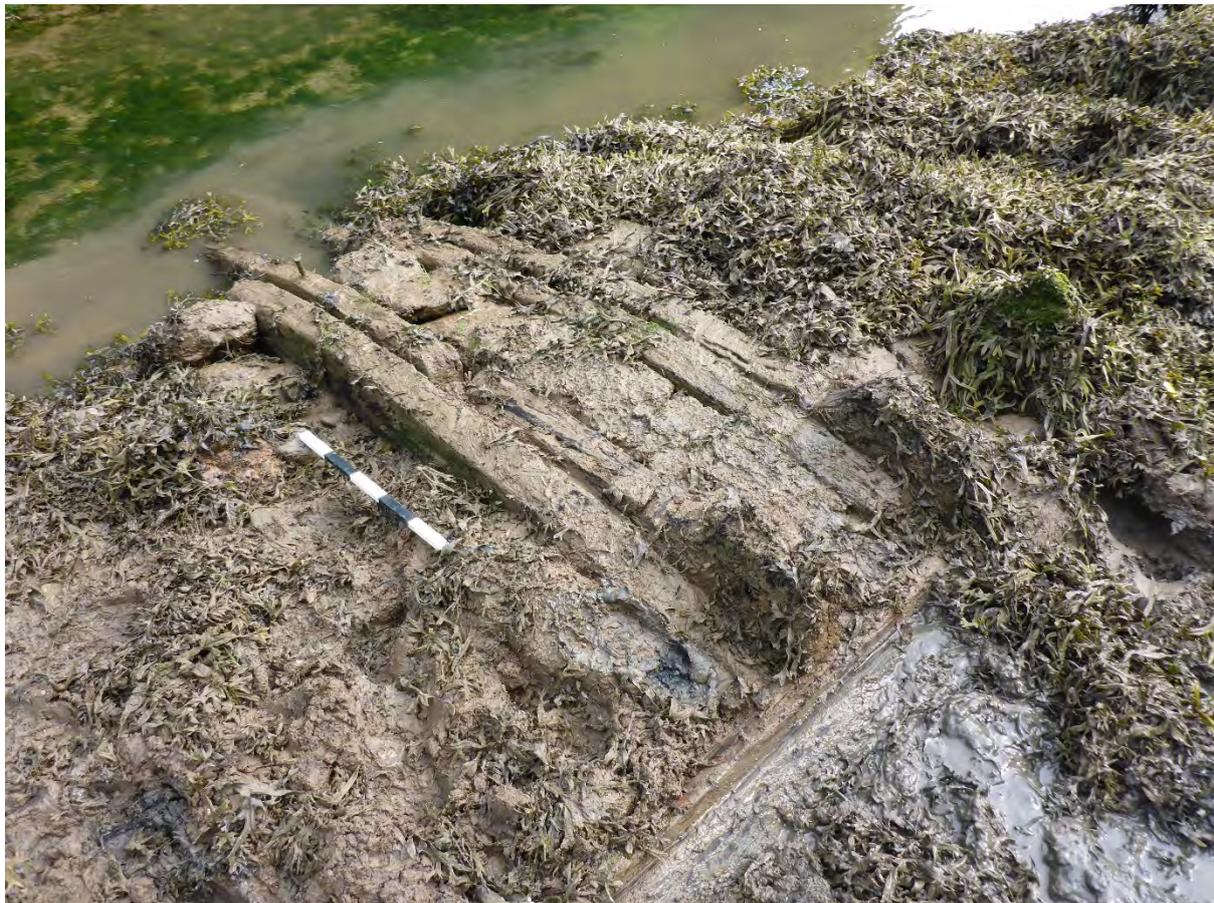
The garboard is in-situ on the starboard side, it has slightly fallen away on the port side, it measures 1' (30.48cm) wide and 1 ½" thick. Outer planking on the port side is 2" (5cm) thick and 8" (20.32cm) wide. Planking is fastened with iron bolts, which are corroded, they appear to be 1" diameter, but may have been ½" originally, there are two bolts per plank, per frame.

Figure 31: Section of hull framing
