Forgotten Wrecks of the First World War

Hulks of the River Dart, Devon

**Hulks of Vessels used during the First
World War, River Dart, Devon:**

***Winifred, Six Brothers, Effort,
Esther (Irene), Fiery Cross, Glory and
Kingswear Castle***

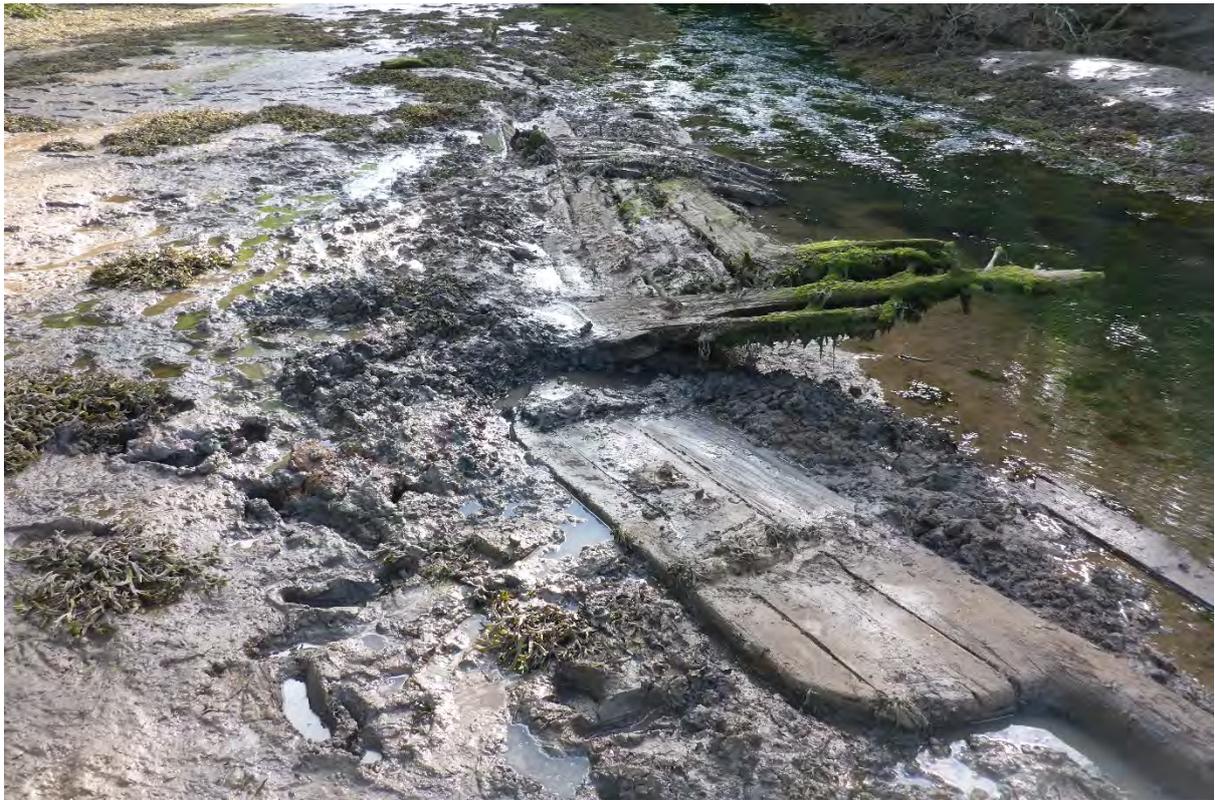
Figure 32: Vessel stern, sternpost and rudder

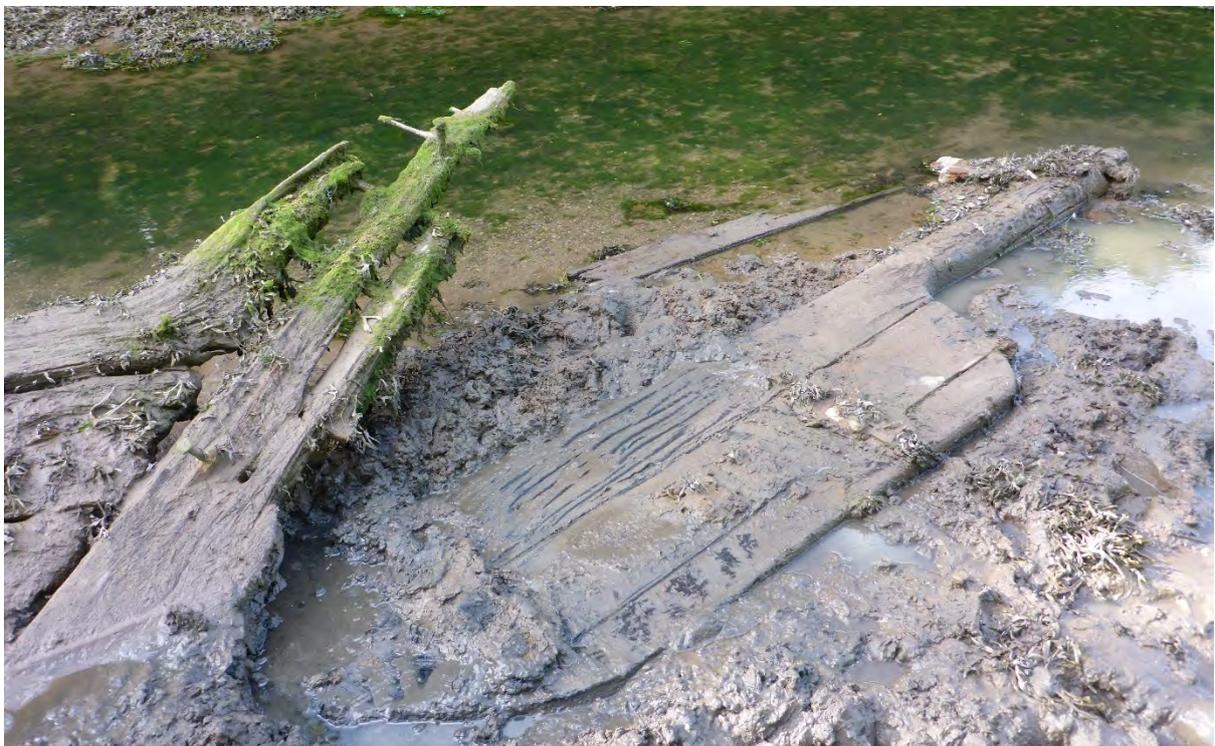
Figure 33: Detail of stern post and rudder

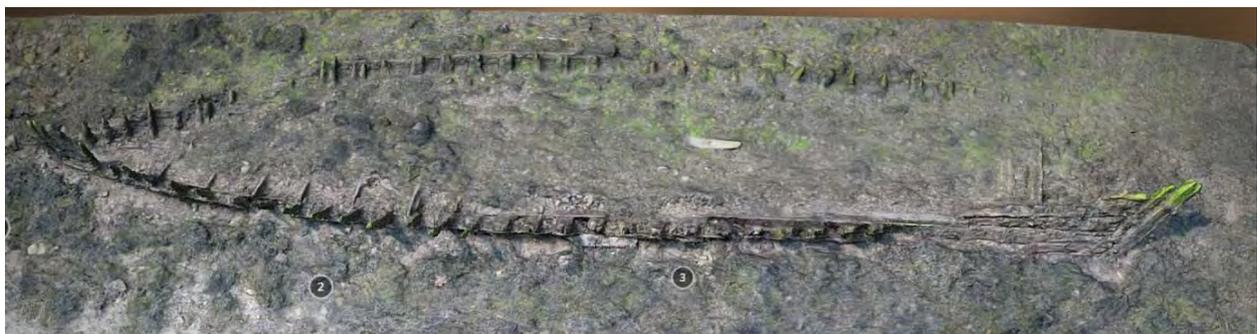
Figure 35: Remains of the *Glory*, image from 3D model created from site photographs

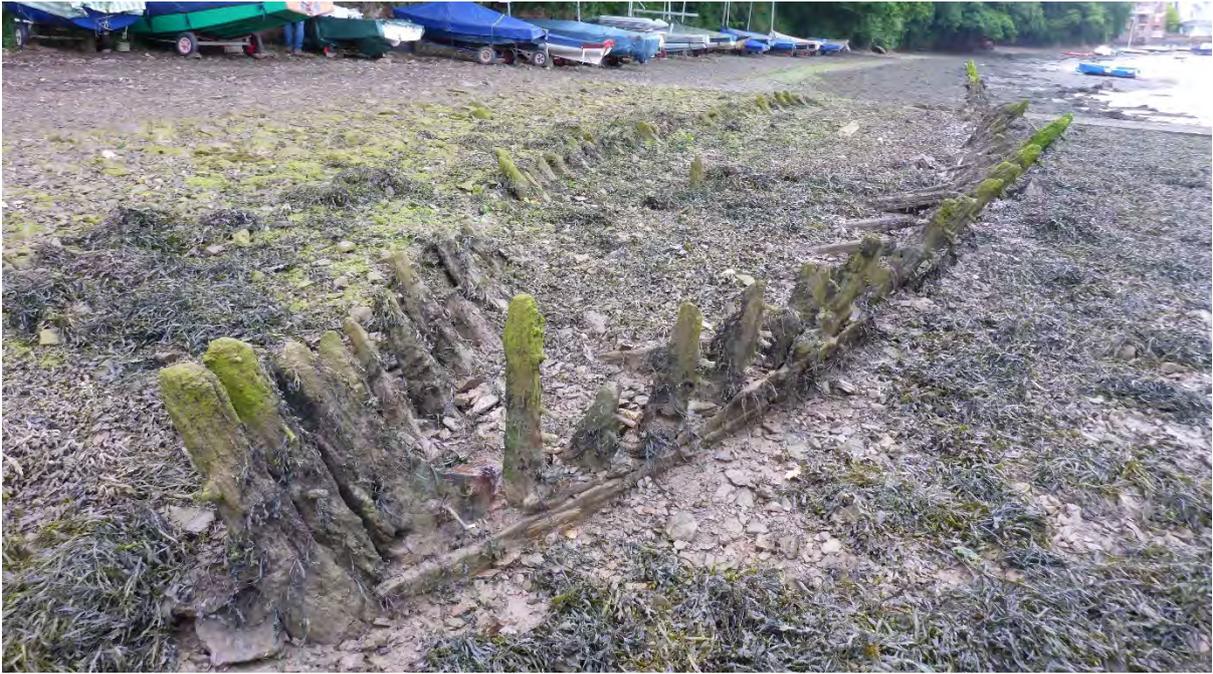
Figure 36: Site of the Glory, bow in foreground

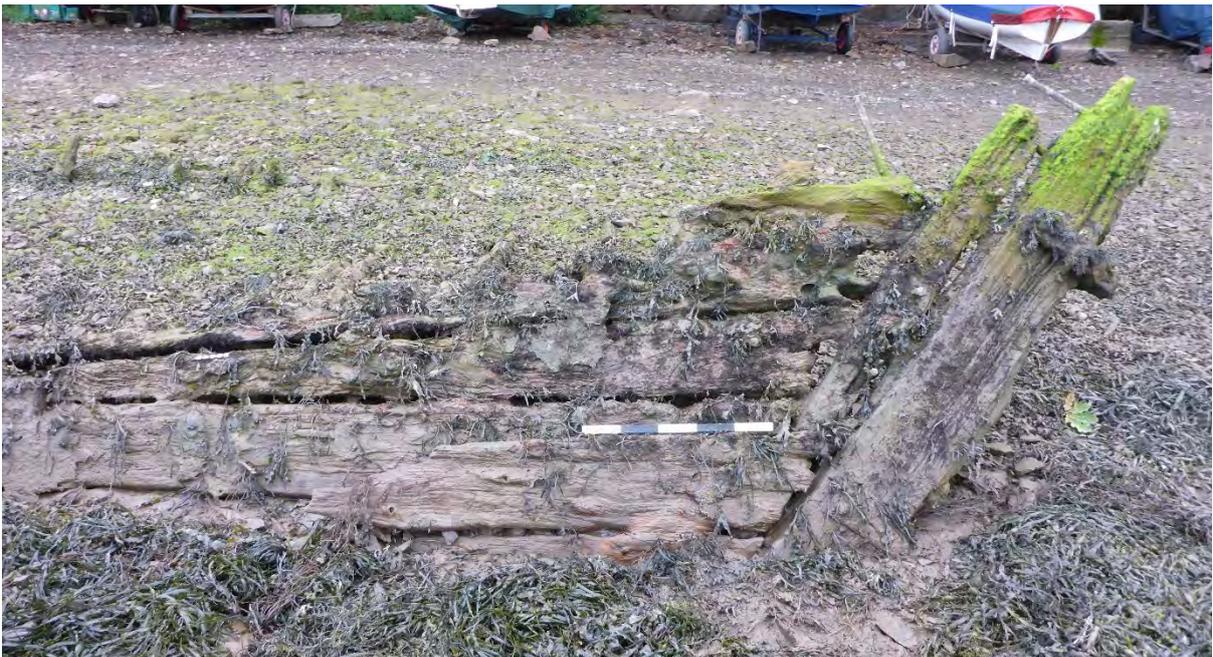
Figure 37: Stern of the Glory including stern post and gudgeons and external planking

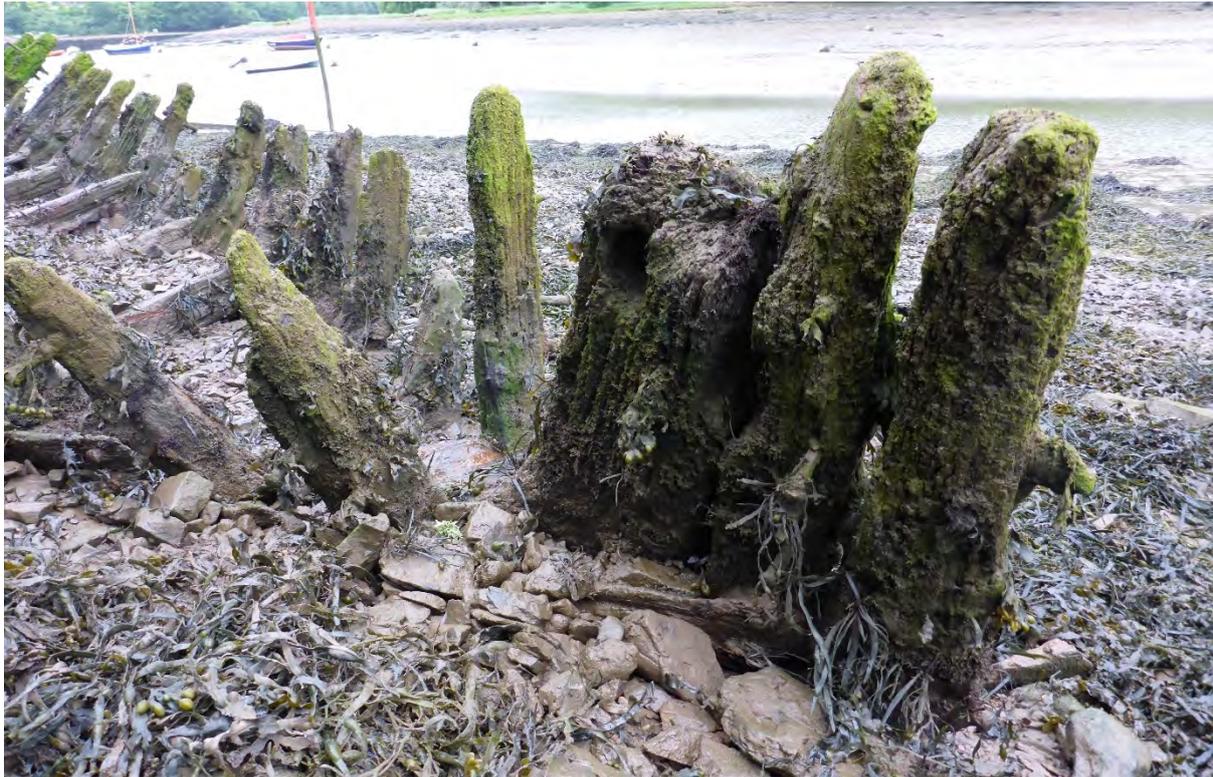
Figure 38: Bow of the Glory

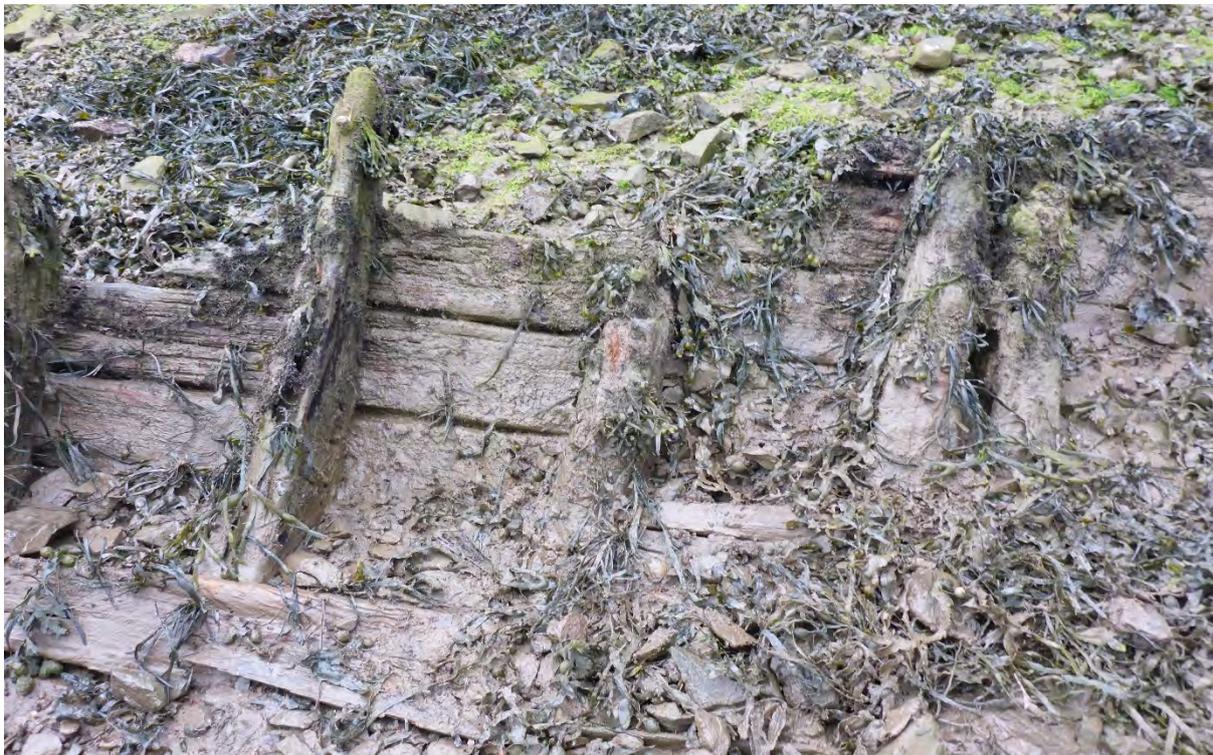
Some ceiling planks are visible (Figure 39) and are 1" (2.54cm) thick and at least 7" (17.8cm) wide. Some external planks are visible on the port side and are 1 ¼" (3.2cm) thick and 8" (20.3cm) wide. Planks and frames are fastened with ½" (1.3cm) iron bolts which are now corroded.

Figure 39: Frames and external planking of the Glory

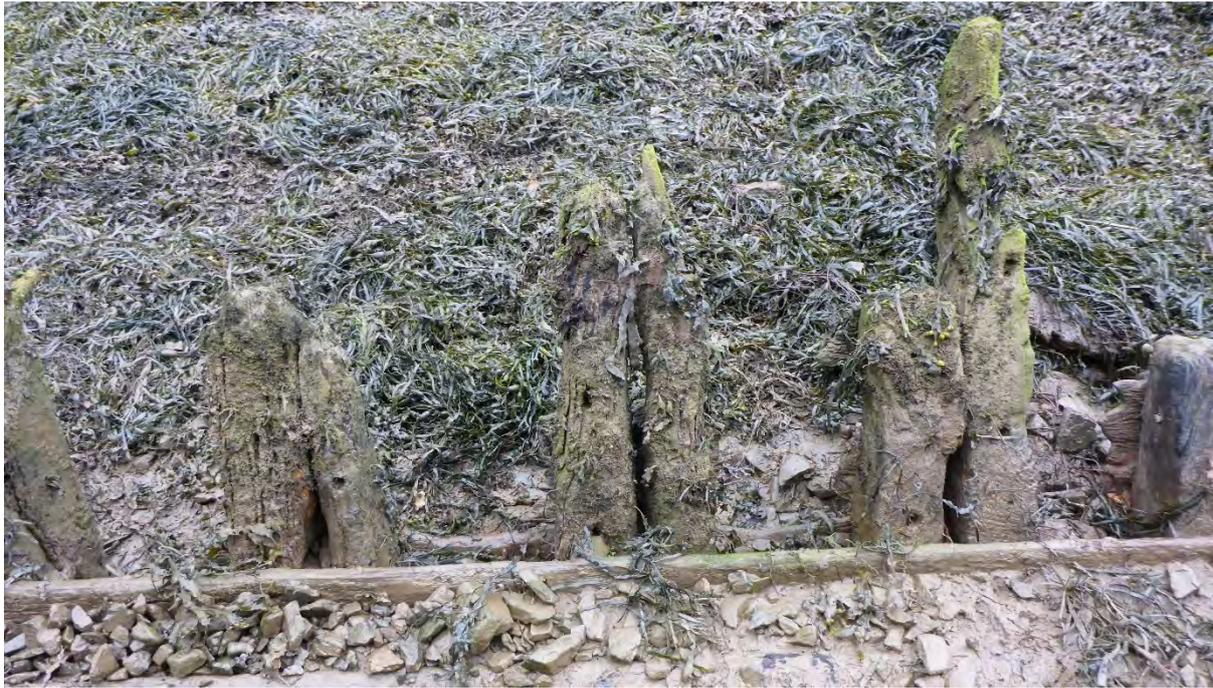
Figure 40: Paired frames showing fastening hole arrangement where ceiling planking has been removed

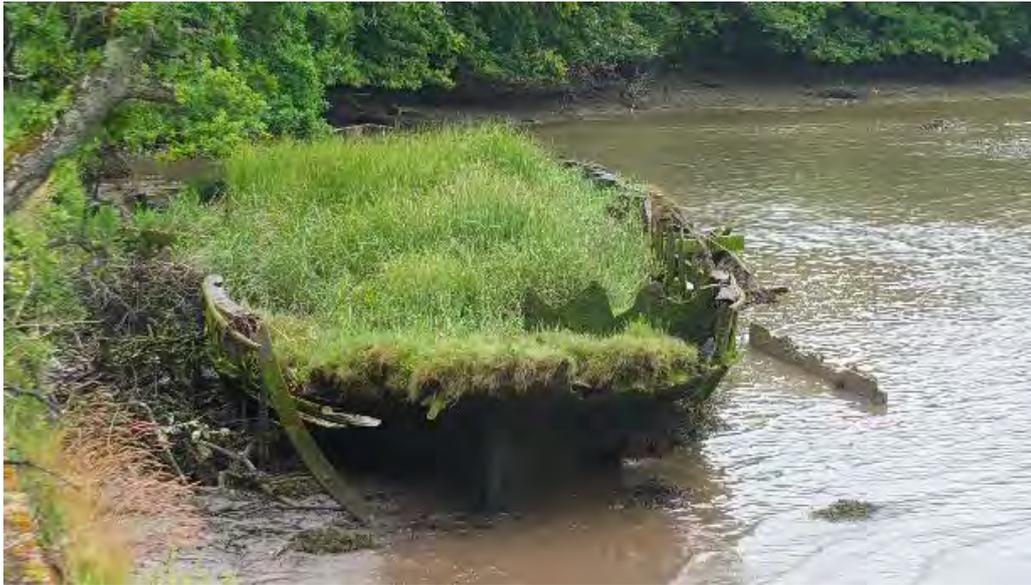
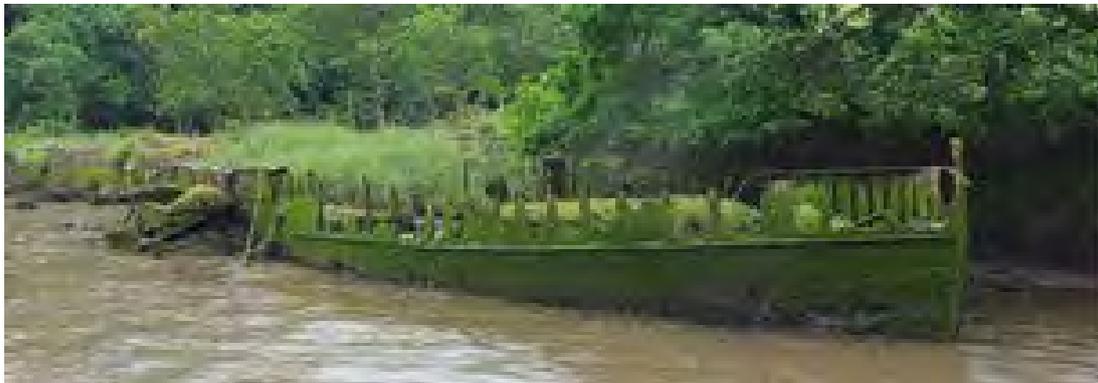
The remains of the original *Kingswear Castle* were visited by staff and volunteers from the Maritime Archaeology Trust at low tide on 26 June 2016. The vessel is pushed up against the bank, port side to shore with grass growing inside the hull (Figure 43 and 44).

Figure 43: Kingswear Castle from the stern

Figure 44: Kingswear Castle, starboard forward quarter

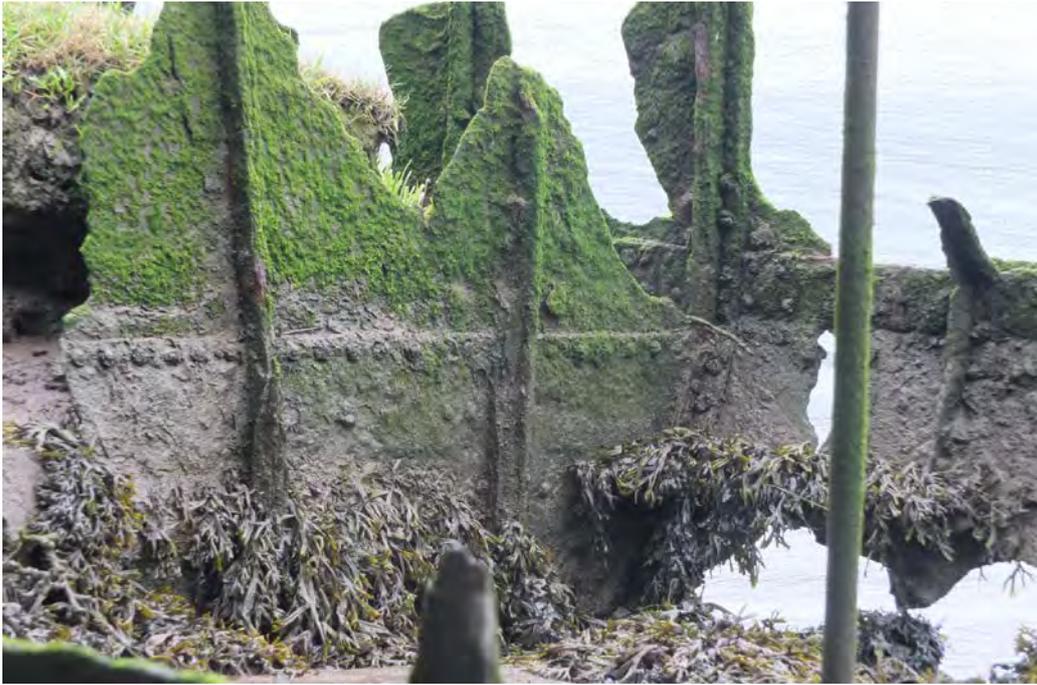
Four bulkheads survive, three forward of the paddle-wheel boxes, one aft. The bulkheads comprise overlapping steel sheets riveted to each other and onto the vessel's frames, with the rivets visible from the inside (Figure 46).

Figure 46: Bulkhead on the starboard side, from aft

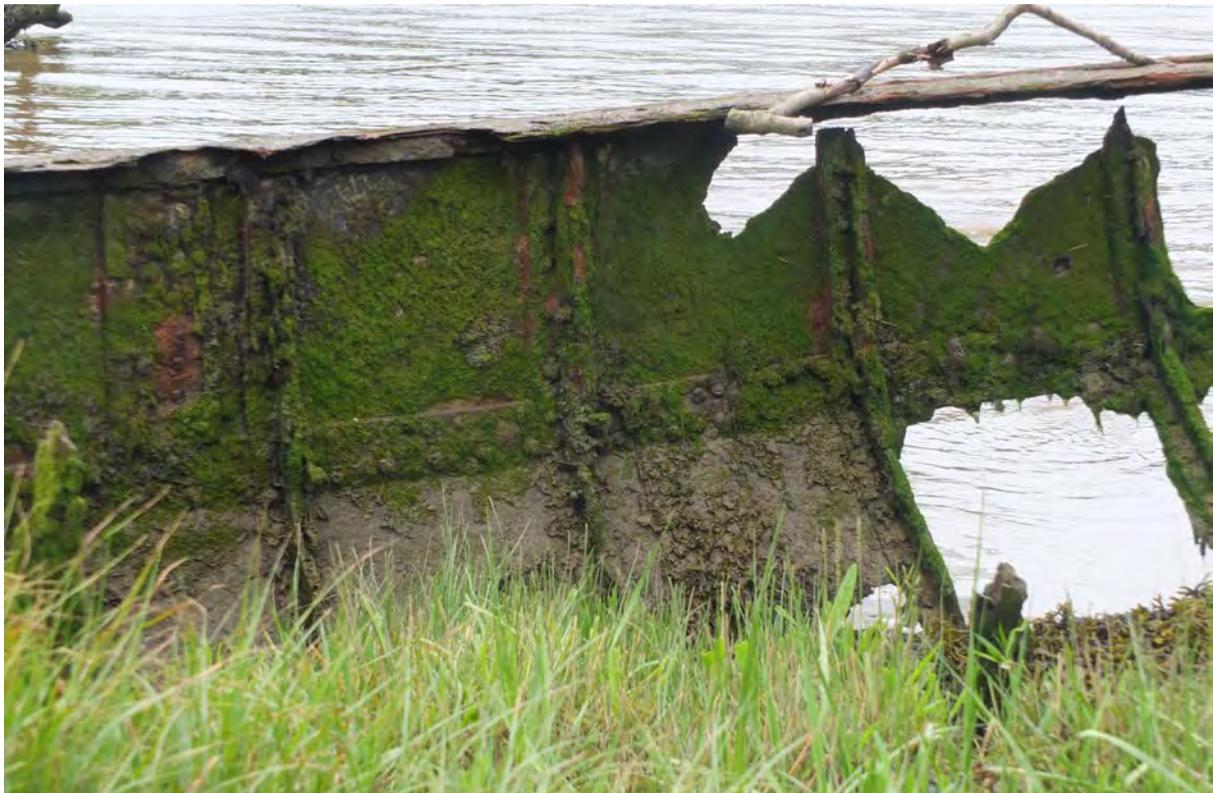
In places, the upper hull plating survives to the gunwhale and the internally riveted overlapping hull plating can be clearly seen (Figure 47).

Figure 47: Starboard side, internal hull plating

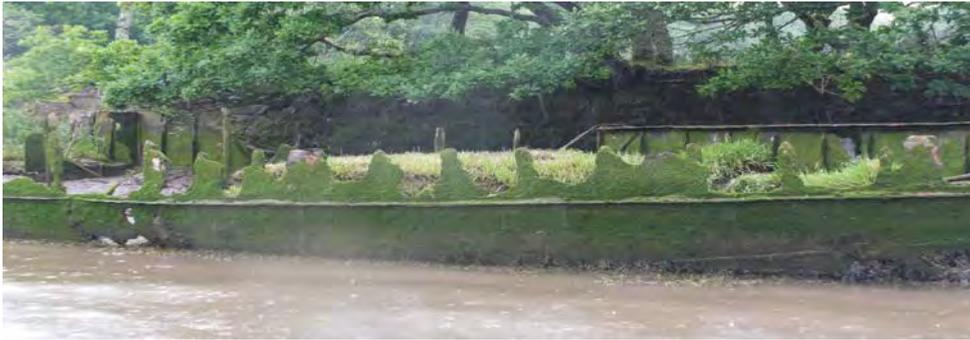
In general, the lower hull plating survives slightly better and in places only frames remain on the upper part of the hull (Figure 48).

Figure 48: Starboard side, towards the bow

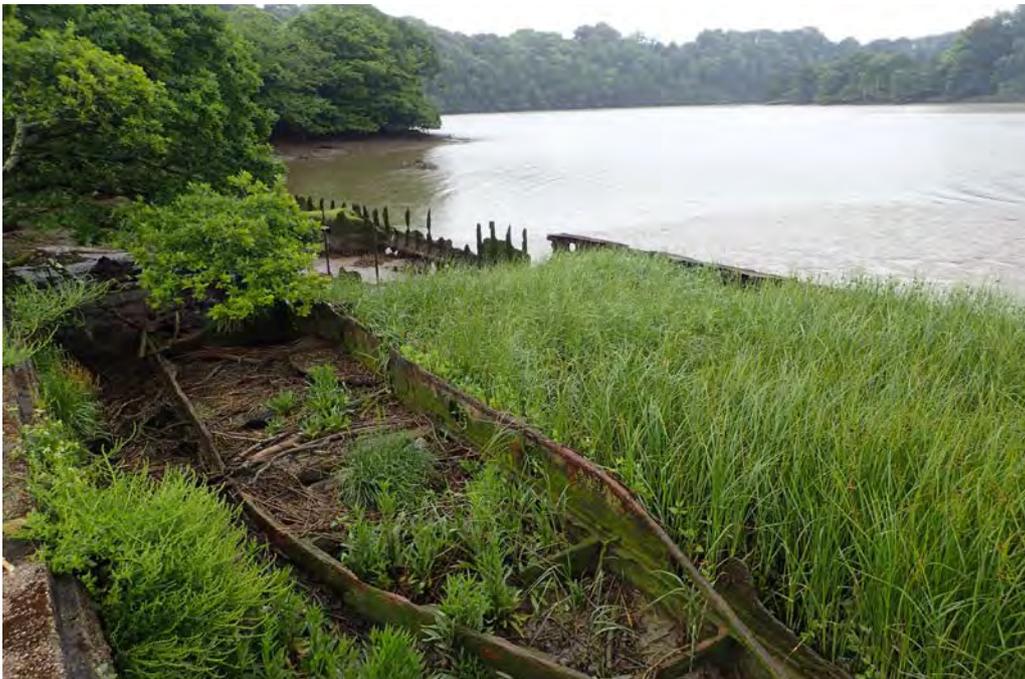
The paddle-wheel boxes are in-situ on both sides (Figures 49 and 50), and the starboard one can be seen to be falling away from the side of the vessel (Figure 50).

Figure 49: Port paddle-wheel box against the bank

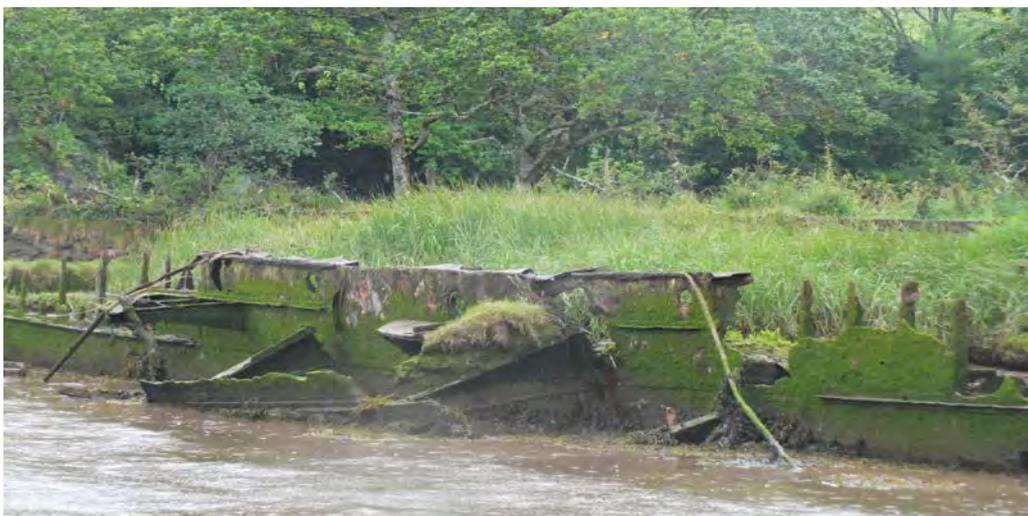
Figure 50: Paddle wheel box, breaking away from starboard side of the hull

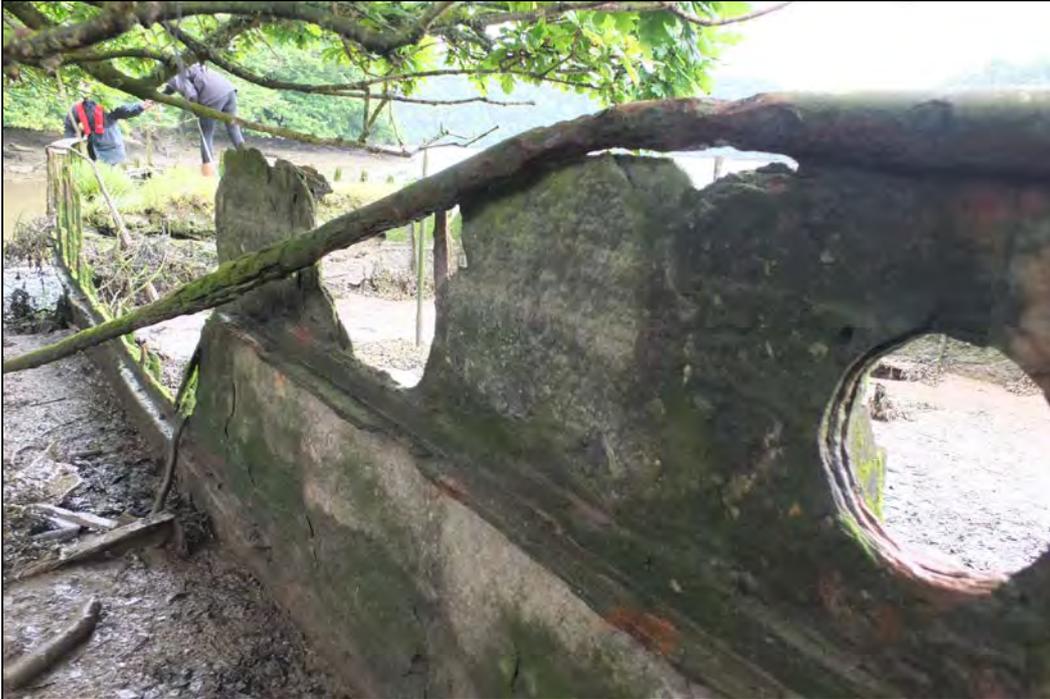
Porthole openings can be seen where upper hull plating survives (Figure 51).

Figure 51: Port side forward of paddle-wheel box

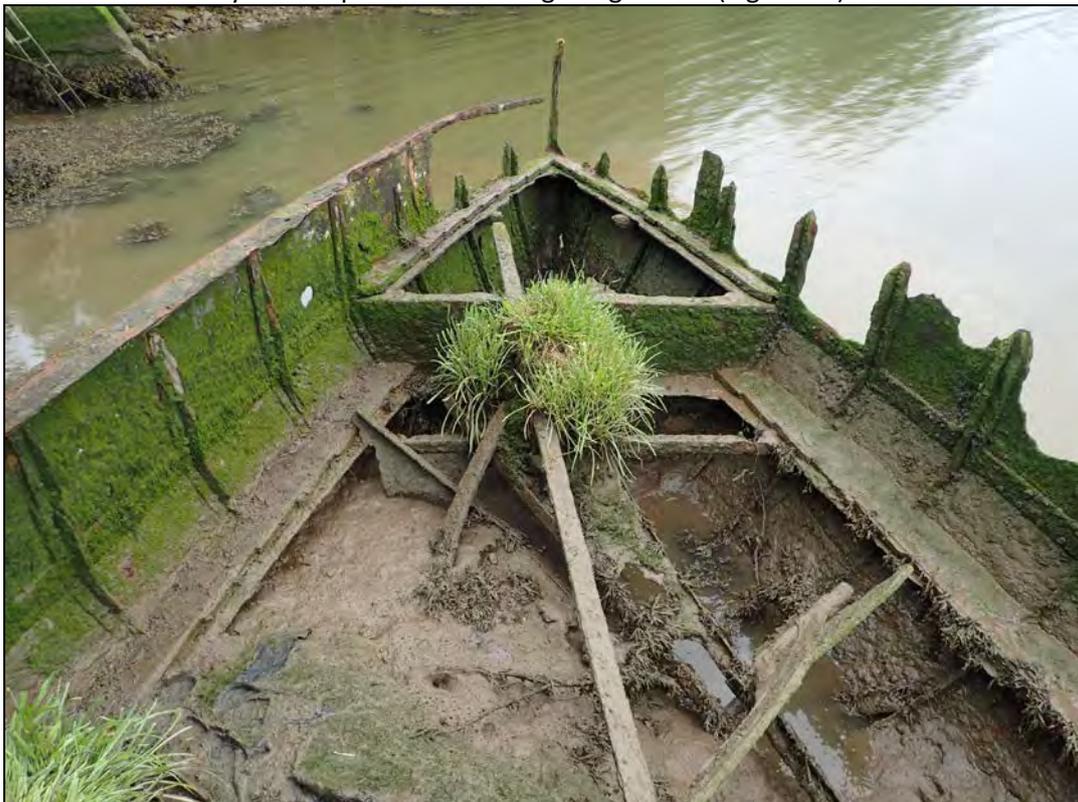
The port bow is relatively intact up to and including the gunwale (Figure 52).

Figure 52: Port bow

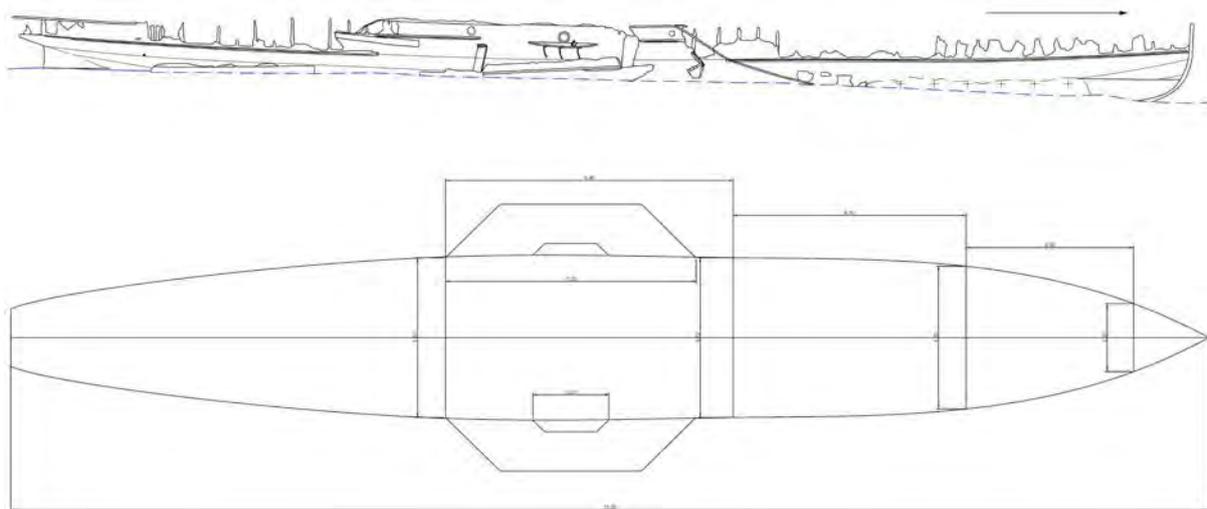
Figure 53: Measured plan of Kingswear Castle in 2016

The remains comprise the steel hull, bows lying to the west, stern to the east. The hull is approximately 34.5m in length, 4.7m breadth with a height above the mud at the bow of 2.3m and 1.3m at the stern (Figure 45).
